## **AIRPROX REPORT No 2013096**

Date/Time: 5 Aug 2013 1515Z

Position: 5622N 0022W  
(19nm E Leuchars Airfield)

Airspace: Scottish FIR/TRA007A  
(Class: C)

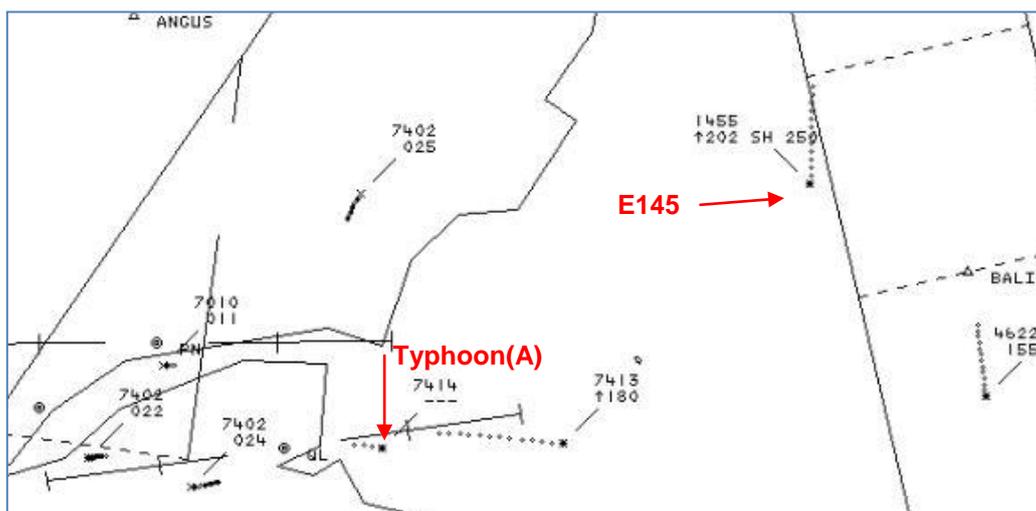
Figure 1: Prestwick MRT – 1513:29

At 1513:29 PC TAY informed the E145 pilot, "... there is traffic off Leuchars presently in your two o'clock range twelve miles heading east indicating flight level 193 climbing" (Figure 1). The E145 pilot acknowledged this information by reporting that he was, "...india mike." The Tactical controller, now aware that the 7413 squawk was out-climbing the E145, instructed the E145 pilot to turn right heading 210° to improve the geometry between the two aircraft.

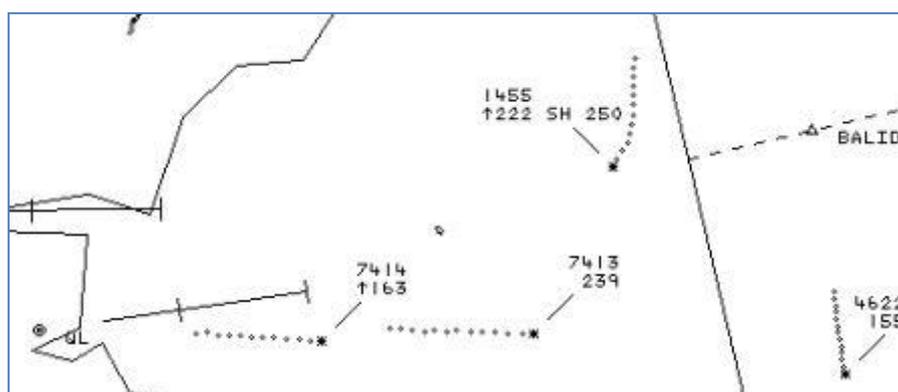
Figure 2: Prestwick MRT – 1514:30

The previous telephone conversation between Leuchars and the TAY Planner had continued and at 1514:00 the Planner requested co-ordination on the 'one behind' [the 7413 squawk]. The Planner requested that this traffic, Typhoon(A), remain 1000ft below the E145. This was co-ordinated at 1514:30 and the call terminated (Figure 2). The Tactical controller subsequently recalled being aware of this second co-ordination as it was taking place and issued a turn and passed traffic information as described below [after Figure 3].

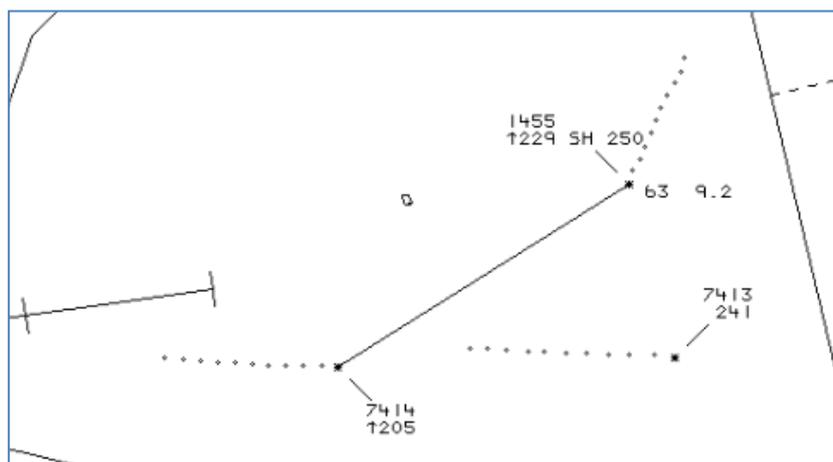
Figure 3: Prestwick MRT – 1514:55

Shortly afterwards, at 1514:54, the Planner called Leuchars back to confirm that Typhoon(A) was going to stop at FL220. Leuchars stated that it was stopping at FL220; however, there then followed an exchange in which the Planner observed that Typhoon(A) had 'bust' this level and Leuchars indicated that communications had been lost with the aircraft.

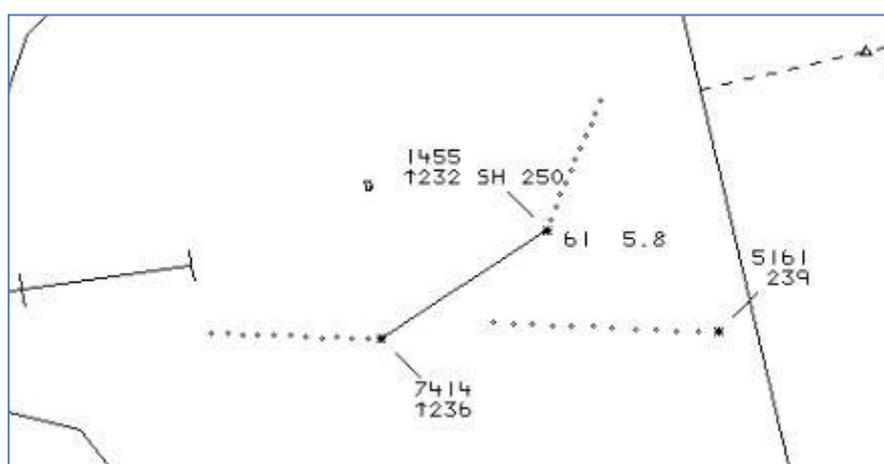
Immediately after being informed of the TA, at 1515:13, the PC TAY controller instructed the E145 pilot to, "...turn right heading 350 degrees immediately traffic indicating flight level 239 heading east." Low-level STCA activated. The E145 pilot responded, "...TCAS R A and descending." This was acknowledged by the controller. Subsequently the Tactical controller was aware that avoiding action phraseology had not been used; however, the unit believed that an appropriate urgency had been conveyed to the E145 pilot and that the crew had responded accordingly.

Figure 4: Prestwick MRT – 1515:13. NOTE: the Typhoon was now above the E145

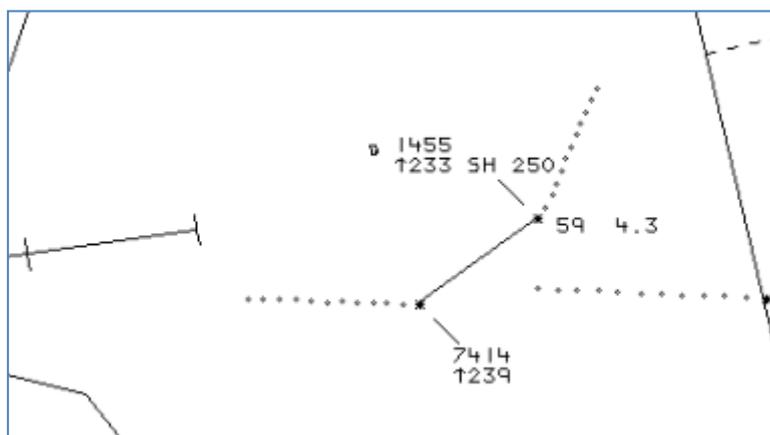
Deconfliction Minima was lost at 1515:20 when the distance between the two aircraft became 4.3nm laterally and 600ft vertically; where 5nm and/or 1000ft was required (Figure 5).

Figure 5: Prestwick MRT – 1515:20. Deconfliction Minima lost.

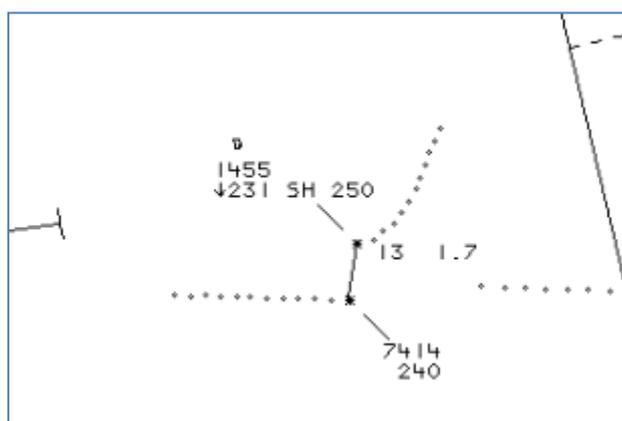
The E145 reached FL234 before descending as it turned right to pass north of Typhoon(A). Minimum distance between the two aircraft, as determined by MRT, occurred at 1515:37 when the E145 passed 1.7nm north of Typhoon(A) and 900ft below (Figure 6). Analysis of various single source surveillance recordings also showed that the closest lateral distance between the two aircraft occurred around 1515:38 (1.6 to 1.8nm); however, the Mode C of Typhoon(A) had not been displayed at this time. Immediately prior to losing Mode C detection, the single sources showed Typhoon(A) between FL239 and FL241. The NATS Separation Monitor Function (SMF) recorded a minimum distance at 1515:36 of 1.6nm and 300ft.

Figure 6: Prestwick MRT – 1515:37. Minimum distance between E145 and Typhoon as recorded by MRT.

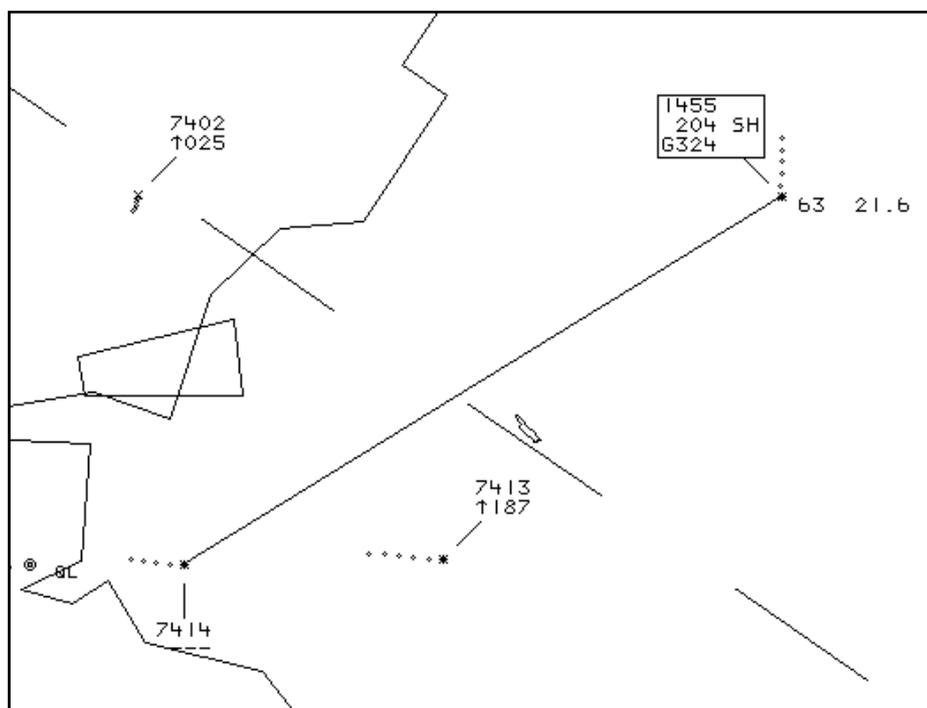
**Figure 1:** Incident Geometry at 1513:33.

The Tay sector contacted Leuchars via landline and the call was initially answered by Leuchars Approach (APP). Once it became clear that co-ordination was required, the call was transferred to Leuchars DEP at 1513:33; unfortunately, the audio from the Leuchars APP position was not impounded, thus the initial part of the call between Leuchars APP and the Tay sector was not available to BM SPA. Figure 1 depicts the incident geometry at this point; SSR 3A 7414 was Typhoon(A), SSR 3A 1455 was the E145, SSR 3A 7413 was Typhoon(B) in receipt of a Traffic Service from Leuchars DEP.

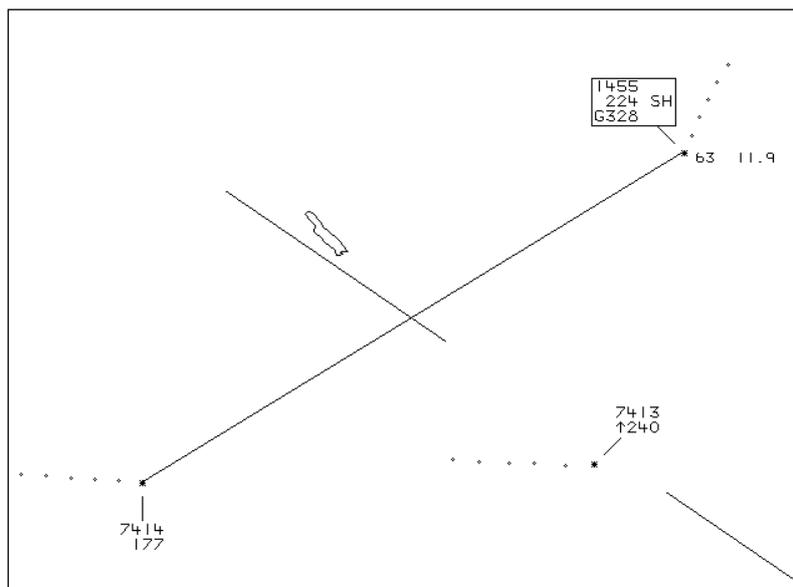
**Figure 3: Incident Geometry at 1514:39.**

The radar replay highlights that, during this landline exchange, the E145 adopted a south-westerly track from 1514:13. As the landline exchange was finishing, at 1514:25, the pilot of an unrelated GA aircraft departing Leuchars called DEP on VHF, overlapped by a further call at 1514:28 from Typhoon(B)’s pilot requesting “own nav”; both these transmissions and the transmission from the GA pilot at 1514:08 were unanswered. At 1514:33, the pilot of Typhoon(B) called Leuchars DEP again requesting a “radio check” and was advised “readability 5.” He then re-stated his request for “own nav” and was advised, at 1514:39, “err negative, remain this heading for coordination” which was acknowledged. This suggests that Leuchars DEP may have begun to confuse the identities of the two Typhoons on the RTF, as the co-ordination applied to Typhoon(A) alone. Figure 3 depicts the incident geometry at this point.

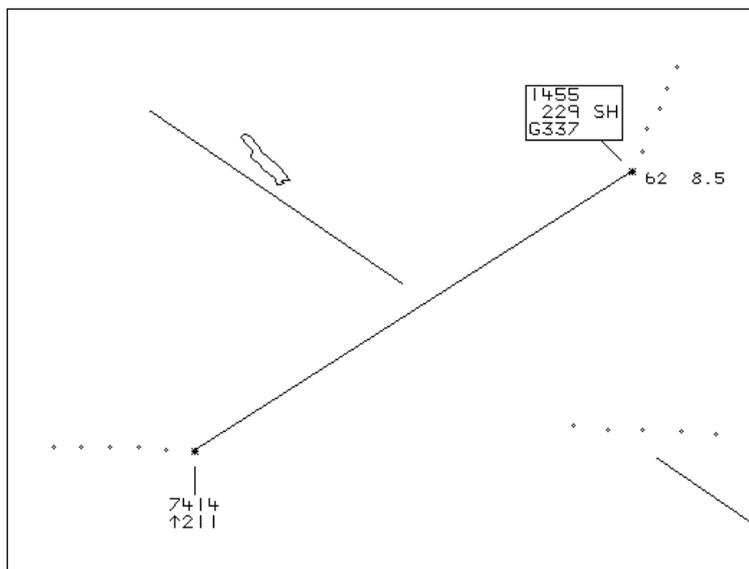
**Figure 4:** Incident Geometry at 1514:58.

At 1514:44, Leuchars DEP instructed Typhoon(B)'s pilot to "squawk 5-1-6-1" in preparation for handing the aircraft over to CRC Hotspur. At 1514:50, the pilot of the GA aircraft who had called Leuchars DEP earlier called again. The trainee was heard on the 'live-mic' expressing frustration and the instructor was heard saying "you're ok mate." The trainee then responded to the GA pilot, instructing him to stand-by and, at 1514:58, a voice was heard on the 'live-mic' asking "is he [Typhoon(A)] stopping at 2-2-0?" Figure 4 depicts the incident geometry at this point.
