AIRPROX REPORT No 2013102

Date/Time: 14 Jul 2013 1752Z (Sunday)

Position: 51 44N 001 24W
(6.7nm SE of Brize Norton)

Airspace: Brize Norton CTR (*Class:* D)

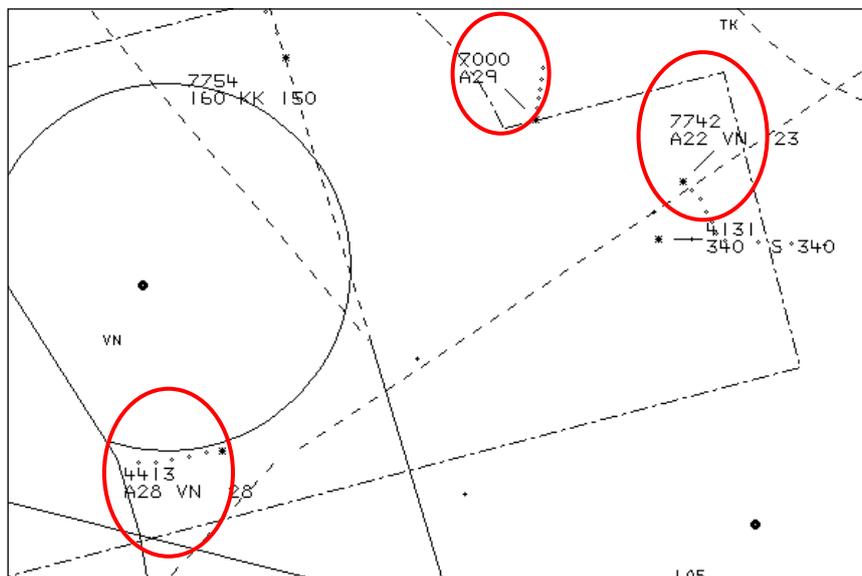
Figure 1: Incident Geometry at 1751:07.

The incident sequence commenced at 1751:07 as the Beech 76 entered the Brize Norton CTR without clearance from, and not in communication with, Brize Norton ATC. Figure 1 depicts the incident geometry at this point; SSR Mode 3A 4413 is the Falcon 900, SSR Mode 3A 7000 is the Beech 76 and SSR Mode 3A 7742 is an unrelated B747 also inbound to Brize Norton. Twenty-six secs previously, Director had issued a closing heading for the ILS to the B747, warning them of the presence of the Beech 76 outside the CTR. The Aerodrome Controller, who was the ATCO I/C of the shift monitoring the situation on the Hi-Brite display within the VCR, advised Director via the radar clearance line "if it [the Beech 76] comes in, avoid it." Shortly after, the Beech 76 entered the CTR and Director issued avoiding action to the B747.

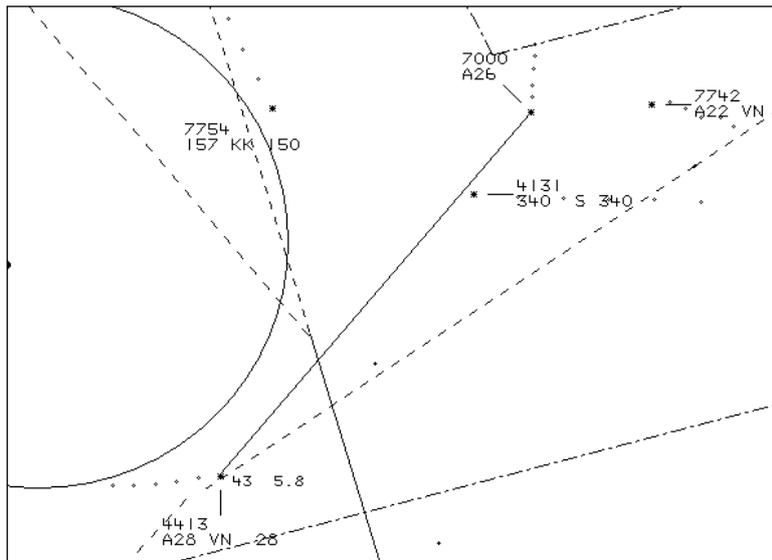
Figure 2: Incident Geometry at 1751:26.

After the conflict between the unrelated B747 and the Beech 76 was resolved, Director instructed the Falcon 900, at 1751:26, to "turn left heading 0-7-5. Traffic north-east, 5 miles, tracking south, indicating 300 feet below." The Falcon 900's pilot read back the control instruction and advised that they were "looking for traffic 5 miles north-east." Figure 2 depicts the incident geometry at the point that Director passed this Traffic Information. A vector of 075° is a standard downwind heading in use at Brize Norton to parallel the southern edge of the CTR.

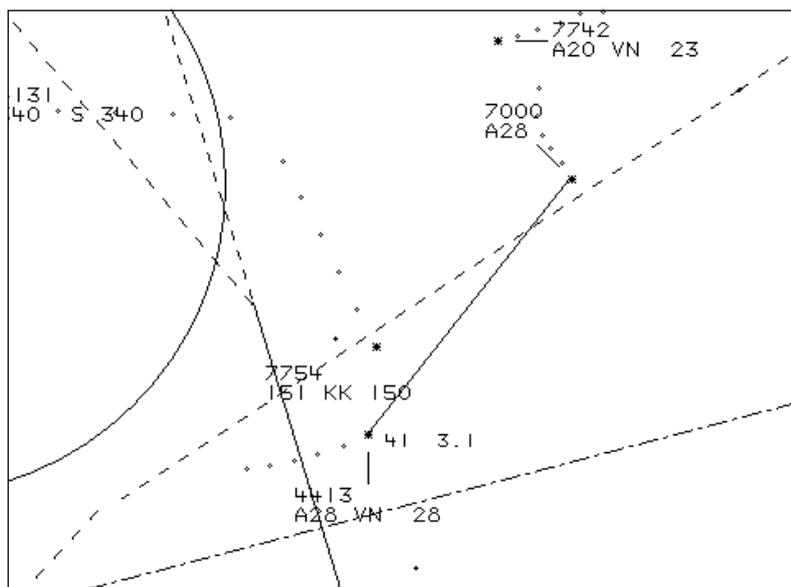
Figure 3: Incident Geometry at 1752:03.

Director was then involved in an exchange of R/T with the unrelated B747 until 1752:03, when they updated the Traffic Information on the Beech 76 to the Falcon 900, advising them “previously reported traffic now 11 o'clock, 4 miles, crossing left-right, indicating 100 feet below.” In reply, the Falcon 900 pilot advised Director that they were “visual with traffic.” Figure 3 depicts the incident geometry at this point.

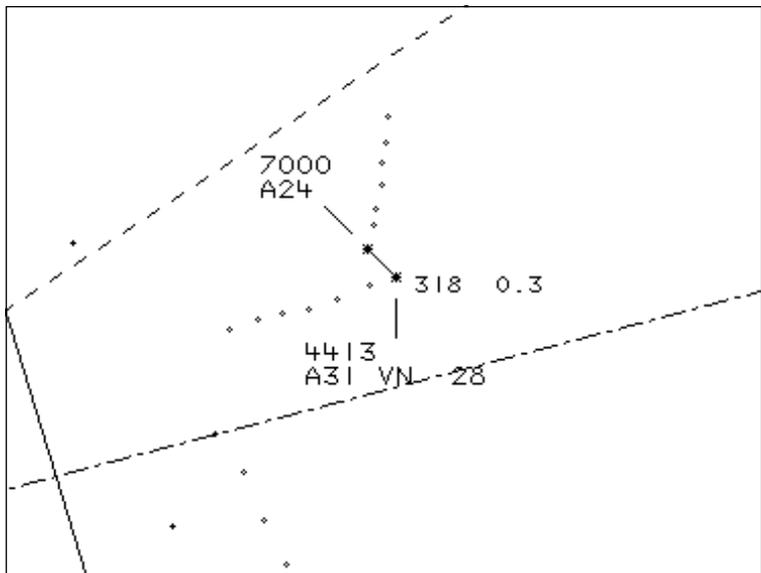
Figure 4: Incident Geometry at 1752:42.

responding to a TCAS RA, and then reported at 1752:48 that they were “clear of conflict, remaining at 2300 feet.” The CPA occurred between sweeps of the radar replay at 1752:40, as the Beech 76 passed 0.3 nm North-North-West of the Falcon 900, indicating 700 ft below; figure 4 depicts the incident geometry at 1752:42.
