## **AIRPROX REPORT No 2013108**

Date/Time: 9 Aug 2013 1450Z

Position: 5154N 00210W  
(1.3nm E Gloucestershire A/D  
- elevation 101ft)

Type: Merlin HC3 Mooney M20C

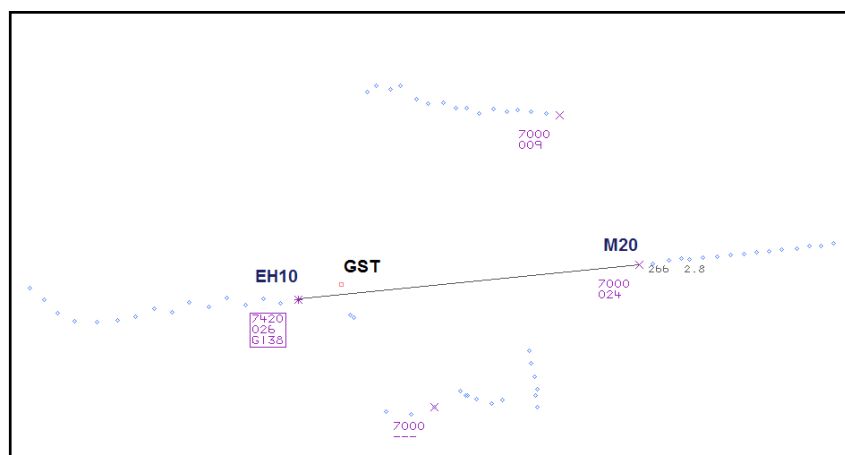
Figure 2 – Swanwick MRT at 1450:00

At 1450:00 the Merlin pilot reported, *“[Merlin C/S] beacon outbound”*. After a 10sec pause the controller replied, *“[Merlin C/S] report commencing the base turn”*. This was acknowledged *“[Merlin C/S] Wilco”*. The two aircraft were on reciprocal tracks, with a horizontal distance of 2.8nm and a vertical separation of 200ft (Figure 2).

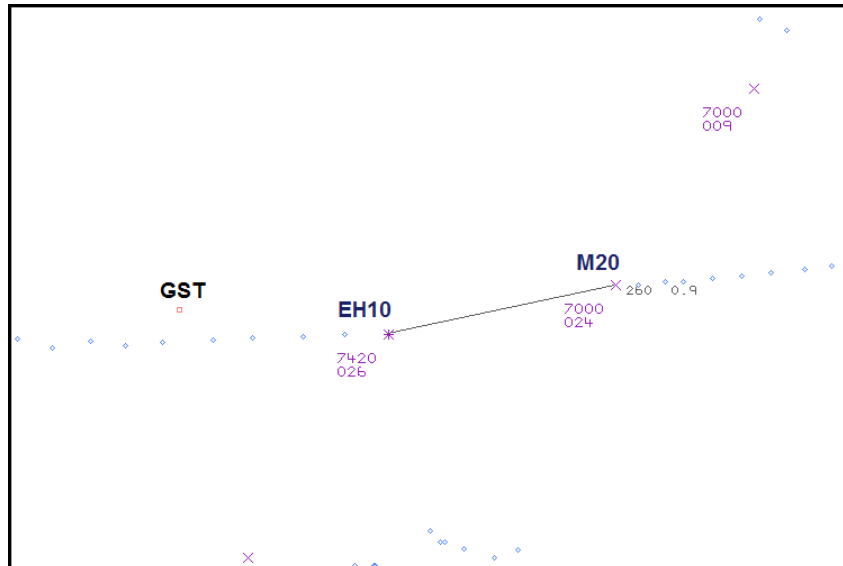
Figure 3 – Swanwick MRT at 1450:27

At 1450:27 the Merlin was Beacon Outbound indicating FL026 (2800ft) with the M20 slightly left of the Merlin’s 12 o’clock at a range of 0.9nm indicating 200ft below (Figure 3). At this point the handover of the Tower frequency was completed and the frequencies split.

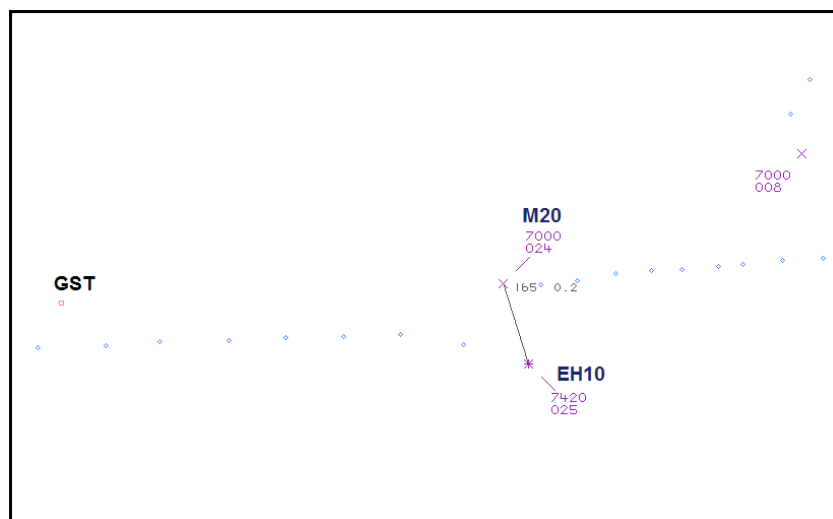
Figure 4 – Combination picture of Swanwick MRT and CLH as single source at 1450:44

At 1450:44 the two aircraft passed abeam at a horizontal distance of 0.2nm and a vertical separation of 100ft. The Merlin pilot's written report indicated that he took no form of avoiding action, his right turn presumably being the outbound turn for the procedure (Figure 4).

Cause: In the absence of Traffic Information, the Merlin pilot descended into conflict with the Mooney.

Degree of Risk: A.

It is recommended that prior to the implementation of combined Aerodrome and Approach arrangements at non-mandated times, the ATSU take action to ensure that appropriate limitations and restrictions are applied to ensure traffic levels are adequately managed.

It is recommended that the ATSU introduce a means for the robust control of the vertical environment in situations when aircraft are using the GST holding pattern prior to commencing an instrument approach and ensure that controllers utilise the appropriate phraseology tools for aircraft vacating passing or reaching assigned levels.
