The incident occurred at 1042:37, 2.6nm south-southeast of Oxford Airport, within Class G airspace between a Grob Tutor G115E and a Cessna 550 Citation Bravo. The Tutor pilot was making a VFR recovery and was in receipt of a Traffic Service from Benson APR on UHF frequency 376.650MHz. The C550 pilot was operating IFR on a flight inbound to Oxford, for an ILS approach to RW19 and was in receipt of a Procedural Service from Oxford APP on frequency 127.750MHz. An extract from the UK AIP, Page AD 2-EGTK-8-2, dated 20 Sep 12, Oxford Instrument Approach chart, is reproduced below, see Figure 1.

A Tutor and a C550 flew into conflict at 1043 on 4<sup>th</sup> October, 2.6nm south of Oxford Airport. The Tutor pilot was operating under VFR, in receipt of a Traffic Service from RAF Benson, the C550 pilot under IFR and in receipt of a Procedural Service from Oxford.

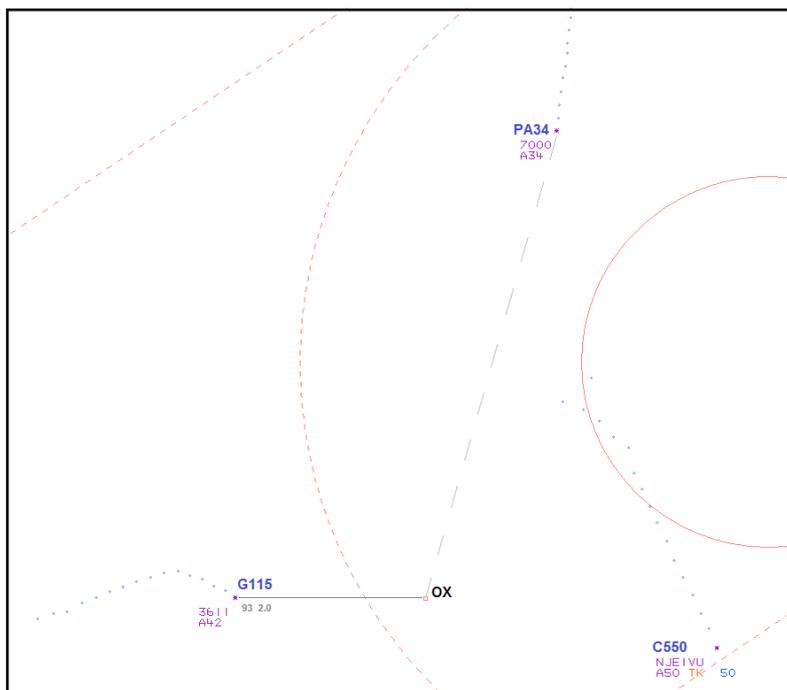
Figure 2: Swanwick MRT at 1040:30

At 1040:30, Benson APR contacted Oxford APP and advised that the 3611 squawk [the Tutor], 2nm west of the Oxford ATZ, was descending to 3500ft. The Oxford controller reported that he had traffic inbound about 4nm to the north, inbound to the 'OX' at 3500ft to follow the entry procedure and then go straight outbound and other traffic which was in the hold southeast of Oxford at 5000ft, see Figure 2.

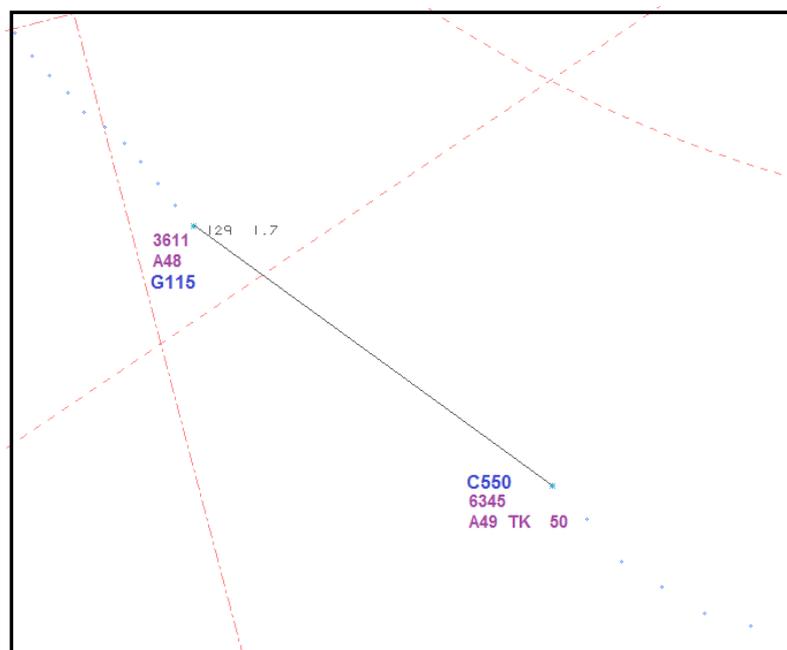
Figure 3: Swanwick MRT at 1041:58

Benson APR advised Oxford APP that the Tutor pilot was now stopping the descent at 4000ft, which was acknowledged by Oxford. The Tutor pilot descended to 3900ft and, at 1040:57, commenced a right turn onto southwest followed by a left turn onto southeast and then started to climb. At 1041:58, the C550 pilot was turning back towards the OX at 5000ft and the Tutor pilot was on a reciprocal track at a range of 3.9nm indicating 4800ft, see Figure 3.

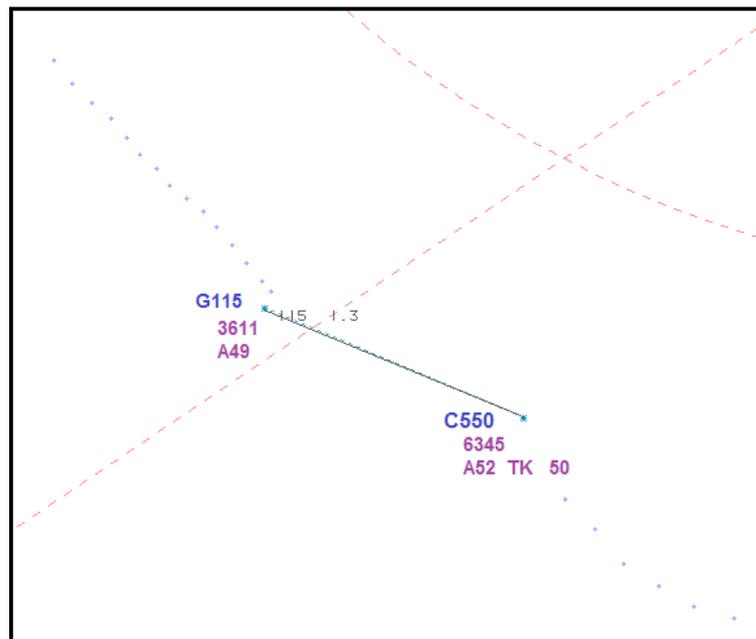
Figure 4: Swanwick MRT at 1042:37

At 1042:21, the C550 pilot reported a TCAS RA which was acknowledged by the controller. At 1042:37, the Tutor pilot made a right turn at 4900ft and the C550 was shown in the climb passing 5200ft. The lateral distance between the two aircraft was 1.3nm and vertical distance was 300ft, see Figure 4.

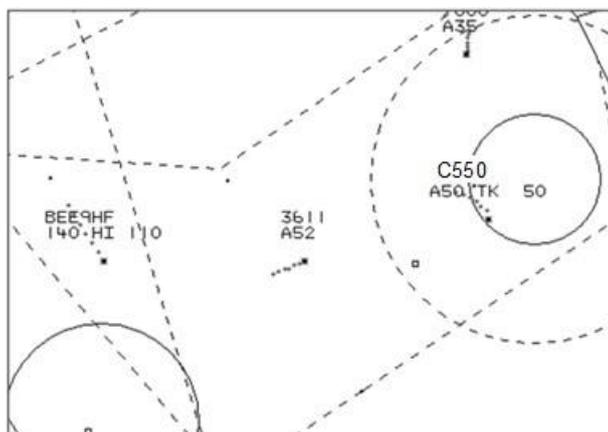
Figure 1: Tutor squawking 3611 and C550 at 1039:47

At 1039:47, the Tutor pilot requested descent to 3,500 feet, to enable a VFR recovery. APR asked if the Tutor pilot was planning to route via the Oxford overhead and the Tutor pilot replied, 'Negative, we were just er twelve miles north er northeast of Brize Norton.'

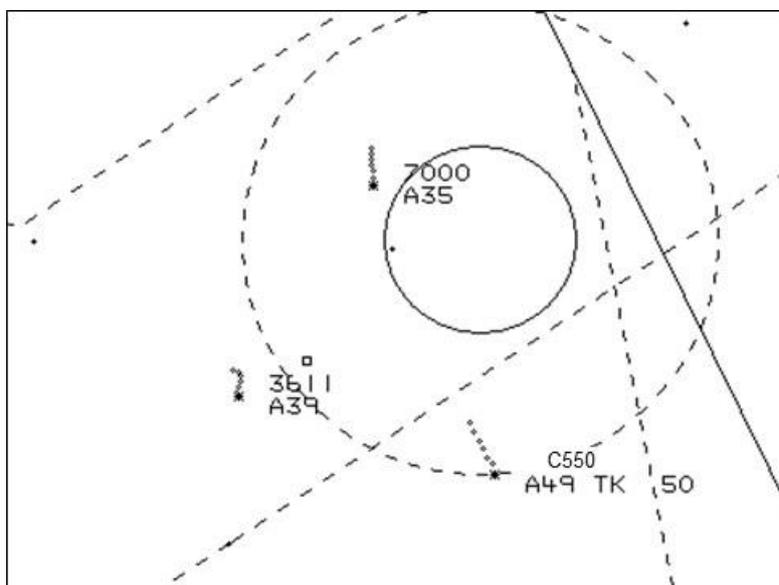
Figure 2: Aircraft geometry at 1041:07

The APR passed TI on the Tutor's descent to Oxford and received an update on two aircraft inbound to Oxford. Following the update from Oxford, the APR controller passed TI to the Tutor pilot at 1041:07. The radar replay, at Figure 2, captures the traffic situation at 1041:07; the TI from APR is accurate and timely.

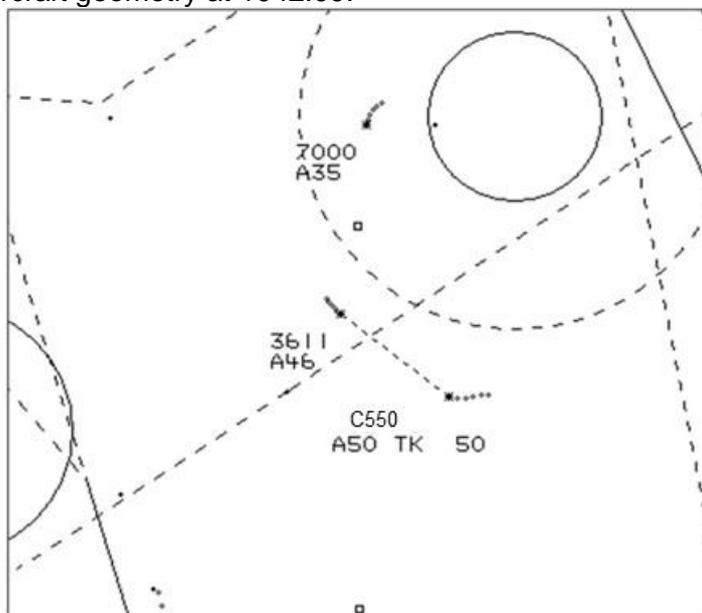
Figure 3: Aircraft geometry at 1042:09

The Tutor pilot copied the TI and changed intention to climb back to 5000ft, to remain VFR, and requested a radar pick up. The Benson APR updated the C550 position on three occasions, at 1041:59, 1042:09 and 1042:46 and at 1042:20 suggests that the Tutor pilot stops the climb; Figure 3 shows the aircraft geometry at 1042:09.

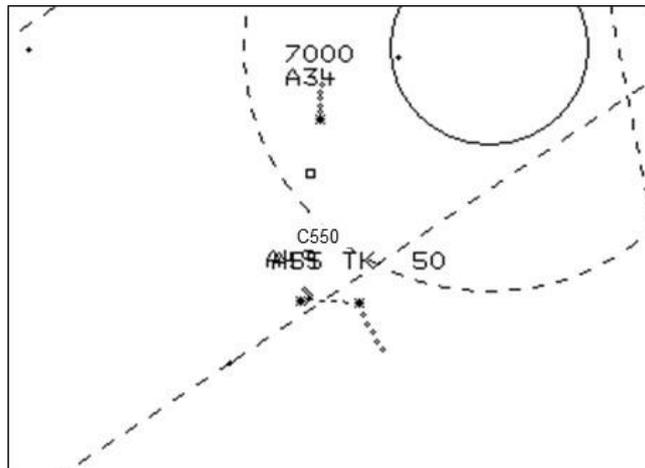
Figure 4: Aircraft geometry at 1042:46

Throughout the incident, the APR controller constantly updated the Tutor pilot; the update at 1042:46, at Figure 4, demonstrates that the Tutor pilot had initiated a turn to the southwest and that the C550 pilot's inbound track would take it down the left hand side of the Tutor, with separation on the radar replay being reduced to 1.1nm. Oxford called Benson APR by landline at
