AIRPROX REPORT No 2013156

Date/Time: 5 Nov 2013 1202Z

Position: 5138N 00039W
(Bovingdon hold)

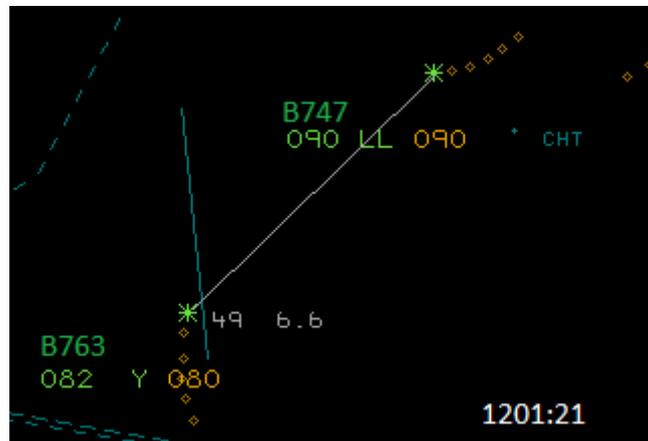
Figure 1.

At 1201:20 the radar display indicated that the B767 was passing FL82, 6.6nm SW of the B747 (Figure 1) and the NW Deps controller asked the B767 pilot to confirm that he had 1013hPa selected and instructed him to turn left heading 270°. The B767 pilot read back the instruction to turn onto 270° and read back '1013'.

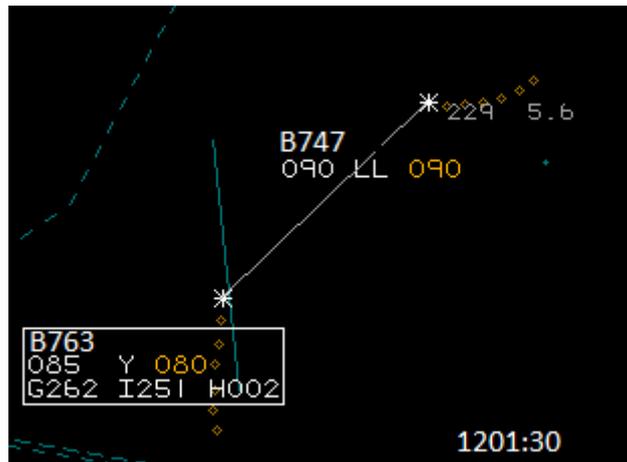
Figure 2.

At 1201:26 low level STCA activated between the B767 and the B747 in the BNN hold. The Mode S from the B767, as obtained from the radar replay, indicated that its Barometric Pressure Setting (BPS) was 991hPa. At 1201:30, the NW Deps controller informed the B767 pilot that his aircraft was indicating FL85 (Figure 2) and to, "turn left now heading 270 degrees". At 1201:32 the INT N mentor, having noticed that the B767 pilot had 'bust' his level, took over from his trainee to give avoiding action to the B747 pilot, "avoiding action, turn right now heading zero two five". At 1201:36 the NW Deps controller instructed the B767 pilot, "avoiding action turn left heading 270 degrees". Traffic Information was passed to the B747 pilot on the B767; the B747 pilot queried the heading. The heading of 025° was re-iterated by the INT N DIR.

At 1201:40 the radar replay showed that the B767 was at FL86 and the BPS from the B767 changed to 1013hPa. The B767 pilot descended to FL80 before he asked the NW Deps controller to confirm that it was a right turn to 270°. The NW Deps controller instructed the B767 pilot to fly a heading of north and to maintain FL80 on 1013hPa.
