AIRPROX REPORT No 2013163

Date/Time: 21 Nov 2013 1452Z

Position: 5220N 00132W
(Coventry ATZ)

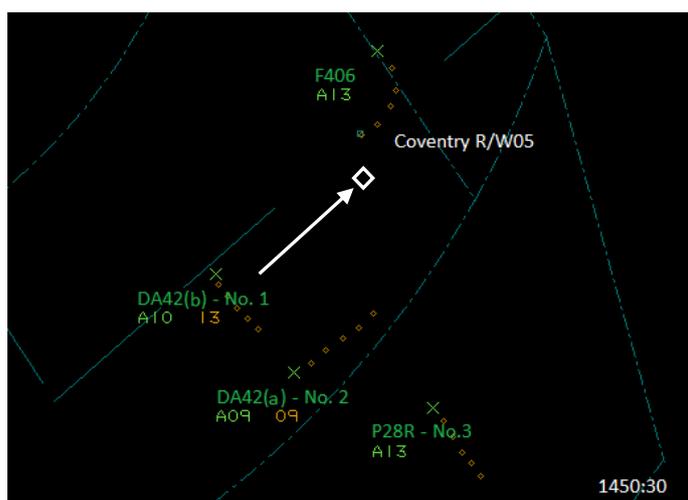
The F406 pilot was operating under VFR and was in receipt of an Aerodrome Control Service from Coventry TWR. The DA42(a) pilot was operating under VFR and was also in receipt of an Aerodrome Control Service from Coventry TWR. Prior to the incident, the Coventry TWR had a number of training aircraft on frequency. He reported his workload as high due to language problems. Just prior to the incident there were a number of crossed transmissions on the frequency. Figure 1 below shows an area radar recording screenshot displaying the traffic situation at 1450:30.

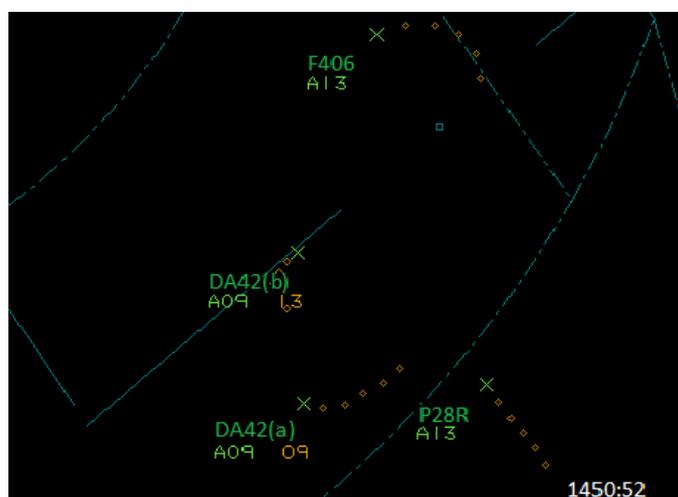
Figure 2

At 1450:52, the F406 pilot called ready for left base (see Figure 2). DA42(a) had started the turn towards base and was 1.8nm behind DA42(b).

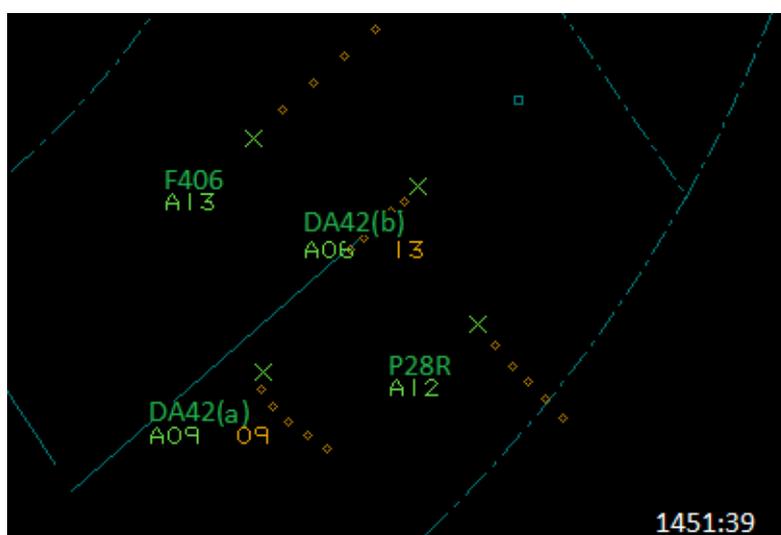
Figure 3

At 1451:39, the DA42(b) pilot reported on short final and was cleared to land. The DA42(a) pilot had started a right turn onto final, and the F406 pilot had not yet turned left base (see Figure 3).

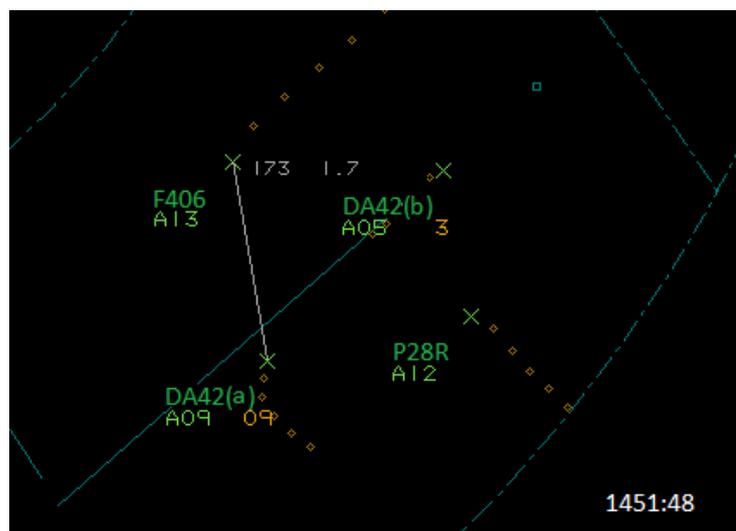
Figure 4

At 1451:48, the Coventry TWR informed the F406 pilot, without any urgency or authority, that "*traffic's cut in front three mile final is a Twinstar report visual*" (see Figure 4).

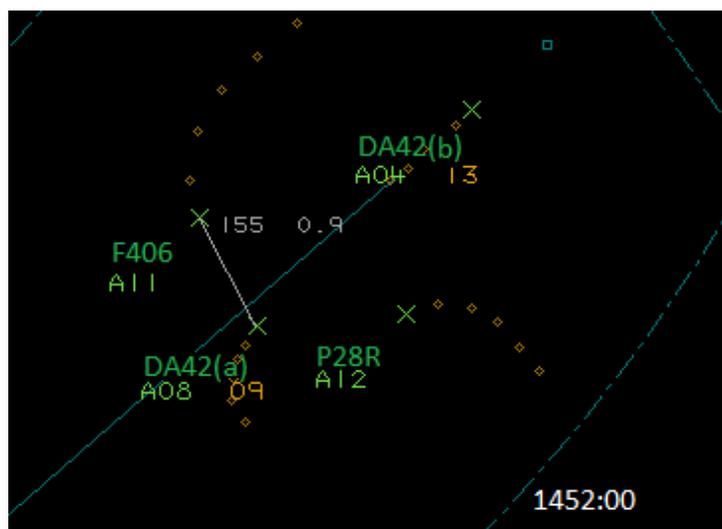
Figure 5

The F406 pilot replied that he was visual with a Twinstar that was on short final and then, at 1452:00, see Figure 5, "*oh yeah sorry it's in our twelve now*".

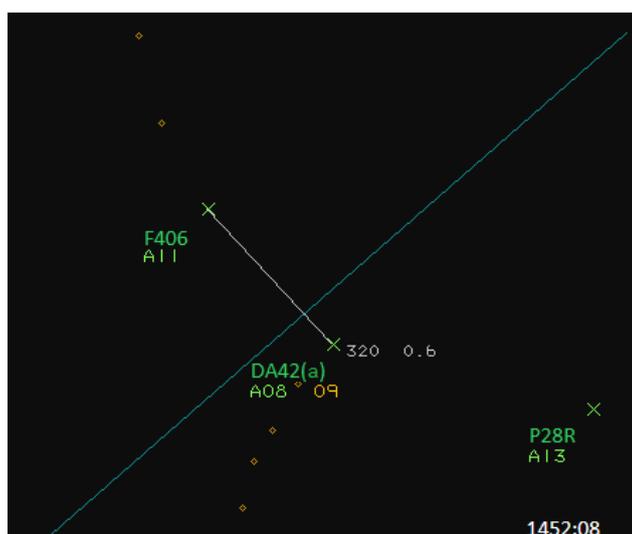
Figure 6

The two aircraft were 0.9nm apart when the controller instructed the F406 pilot to turn left to avoid the traffic and reposition onto a base leg. The F406 replied that he would do a right-hand orbit for spacing (see Figure 6).
