AIRPROX REPORT No 2013175

Date/Time: 12 Dec 2013 1226Z

Position: 5150N 00119W
(Oxford NDB)

Airspace: London FIR (Class: G)

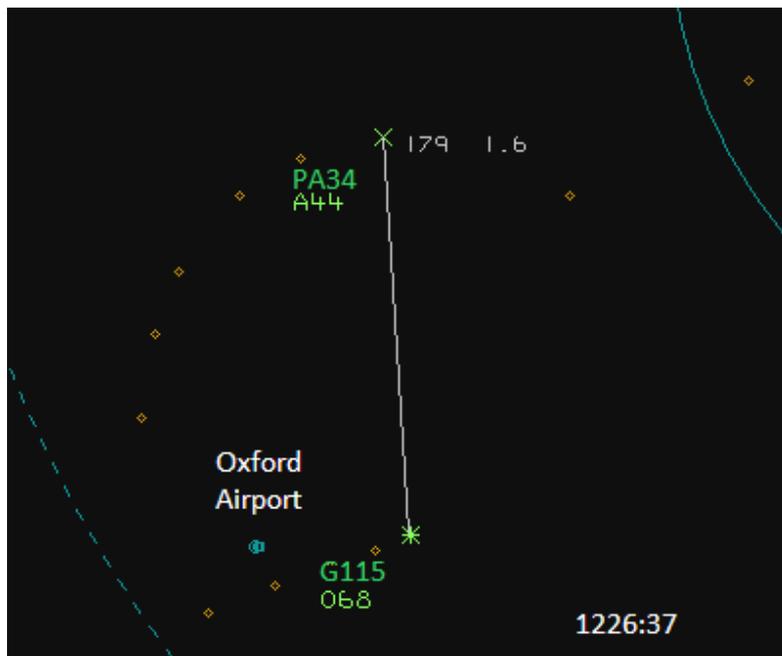
Figure 1.

The Tutor pilot maintained FL73, manoeuvring in the vicinity of the OX hold, until 1226:37 when the Mode C from the Tutor changed to FL68 (Figure 1).

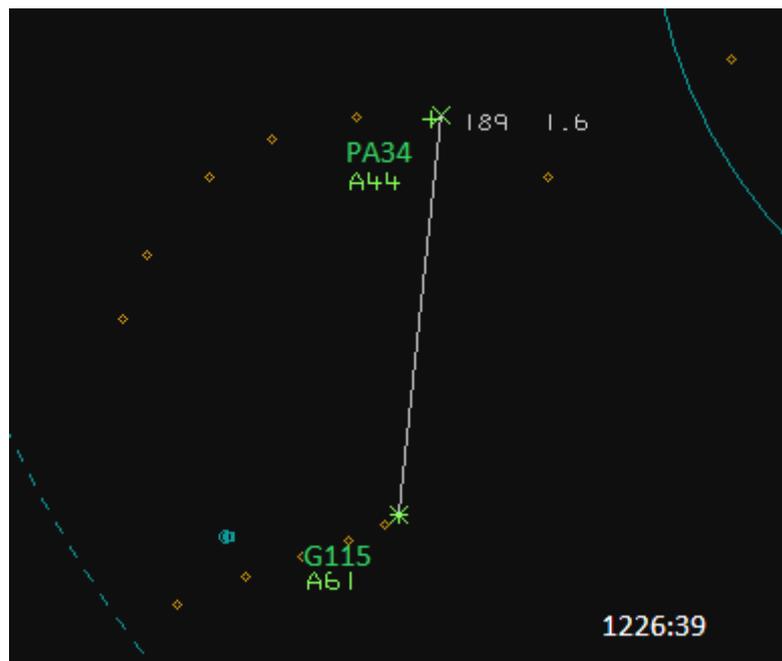
Figure 2.

On the next update of the area radar recording the Tutor was shown at altitude 6100ft with the Mode S rate of descent indicating 7600fpm (Figure 2).

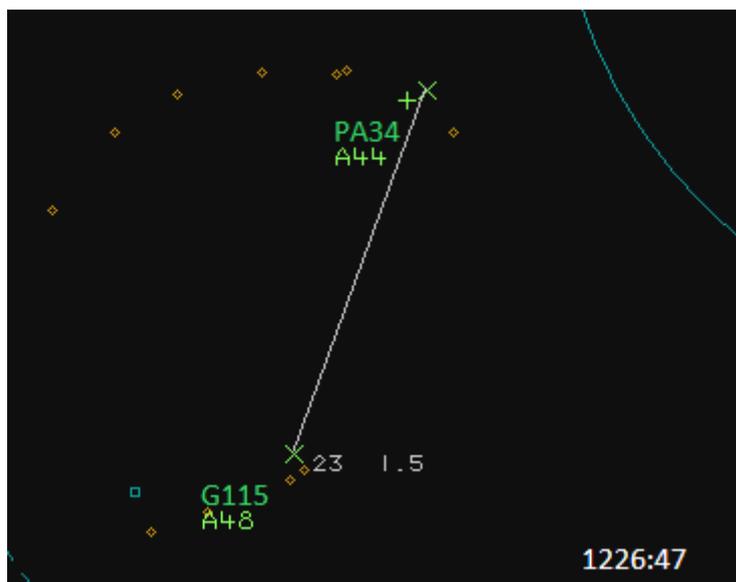
Figure 3.

At 1226:47 the Tutor was shown 1.5nm south-southwest of the PA34 at altitude 4800ft with the Mode S rate of descent indicating 9800fpm (Figure 3). The Tutor pilot subsequently climbed away to the west at approximately 500fpm.

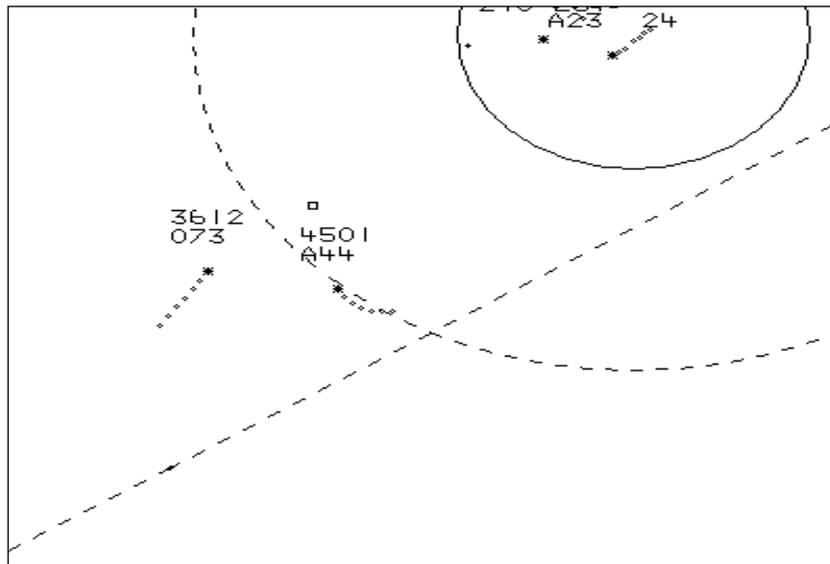
At 1224:55 the APP controller provided Traffic Information to the Tutor pilot, “[Tutor C/S] *traffic south east one mile tracking north west indicating three thousand feet below.*” The radar replay at 1224:55 (Figure 1) demonstrates accurate Traffic Information was issued by the APP controller. The Closest Point of Approach for horizontal separation was at 1225:27 at 0.3 nm, at which point vertical separation was 2900ft.

Figure 1: Aircraft geometry at 1224:55 (3612 Tutor, 4501 PA34).

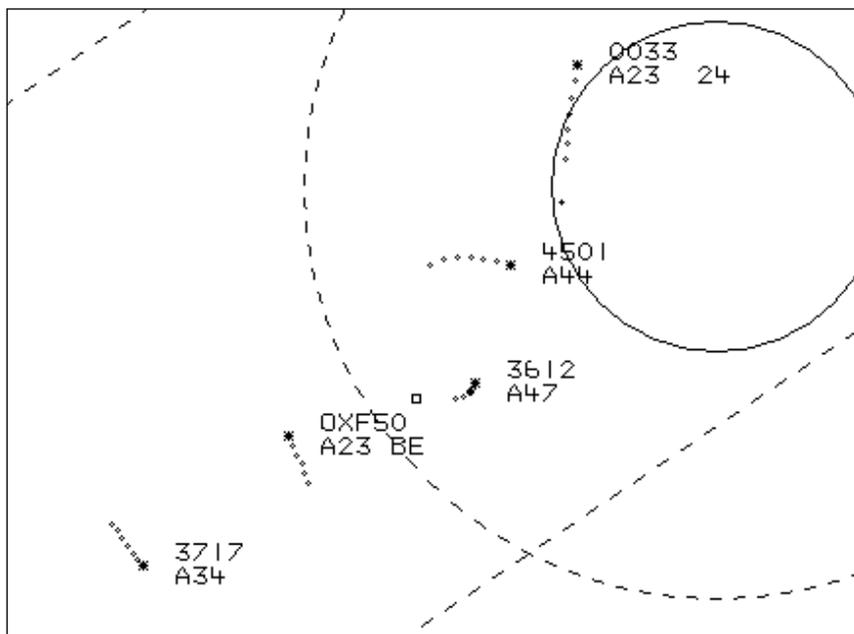
At 1226:47 the aircraft were at their closest points vertically at 300ft, at which point horizontal separation was 1.5nm (Figure 2). At 1228:11, the APP controller attempted to call the Tutor pilot to provide an update; he made seven broadcasts to the Tutor pilot and was eventually answered at 1229:15. The update from the APP controller at 1229:16 was “[Tutor C/S] *traffic south east two miles tracking north, indicating two thousand feet below. He is operating in the Oxford hold, they are requesting if you could manoeuvre away from their overhead, understand you’re above it but their hold’s up to 4000 feet.*” The Tutor pilot replied with, “*Approach, [Tutor C/S] we’re trying to complete ??? exercise so whilst we’ll do our best err this is the err best area where the weather as it is right now.*”

Figure 2: Aircraft geometry at 1226:47.

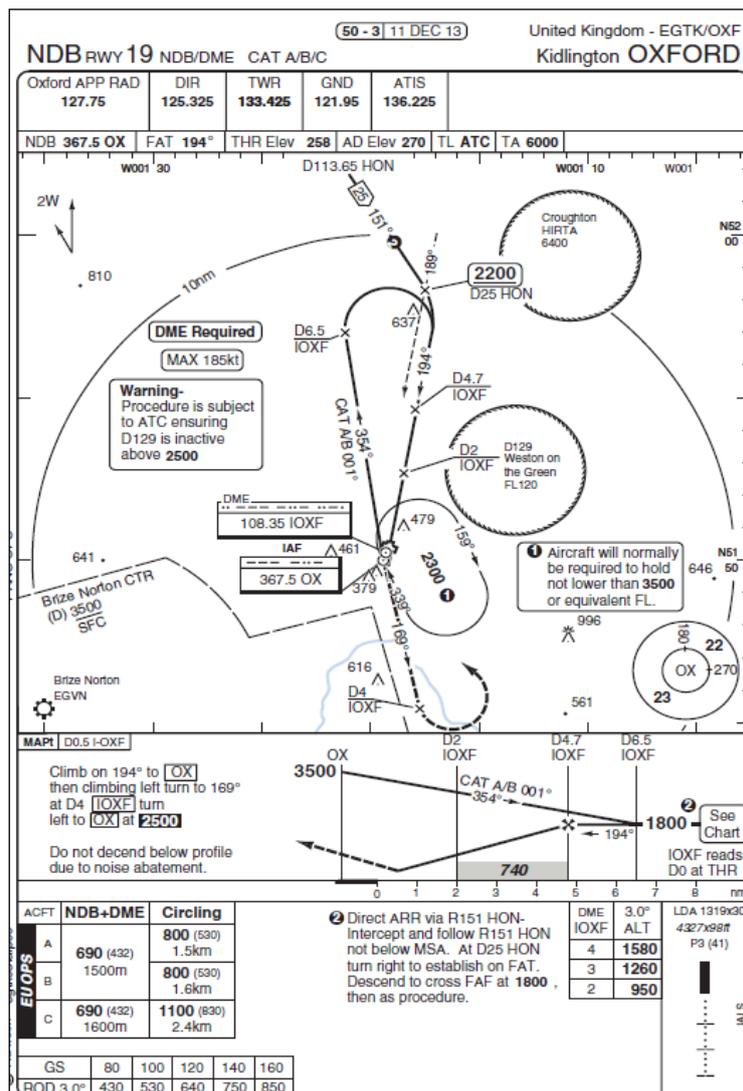
Figure 3: Oxford NDB procedure RW 19.

There is limited protection for an aircraft in IMC, in an NBD Hold in Class G airspace, particularly in an area where traffic gets funnelled due to airspace constraints.
