AIRPROX REPORT No 2014025

Date/Time: 24 Mar 2014 1537Z

Position: 5142N 00038W
(3.5nm SW of Bovington)

Airspace: London FIR (Class: G)

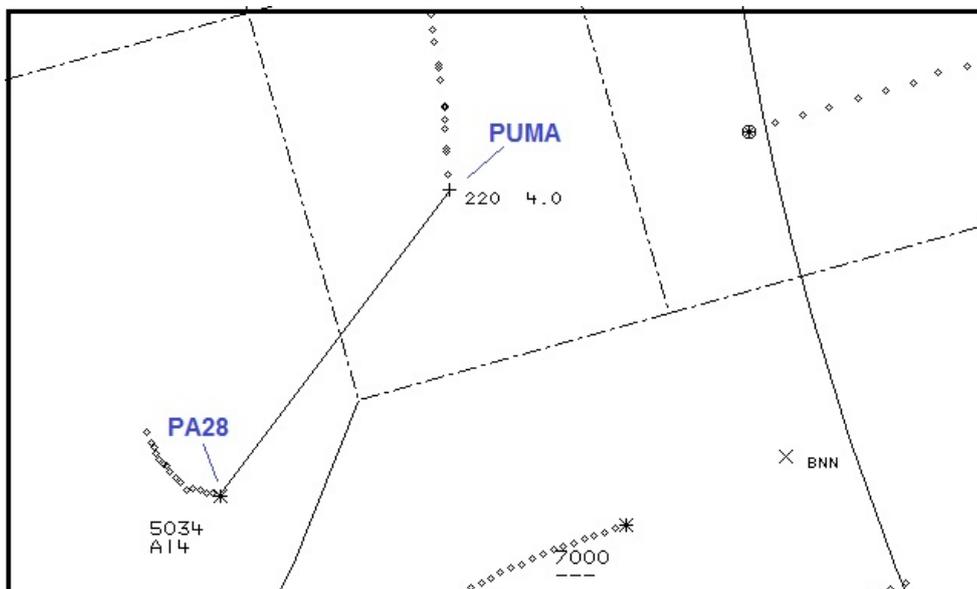
Figure 1 – Swanwick MRT at 1535:24

At 1535:24 the PA28 was 6nm west-southwest of BNN⁸ and having just completed a manoeuvre was tracking east and climbing through 1400ft. The Puma was 4nm northeast of the PA28 tracking south and shown only as a primary contact - Figure 1.

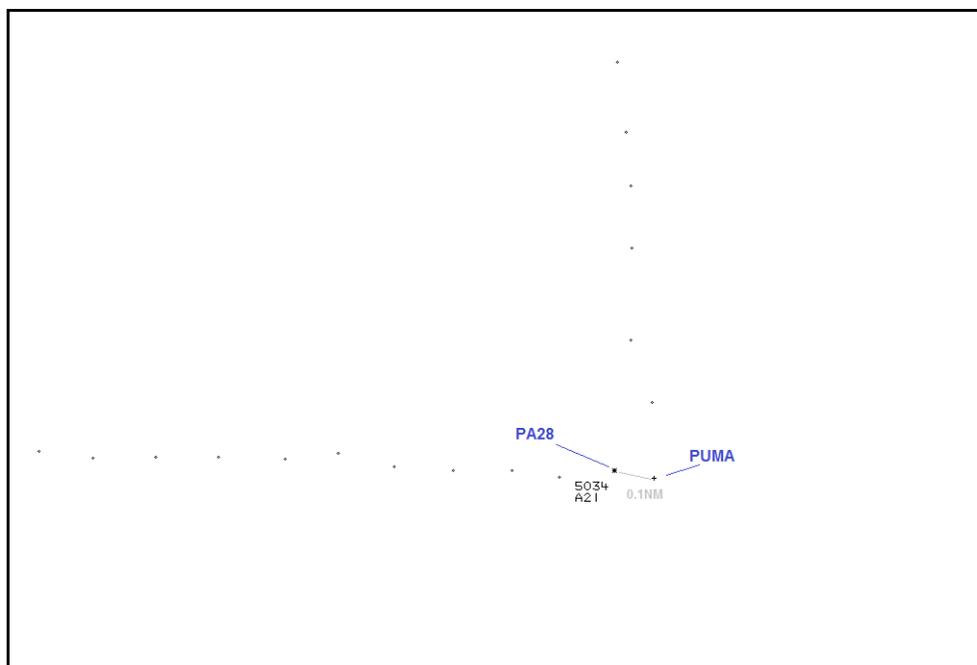
Figure 2 – Swanwick MRT at 1537:22

The PA28 climbed to 2300ft and the two aircraft continued to converge. At 1537:22 the distance between the aircraft appeared to be 0.1nm, with the PA28 indicating 2100ft. There was a degree of jitter on the Puma return so exact geometry of the encounter could not be verified – Figure 2.

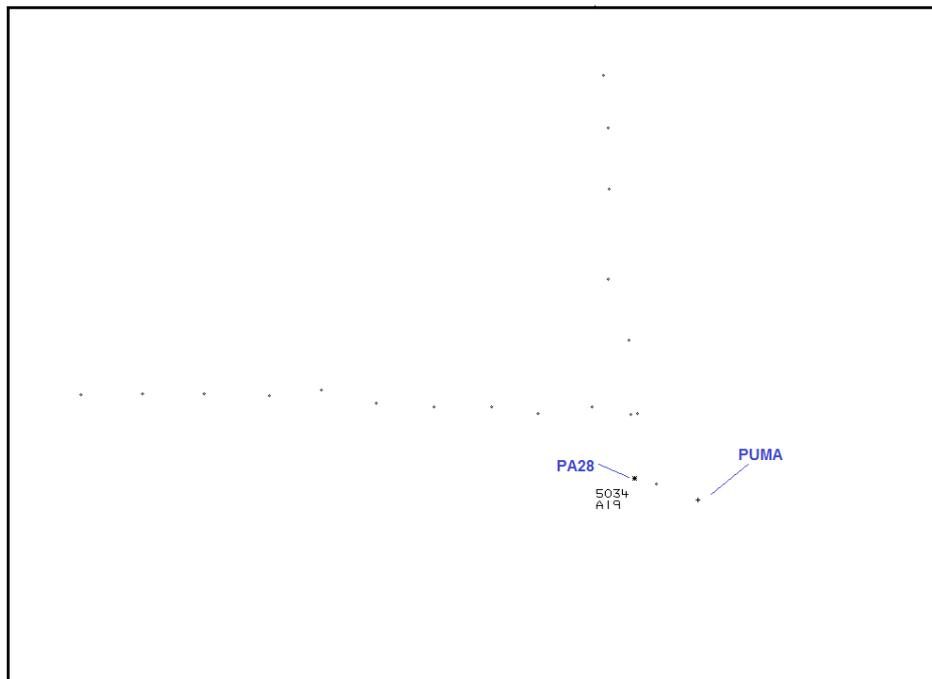
Figure 3 – Swanwick MRT at 1537:30

The returns are intermittent on the next radar update. At 1537:30 the PA28 appeared to be in a right turn, and the Puma in a left turn as the tracks began to diverge – Figure 3.

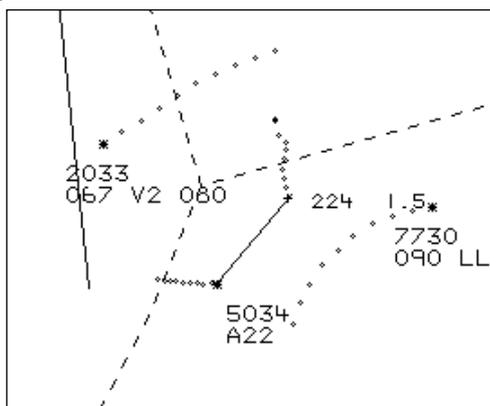
Figure 4: Aircraft geometry at 1536:44 (PA28 squawking 5034).

The radar replay at 1536:44 shows a closing distance of 1.5nm and a Primary radar return only for the Puma, as per Figure 4.

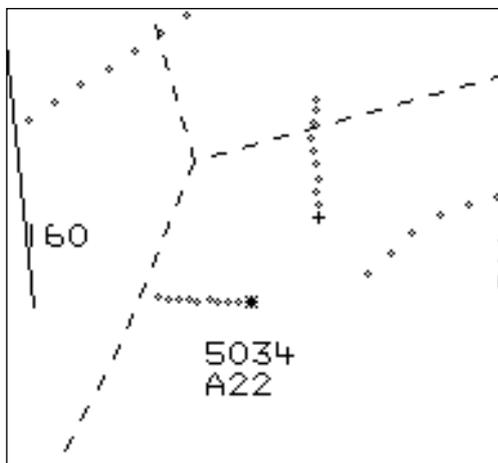
Figure 5: Aircraft geometry at 1536:57.

As per Figure 5, at 1536:57, the aircraft are on a converging heading with no height information available for the Puma.

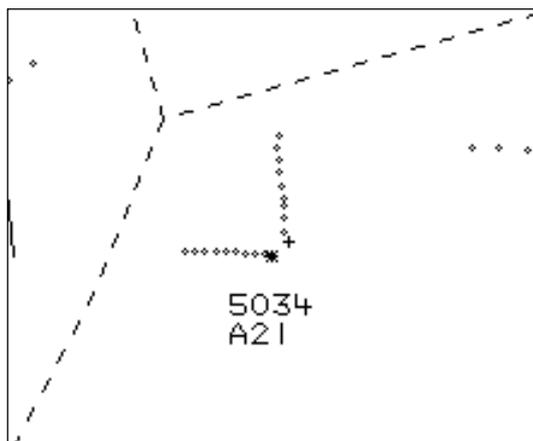
Figure 6: Aircraft geometry at CPA at 1537:21

At 1537:21, as per Figure 6, the aircraft are about to merge on radar. Radar analysis places the CPA between 1537:21 to 1537:25, with a lateral separation of 0.1nm, prior to the Puma disappearing from radar; no height information was available from radar replay.
