AIRPROX REPORT No 2014030

Date/Time: 28 Mar 2014 1704Z

Position: 5132N 00015E
(Damyns Hall Aerodrome)

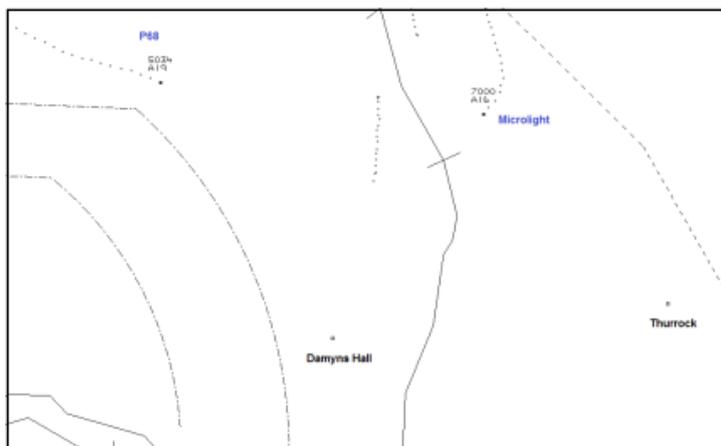
Figure 2: Swanwick MRT at 1702:00

At 1702:00, the Farnborough LARS(N) controller passed Traffic Information to the P68 pilot, "[P68 C/S] you got two contacts to the east of you, one just to the west of the motorway northbound and one to the east of the motorway tracking southwest, similar altitude". The P68 pilot replied, "That's copied looking thanks". The distance between the two aircraft was 4.5nm, see Figure 2 below:

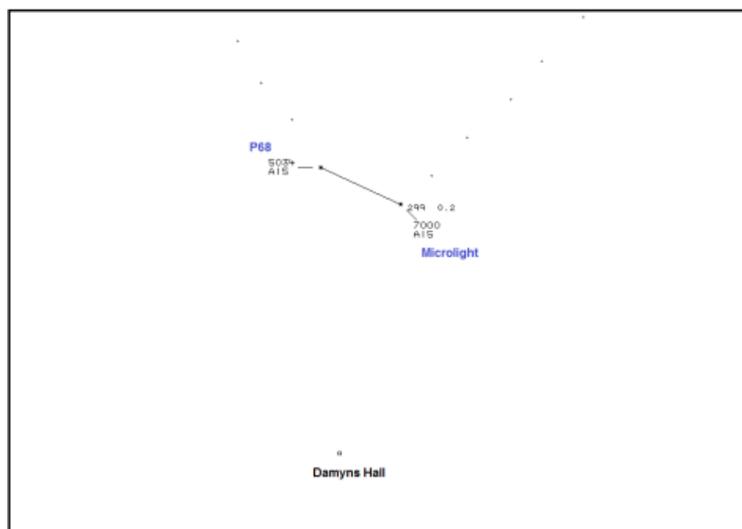
Figure 3: Swanwick MRT at 1703:54

The P68 pilot turned right and tracked towards Damyns Hall and the two aircraft continued to converge until, at 1703:54, the distance between the two aircraft had reduced to 0.2nm. At that point, both aircraft were indicating altitude 1500ft, see Figure 3 below:

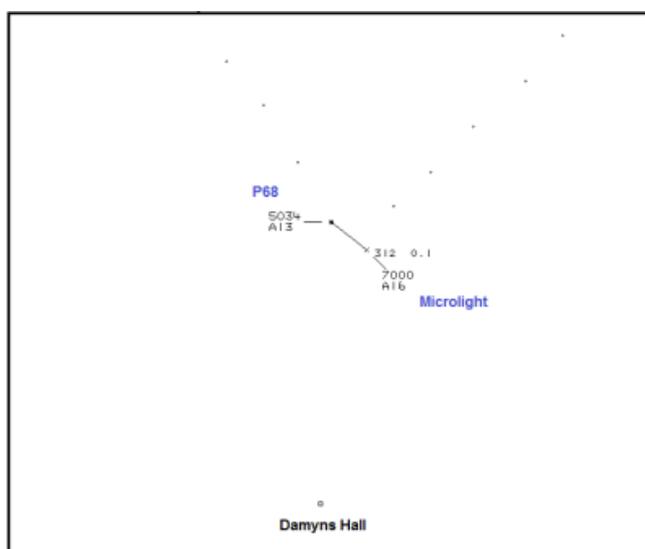
Figure 4: Swanwick MRT at 1703:58

At 1703:58, the horizontal distance between the aircraft reduced to 0.1nm and vertical separation was 300ft, see Figure 4 below:

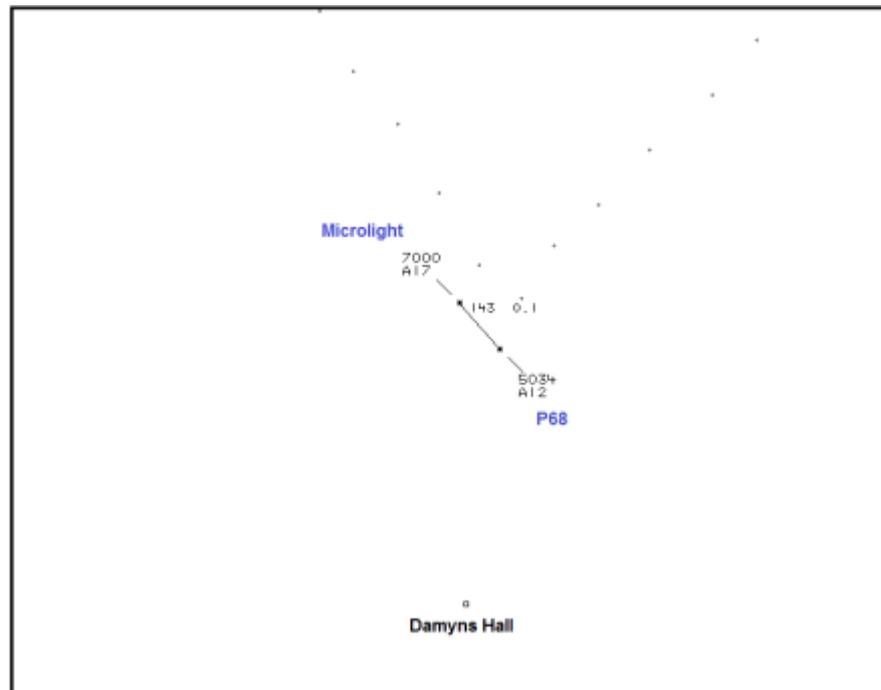
Figure 5: Swanwick MRT at 1704:02

The CPA occurs at 1704:02, when the CTSW pilot appears to have made a right turn and climbed, whilst the P68 pilot continued in the descent, see Figure 5 below:

Considering cause and risk, the Board decided that the Airprox was caused by the late sighting of the CTSW pilot and the non-sighting of the P68 pilot. Notwithstanding the CTSW pilot's avoiding action, the radar recording indicated a small separation at CPA and this, coupled with the CTSW pilot's late sighting, persuaded the Board that safety margins had been much reduced below normal.

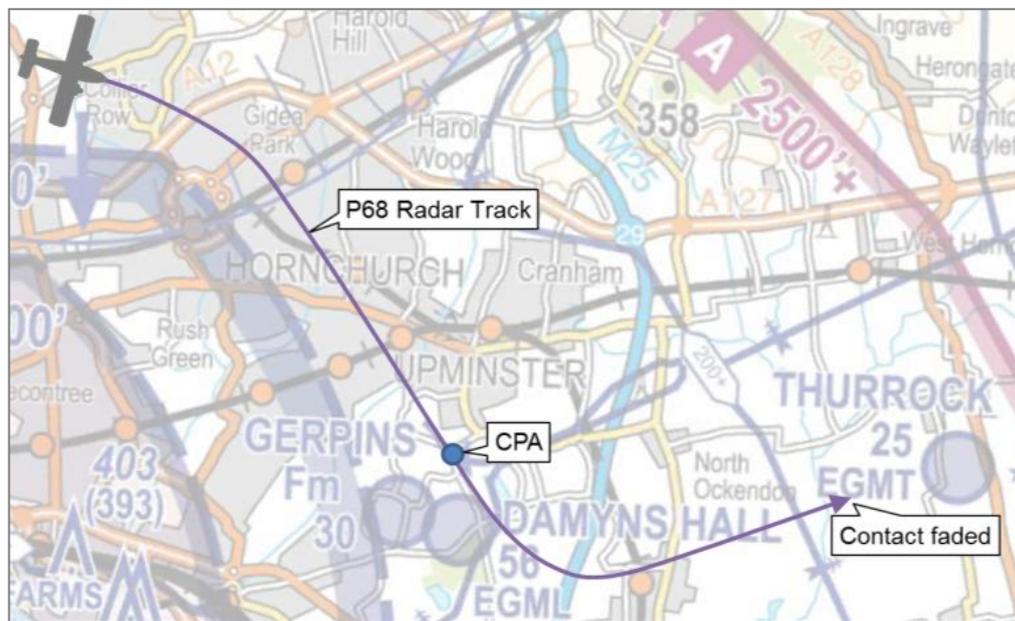
that aerodrome or keep clear of the airspace in which the pattern is formed'⁴. The flight path of the P68, inbound to Thurrock Airfield, was recorded as follows:
