AIRPROX REPORT No 2014199

Date/Time: 7 Oct 2014 1338Z

Position: 5115N 00103W
(2nm ESE Basingstoke)

Type: Chinook Duo Discus

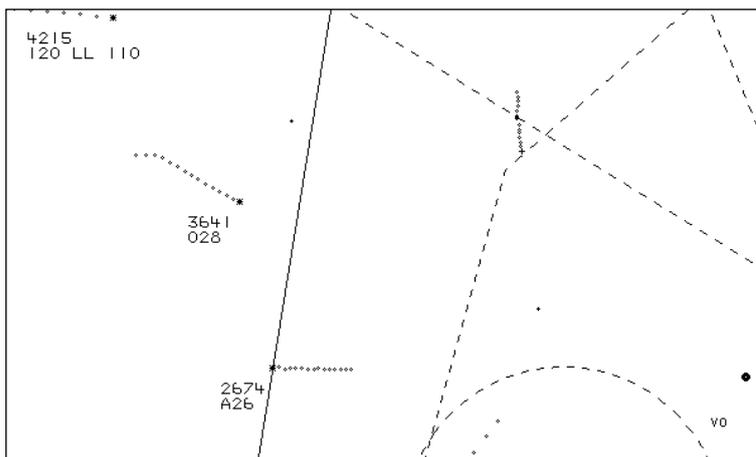
The Airprox took place between a Chinook under a Traffic Service with Odiham Approach, and a Duo Discus glider, listening out on the 'Lasham Gliders' frequency. The Odiham trainee Approach Controller was bandboxing Approach and Director at the time and workload and task difficulty were described as 'low'. The controller was Director-endorsed and had identified the Chinook for an ILS. The glider was called at 5nm and then at 3nm, possibly as a Lasham glider. A turn left was suggested to allow the Chinook to pass behind, and an update was passed at 2nm; the pilot called visual. The controller had two aircraft on frequency and classed the incident as 'low' severity. The Supervisor explained that traffic had been called to the Chinook on several occasions and, once the pilot had reported visual, the controller had descended the aircraft to be at the correct height for the ILS. No other aircraft were showing on radar in the vicinity; radar Suppression had been chosen on the Primary Radar and the Traffic Service had been limited accordingly. At 1334:26, Approach had limited the Traffic Service to the Chinook as, "*Traffic Service reduced all around due to limited surveillance performance*". At 1335:47, Approach called a Squirrel helicopter with which the Chinook pilot was visual and, at 1336:04, (Figure 1), further information was passed as, "*further traffic, left 10 o'clock, 5 miles, crossing left to right, slow moving, no height information*". The Chinook pilot responded with "*looking*".

Figure 1: Traffic Information at 1335:47 (Chinook 3641; glider primary contact only)

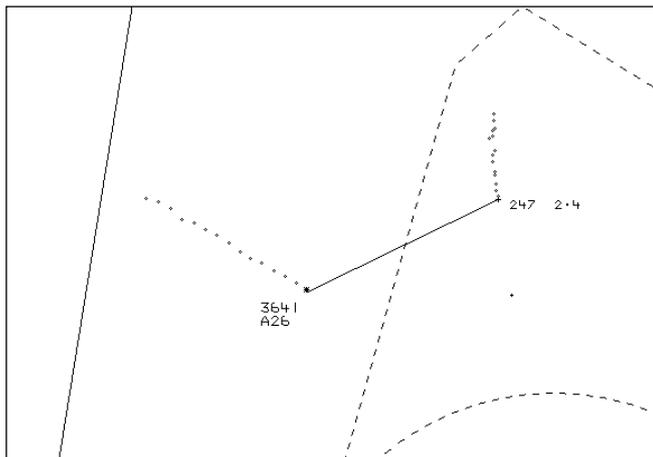
At 1337:02, an update was provided as, “*previously reported traffic now left 11 o’clock, 3 miles, crossing left to right, slow moving, no height information*”. At 1337:27, (Figure 2), a further update was provided, “*previously reported traffic is left, 11 o’clock, tow miles, crossing left to right, no height information. Possibly a glider in the Lasham circuit*”. The Chinook pilot replied with “*still looking*”

Figure 2: traffic Information at 1337:27

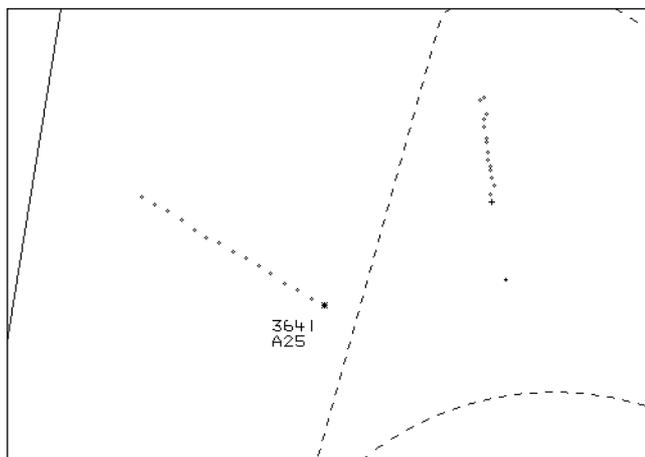
At 1337:37, Approach followed-up with, “*I can give you a slight turn to transit behind if you’re happy?*” A left turn onto 080° was provided at 1337:44 (Figure 3).

Figure 3: Vector provided at 1337:45

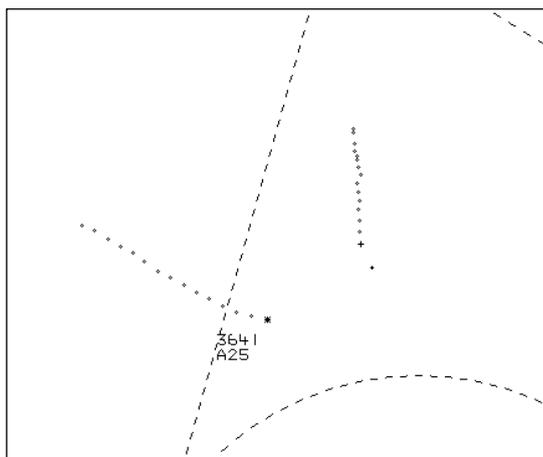
At 1337:58, Approach passed, “*previously reported traffic is north east, one mile, tracking south, slow moving, no height information*”. At 1338:03, (Figure 4), the Chinook pilot reported visual with a glider, left to right at the same height.

Figure 4: Chinook reported visual at 1338:03

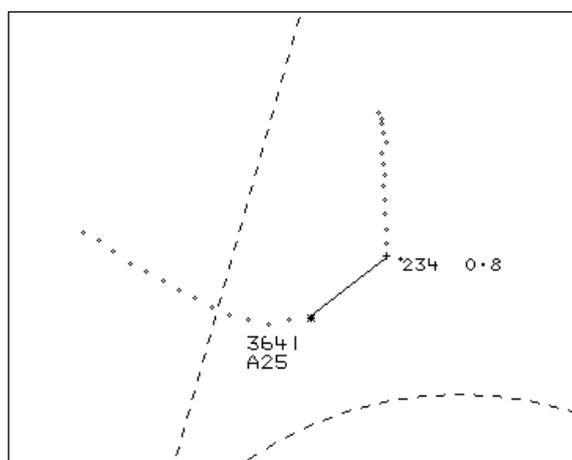
At 1338:06, the Chinook pilot was instructed to maintain heading and descend to 1600ft. The pilot replied with, “*Caution wait*” at 1338:13 (Figure 5) and, at 1338:42, had confirmed clear of a glider inbound to Lasham.

Figure 5: Geometry at 1338:13

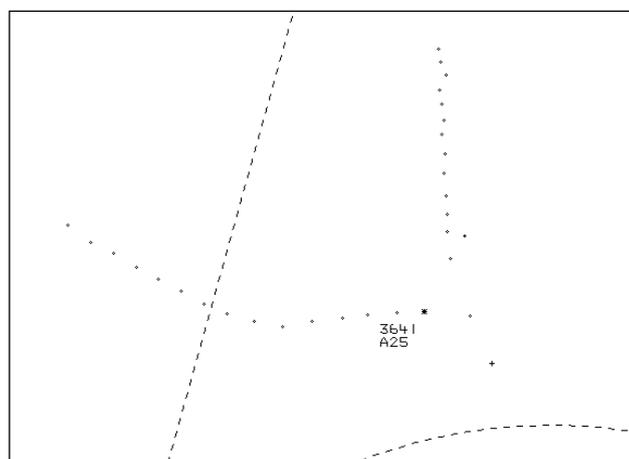
The CPA was estimated on replay at 0.4nm horizontally with no height information available; Figure 6 (1338:24) demonstrates the Chinook pilot’s left turn to avoid the glider.

Figure 6: Geometry at 1338:24
