AIRPROX REPORT No 2014205

Date/Time: 17 Oct 2014 1409Z

Position: 5146N 00051W
(3nm SW Aylesbury)

Type: Eurostar C152

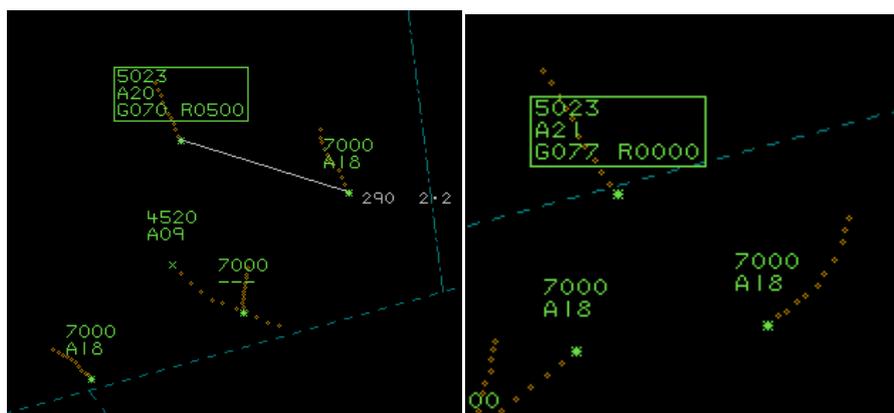
At 1356, the Eurostar pilot called Farnborough Radar and was given a squawk of 5023. A Basic service was agreed. The Eurostar pilot was carrying out general handling in the Aylesbury area. The C152 pilot was in communication with and in receipt of a Basic service from Wycombe Tower. Prior to the Airprox, the Eurostar pilot reported sighting an aircraft carrying out 'erratic manoeuvres' in his 10 o'clock at approx 4nm (Figure 1). The Eurostar pilot reported that he was keeping a look out to the southeast for the previous aircraft, but at 1408:19 (Figure 2) another aircraft (the subject C152) was approaching from the southwest.

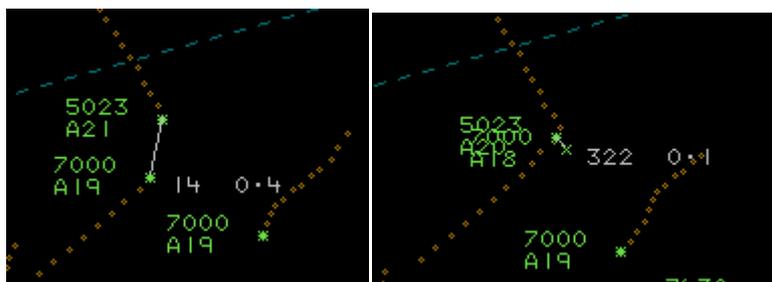
At 1408:37 (Figure 3), the C152 was 0.4nm south-southwest of the Eurostar (the original aircraft having turned to the south). CPA occurred at 1408:55 (Figure 4) with 0.1nm horizontal and 200ft vertical separation.
