AIRPROX REPORT No 2014212

Date/Time: 10 Nov 2014 1813Z (Night)

Position: 5556N 00026W
(60nm E of St Abbs Head)

Type: Falcon 20 Tornado GR4

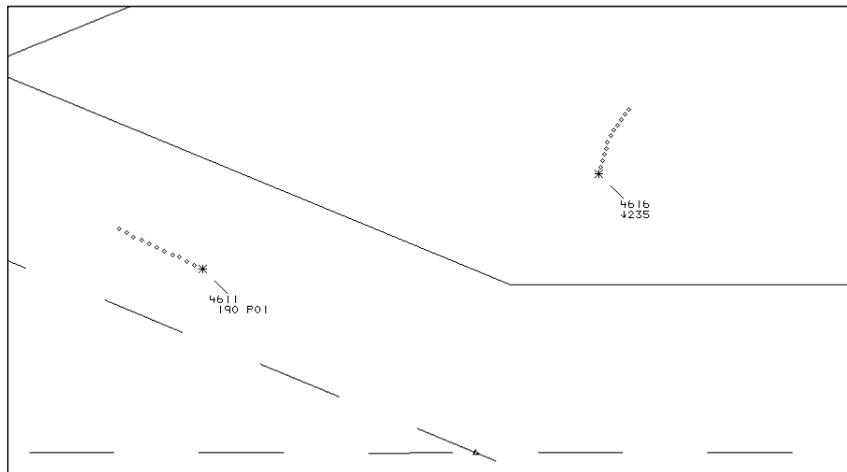
At 1809:35 (Figure 1), 1ACC Surveillance Director called the CRC Boulmer to inform them that the sortie was complete and the FA20 was returning to base. At 1810:15, the FA20 changed from a 0075 to a 4616 squawk, in D613, tracking south in a steady descent to FL190.

Figure 1: FA20 squawk change at 1810:15 (Tornado squawk 4611; FA20 squawk 4616).

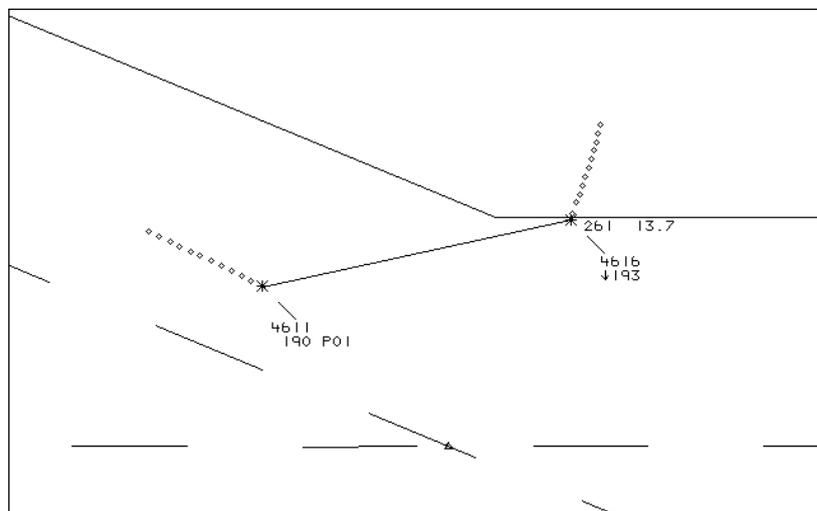
At 1810:19, Psycho formation (Typhoons) called Swanwick, resulting in numerous RT calls until 1812:08. The FA20 departed D613 at 1811:27 with 13.7nm horizontal separation from the Tornado (Figure 2).

Figure 2: Geometry at 1811:27 as the FA20 departed D613.

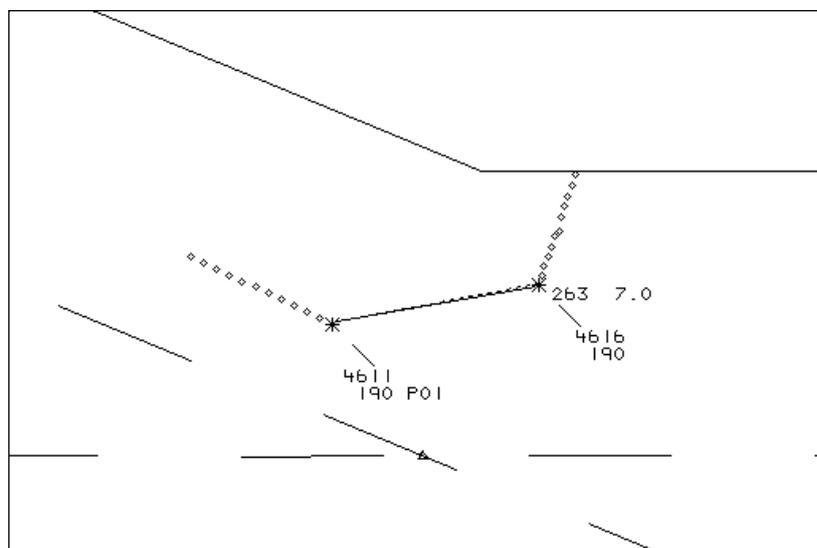
At 1812:11 (Figure 3), a Turbo callsign (single Typhoon) called for handover at FL365.

Figure 3: Geometry at 1812:11.

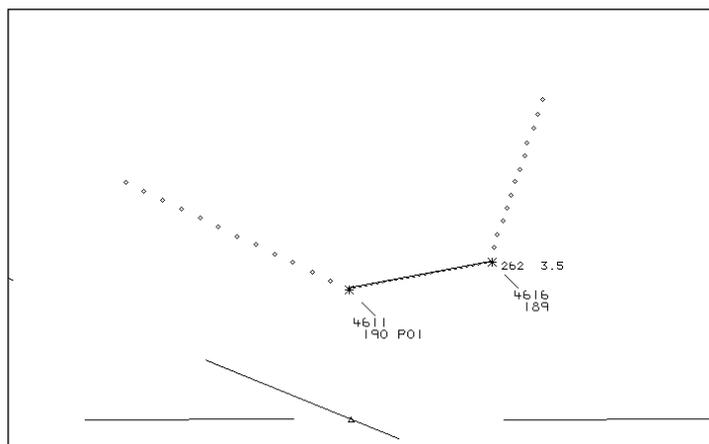
At 1812:38 (Figure 4), Turbo and Psycho were placed under Traffic Services, with 3.5nm horizontal separation and 100ft height separation between the Airprox tracks.

Figure 4: Geometry at 1812:38.

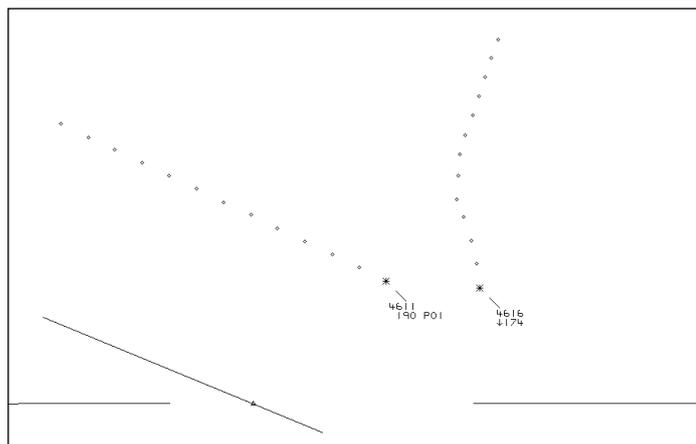
At 1812:48, Psycho requested an internal call with Turbo and with no comment from the controller, an internal conversation began. The Tornado called Swanwick at 1812:58 (Figure 5).

Figure 5: Tornado radio call at 1812:58.

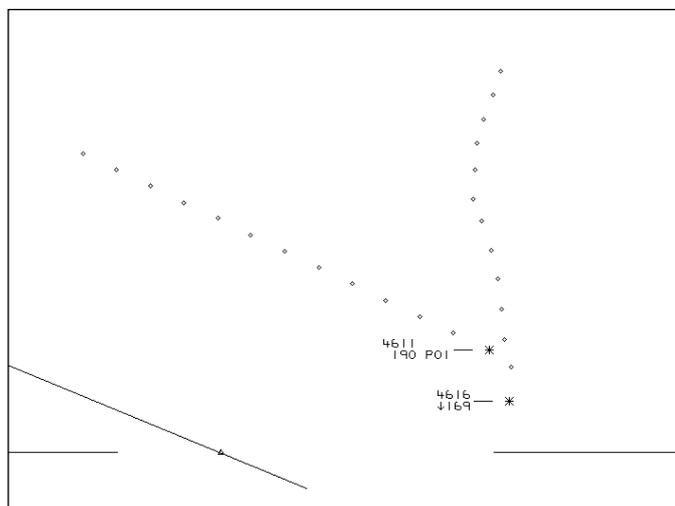
The controller managed to get on air at 1813:10 (Figure 6) to transmit, “[Tornado callsign] *apologies, there’s traffic 12 o’clock, half a mile, tracking south indicating FL160.*” The CPA was estimated at 1813:11 with 0.8nm horizontal separation and 2100ft vertical separation.

Figure 6: Traffic Information at 1813:10.
