AIRPROX REPORT No 2014225**Date/Time:** 8 Dec 2014 1319Z**Position:** 5302N 00031W
(Overhead Cranwell)**Airspace:** Lincs AIAA (Class: G)**Aircraft 1** **Aircraft 2****Type:** Shadow R1 2 x F15**Operator:** HQ Air (Ops) Foreign Mil**Alt/FL:** FL140 FL140**Conditions:** VMC VMC**Visibility:** >10km >10km**Reported Separation:**

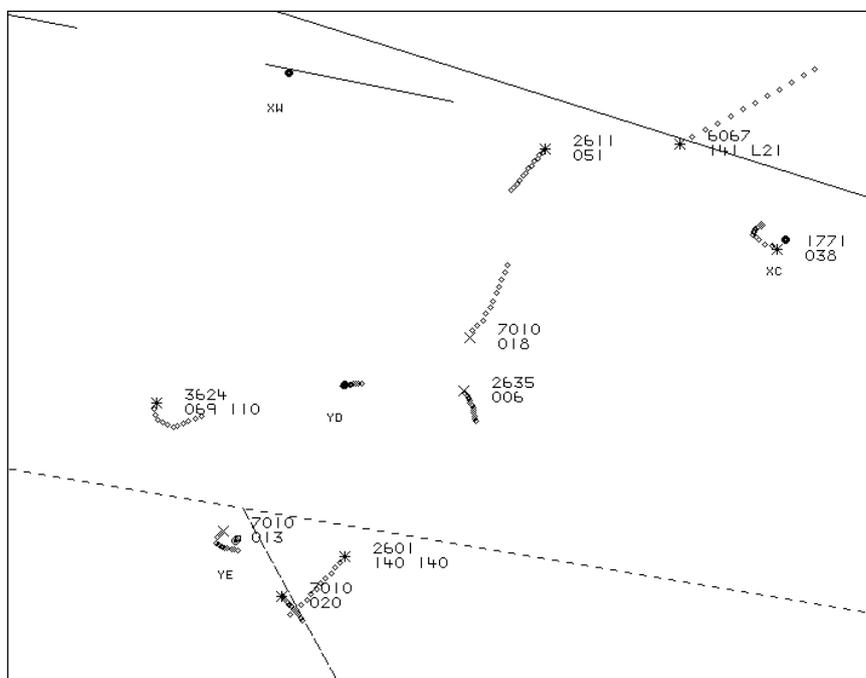
Following Traffic Information at 15nm, the Swanwick Tac controller updated at 1317:04 with “*BRA 220/12 miles in the left hand turn to track north west bound same altitude.*” (Figure 1)

Figure 1: Traffic update at 1317:14 (F15 squawk 6067; Shadow 2601).

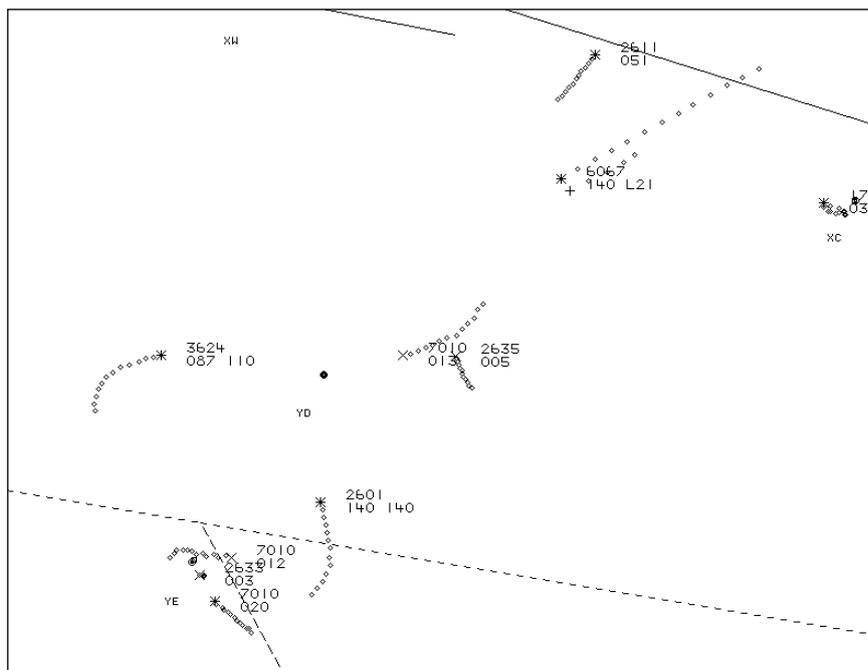
At 1317:40, Swanwick called Cranwell to confirm type of aircraft; Cranwell passed Traffic Information at 1317:52 (Figure 2) as, “*traffic North East, 7 miles, tracking West, same flight level.*”

Figure 2: Cranwell Traffic Information at 1317:52.

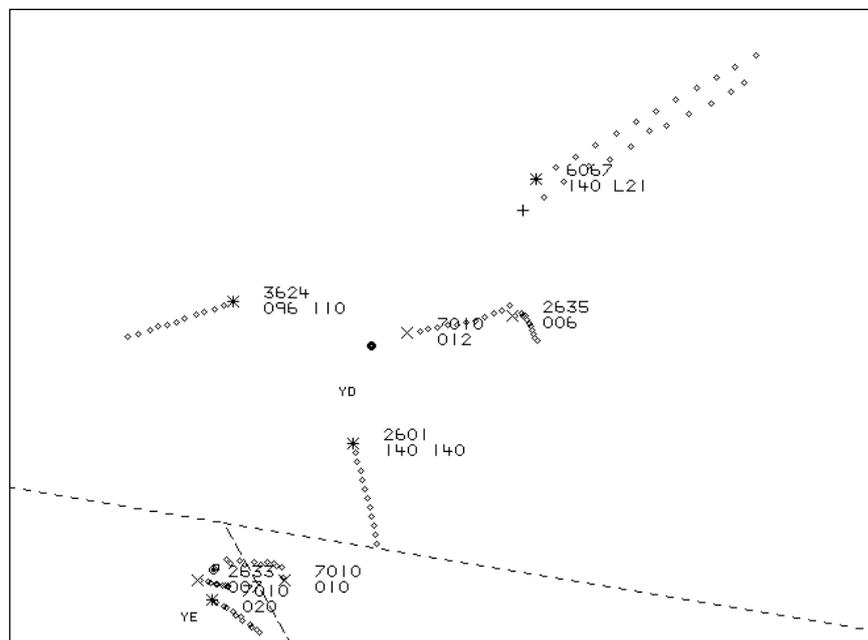
At 1318:07, Swanwick provided ‘own navigation’ to the F15s and at 1318:18 (Figure 3) the Shadow entered the Cranwell radar overhead and the controller confirmed, “Basic Service, radar contact lost in the overhead. Previously reported traffic, North East, approximately 3 miles, tracking West, same flight level.”

Figure 3: At 1318:18 as the Shadow entered the Cranwell radar overhead.

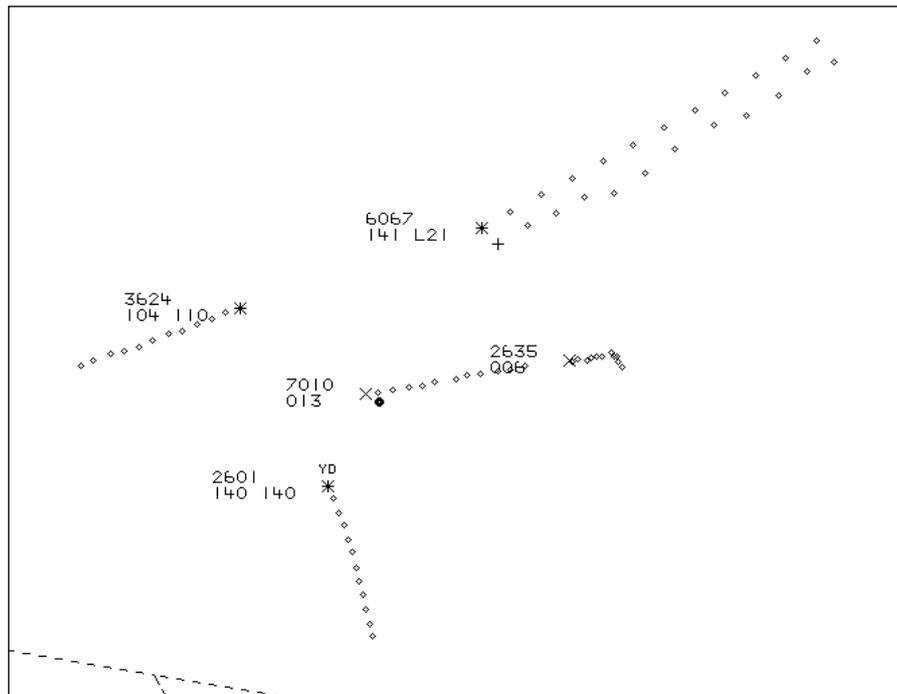
At 1316:25, Swanwick asked the F15s to confirm visual and at 1318:37, the F15s requested a climb at 1318:36 and at 1318:37 (Figure 4), the Swanwick controller confirmed “expedite climb FL150.”

Figure 4: F15s expediting climb at 1318:37.

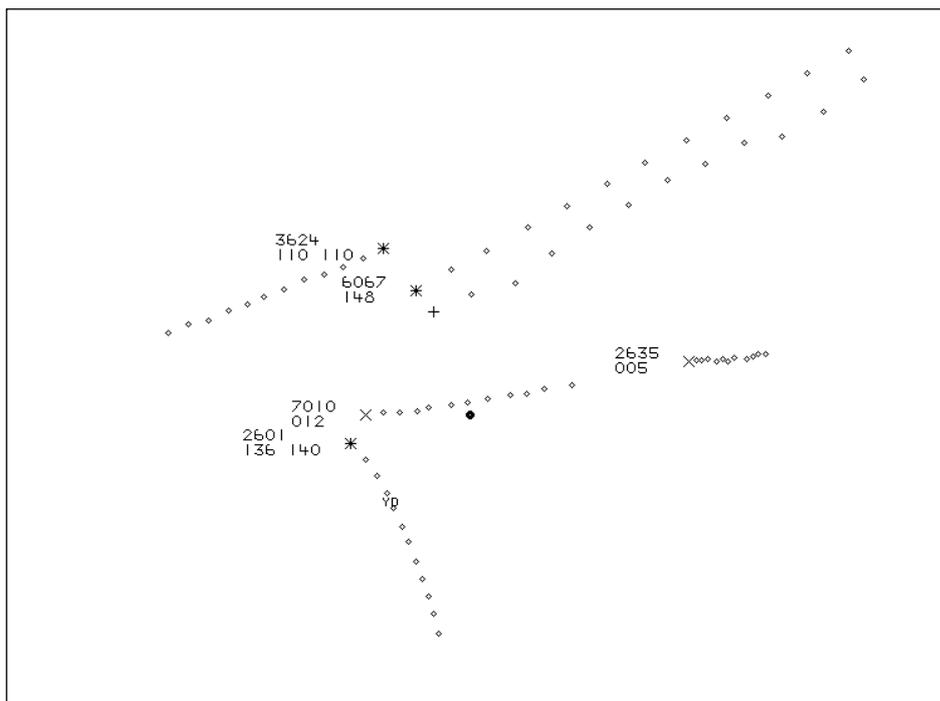
At 1318:57 (Figure 5), the F15s were in the climb passing FL148 and the Shadow was in the descent passing FL136.

Figure 5: Aircraft geometry at 1318:57.

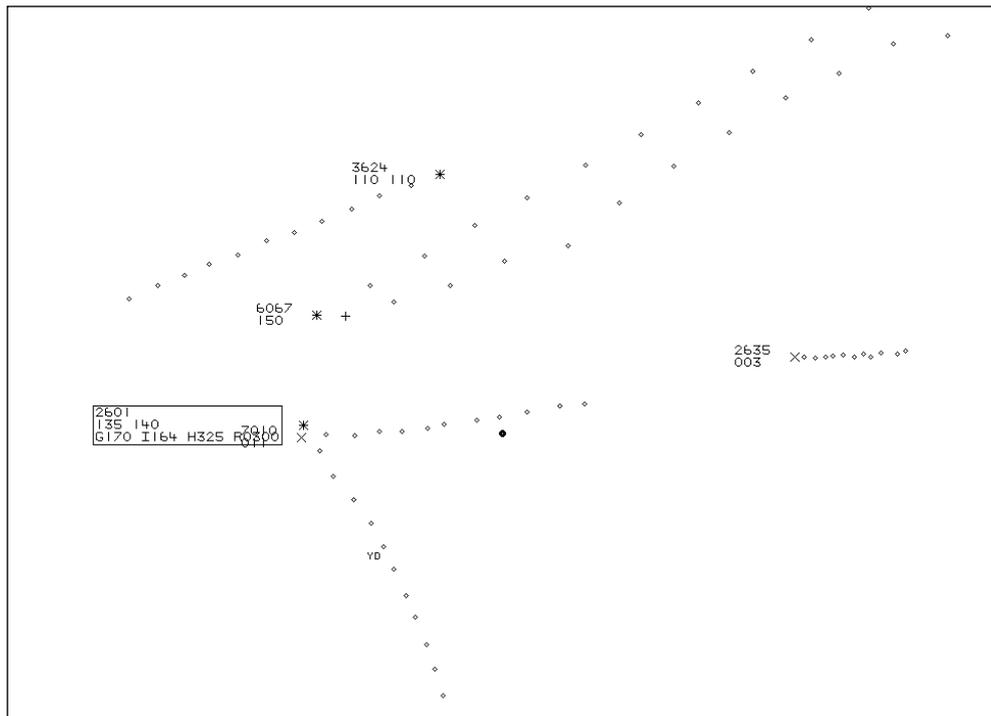
The CPA was estimated at 1319:04 with 0.4nm and 1500ft height separation.

Figure 6: Geometry at 1319:06.
