AIRPROX REPORT No 2014054

Date/Time: 7 Apr 2014 0915Z

Position: 5434N 00102W
(6nm NW RIKUD)

Airspace: UAR UL602 (Class: C)
Scottish UIR

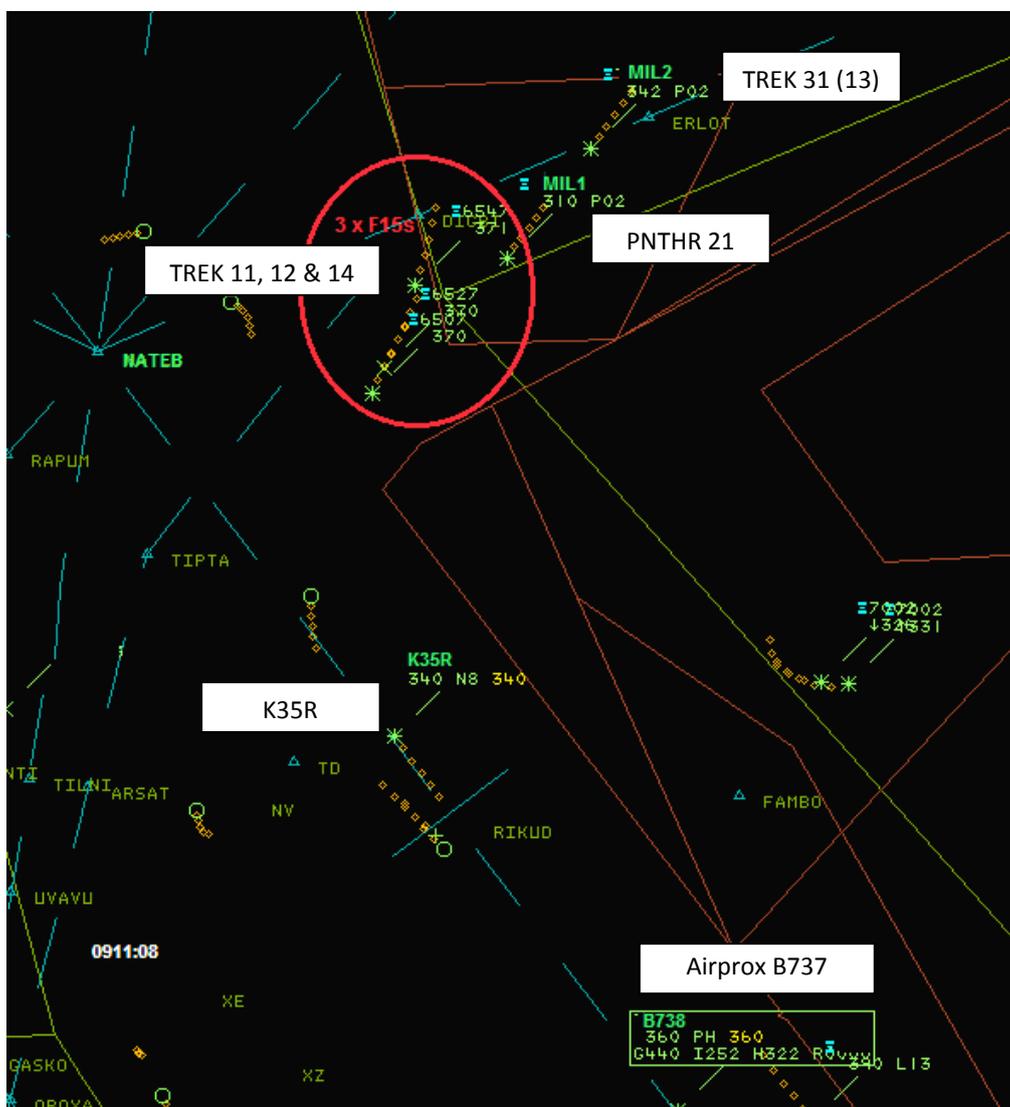
Figure 1.

Figure 1 (0911:08) shows the F15s tracking SSW at FL370 with squawks indicating they were receiving a service from RAF Scampton, although the middle aircraft of the F15 formation subsequently changed squawk to 2622 (this should have been 4622 but the pilot was given the wrong squawk in error by the Swanwick Tac 2 controller).

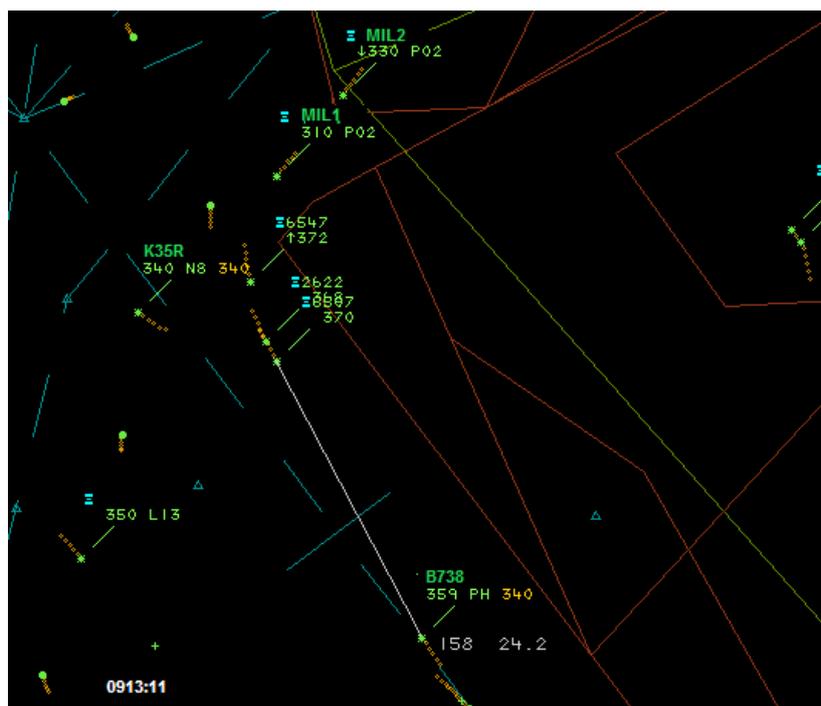
Figure 2.

The Montrose trainee assessed that the track of the B737 would take it behind PNTHR 21 (MIL1) and TREK 31 (MIL2) on their current headings and, at 0913:11, instructed the B737’s pilot to descend to FL320 (to achieve separation with the unknown aircraft at FL370) and to expedite descent. The B737 was passing FL359, opposite direction to the F15s, at a range of 24.2nm (Figure 2). The pilot of the B737 was then instructed to turn left heading 315°.

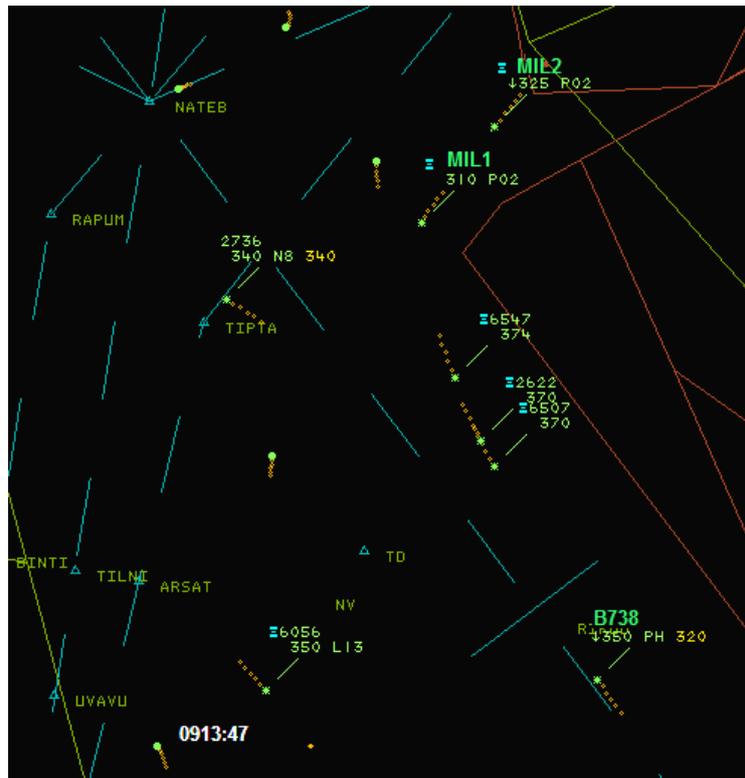
Figure 3

At 0913:47 (Figure 3) the Trainee instructed the B737 pilot “*avoiding action turn r-left immediate-correction [B737 C/S] avoiding action turn right immediately heading zero nine zero degrees*”. At interview the OJTI revealed that the trainee had wanted to turn the B737 pilot left but he had instructed the trainee to turn the B737 pilot right due to a potential confliction with PNTHR 21, TREK 31 and traffic working Spadeadam from 5000ft-30000ft in the Otterburn region. The pilot of the B737 replied “*now heading three one five [B737 C/S] do you mean right zero nine zero*”. The Trainee replied “*[B737 C/S] affirm turn right heading zero nine zero degrees immediately*”. This was read-back by the crew of the B737.

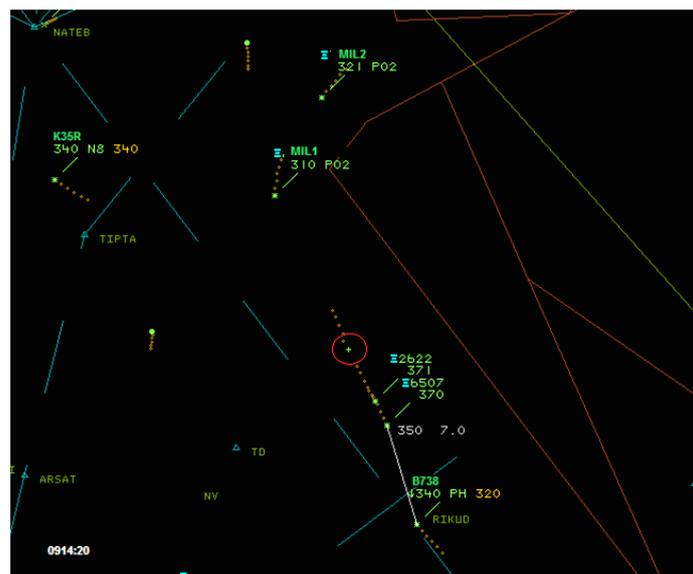
Figure 4.

During this conversation the SSR label of the aircraft previously squawking 6547 (TREK 14) disappeared (the remaining primary target is ringed in red on Figure 4). Traffic Information was passed to the pilot of the B737 as *“traffic is opposite direction five miles indicating flight level three seven zero unverified”* (0914:20, Figure 4). In the meantime, PNTHR 21 (MIL1), which had been co-ordinated as turning right and tracking ahead of the B737, turned left, towards the B737. PNTHR 21 was at FL310. As PNTHR 21 was not RVSM approved, the minimum required vertical separation from the B737 was 2000ft.

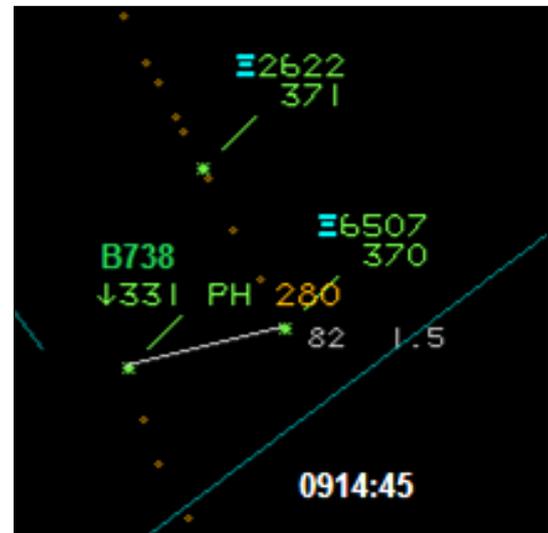
Figure 5.

CPA with the F15 squawking 6507 occurred at 0914:45 (Figure 5); minimum distance between these two aircraft was **1.5nm, 3900ft**.

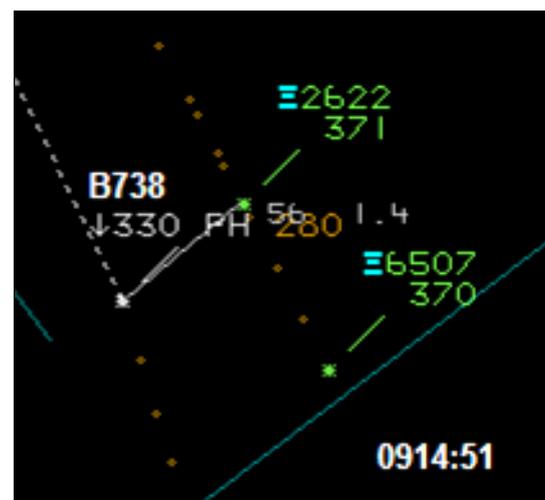
Figure 6.

CPA with the F15 squawking 2622 occurred at 0914:51 (Figure 6), the minimum distance between these two aircraft was **1.4nm, 4100ft**. At the same time, the Short Term Conflict Alert (STCA) activated against PNTHR 21. At this point, TREK 31, at FL320 and co-ordinated to track ahead of the B737, also started a left turn towards the B737.

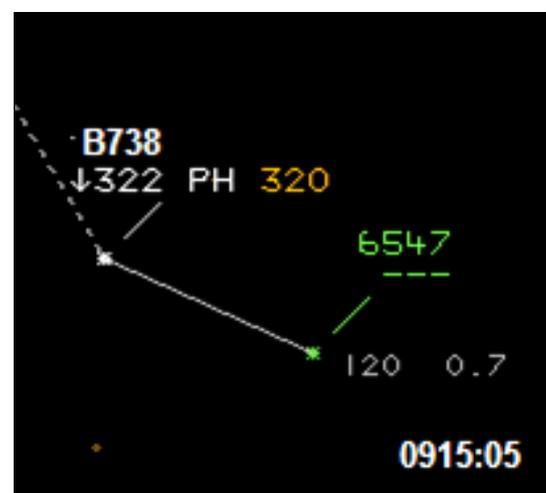
Figure 7.

The SSR code (6547) of the F15 that had reverted to primary only reappeared just before CPA at 0915:05 (Figure 7): the minimum distance between it and the B737 was measured as **0.7nm**. (It was established after the event that the 6547 squawk was maintaining FL370, some **4800ft** above).

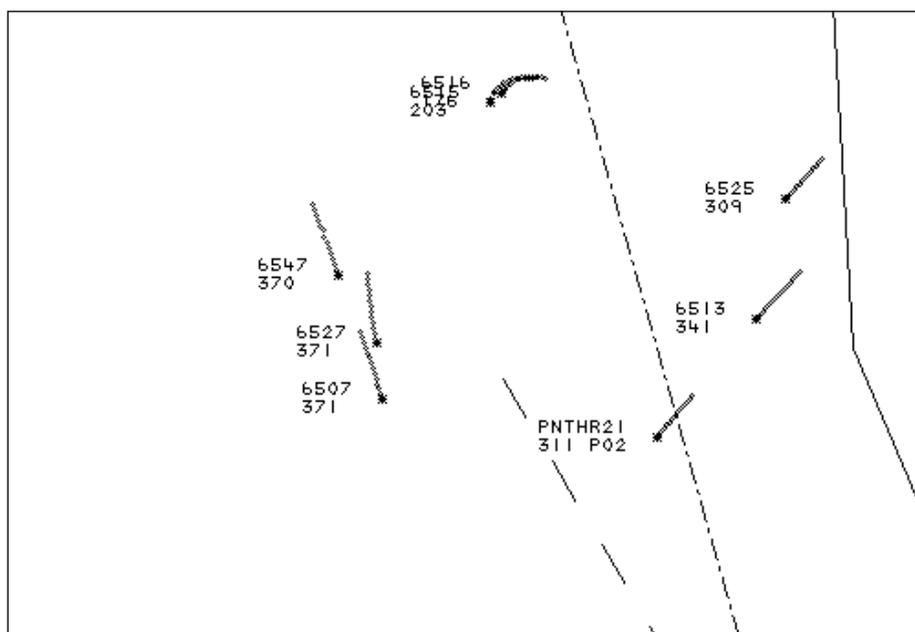
Figure 1: Panther 21 Flight check-in with Tac 2 at 0904:39;
 numerous other formations recovering southbound.

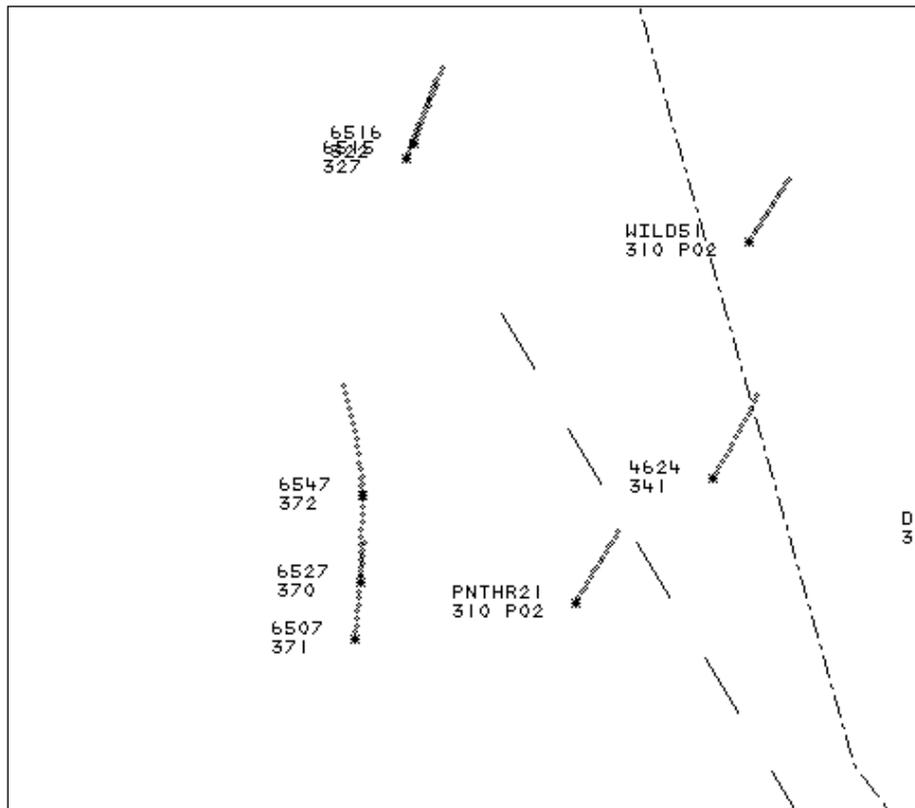
Figure 2: Geometry at 0907:24; Trek 11 Flight squawking 6507, 6527, 6547.

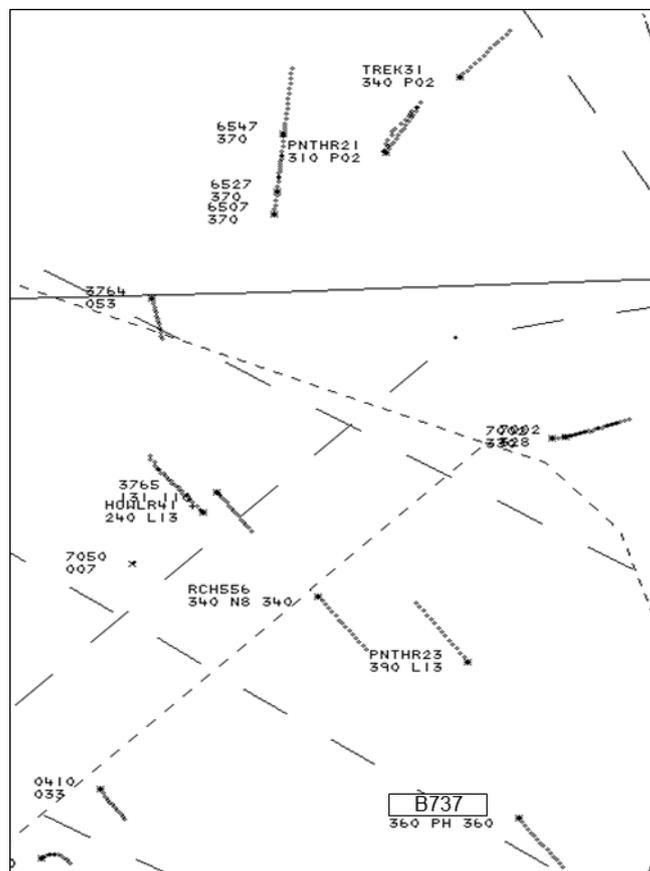
Figure 3: Geometry at 0908:30 as Tac 2 call Montrose for coordination.

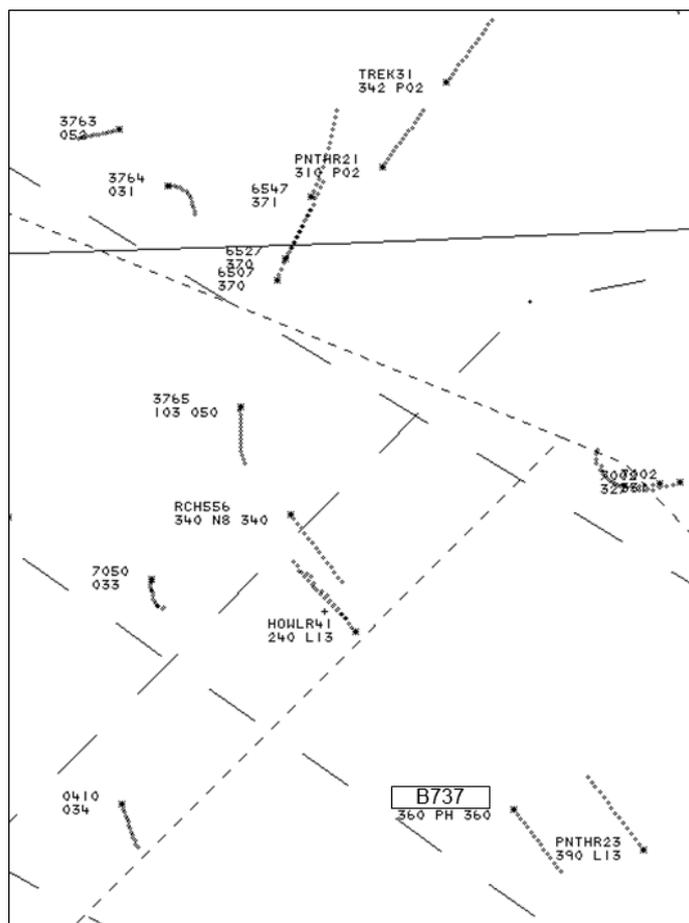
Figure 4: Coordination at 0911:17 for Tac 2 was PNTHR 21 Flight to maintain FL 320, right turn 5° and TREK 31 to descend to FL 320, turn right 5°.

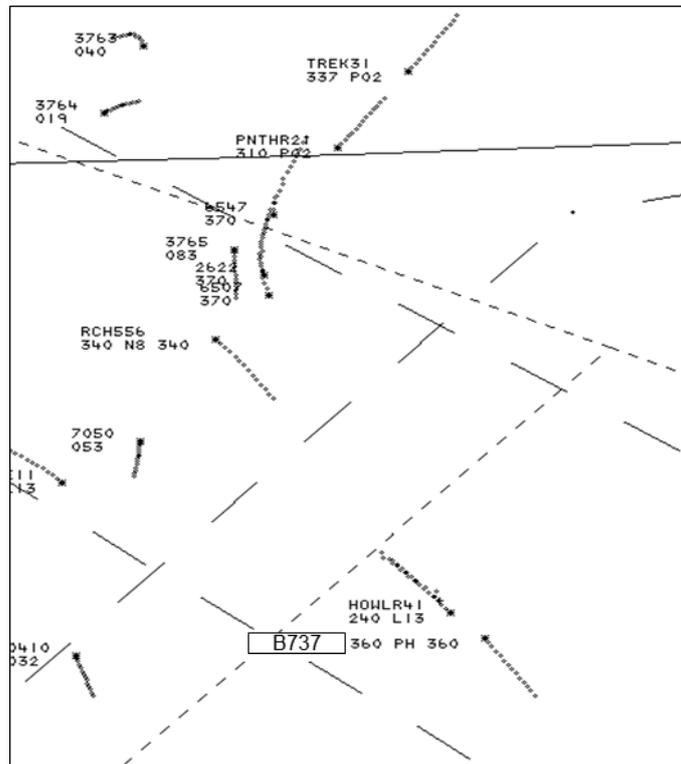
Figure 5: Geometry at 0912:31.

0912:31 – **TREK 11's pilot checked in again on frequency. Tac 2 asked him to 'pass their message'.** At this stage TREK 11 Flight were well south of Swanwick Mil N airspace. The first aircraft in the formation was wearing a BLACKDOG Squawk 6507, the second a squawk of 2622 (a squawk Tac 2 had issued) and the third in the formation was alternating between not squawking and a BLACKDOG Squawk 6547. **TREK 11's pilot stated that they were just paralleling Fox 40 South at this stage as well as informing Tac 2 that they were still at FL 370 and a 3-ship. Tac 2 asked them to maintain FL 370;** however, TREK 11 Flight had not been identified or placed under a service.

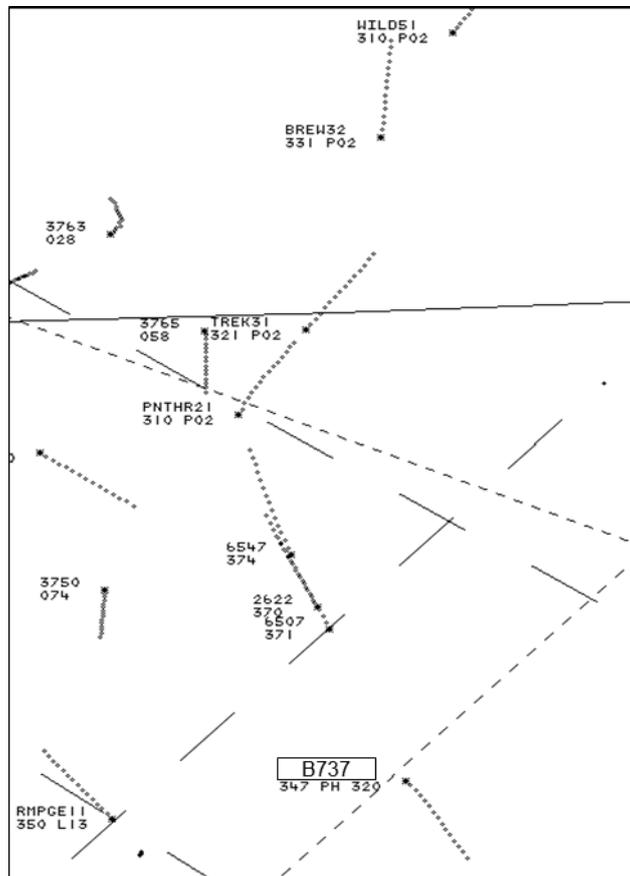
0913:57 - PNTHR 21 Flight began to turn south towards Ottringham (OTR) without instruction from Tac 2. PNTHR had not been instructed to maintain heading or to turn right 5° as per the coordination agreed with Montrose sector.

Figure 6: Geometry at 0913:57 as PNTHR 21 Flight turn south.

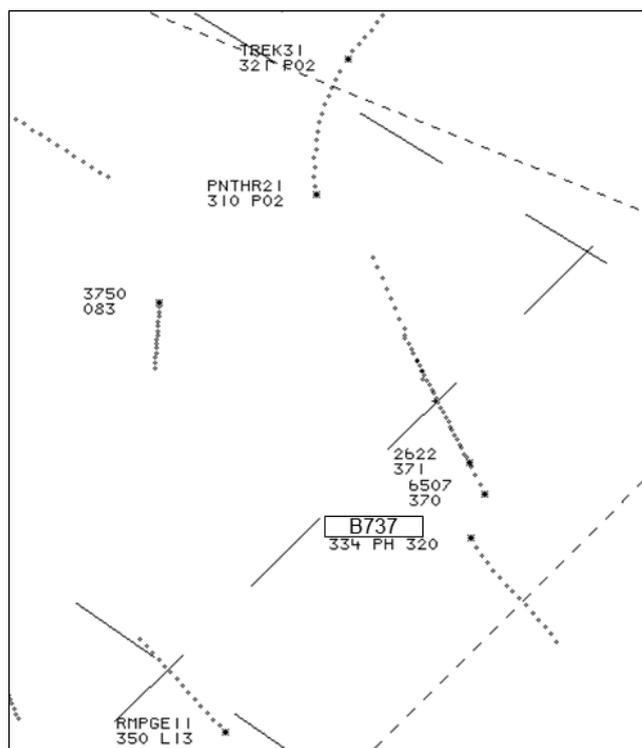
Figure 7: Geometry at 0914:38.

0914:28 – Planner 2 attempted to handover PNTHR 21 Flight to Swanwick Mil NE who informed them of the PNTHR 21 Flight's turn towards the B737. NE suggested they descend PNTHR 21 Flight and would call them back after co-ordinating with Montrose.
