AIRPROX REPORT No 2014056

Date/Time: 10 May 2014 0750Z (Saturday)

Position: 5214N 00135W
(20nm SSE Honiley)

Airspace: Daventry CTA (Class: A)

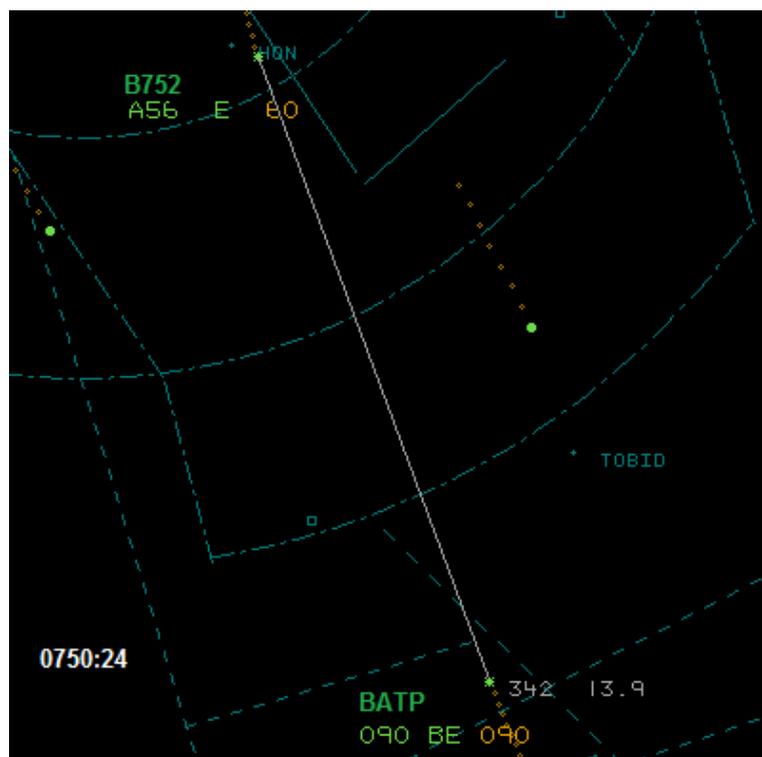
Figure 1

After the ATP pilot was transferred to BHX, the Midlands controller transferred one other aircraft to another frequency. He then had no aircraft on frequency for a couple of minutes before the B757 pilot called. At 0750:24 (Figure 1) the Midlands controller instructed the B757 pilot to climb to FL190. The Midlands controller reported picking up the FPS for the B757 from the departure bay, writing 'climb FL190' on it and re-placing it without scanning the rest of the bay.

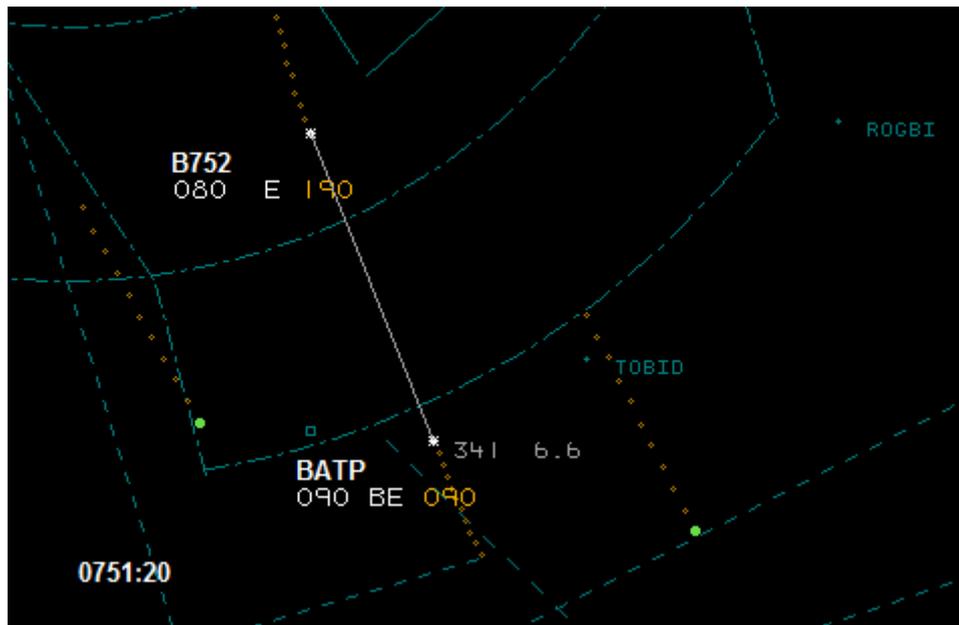
Figure 2

At 0751:18, two seconds before the low level Short Term Conflict Alert (STCA) activated (Figure 2), the Midlands controller saw the conflict and instructed the B757 pilot to stop the climb at FL80 and gave avoiding action to turn right heading 215°. The B757 pilot was climbing at a rate of approximately 3500fpm at the time the instruction was issued. At the same time BHX Approach gave avoiding action to the ATP pilot to turn right heading 090°.

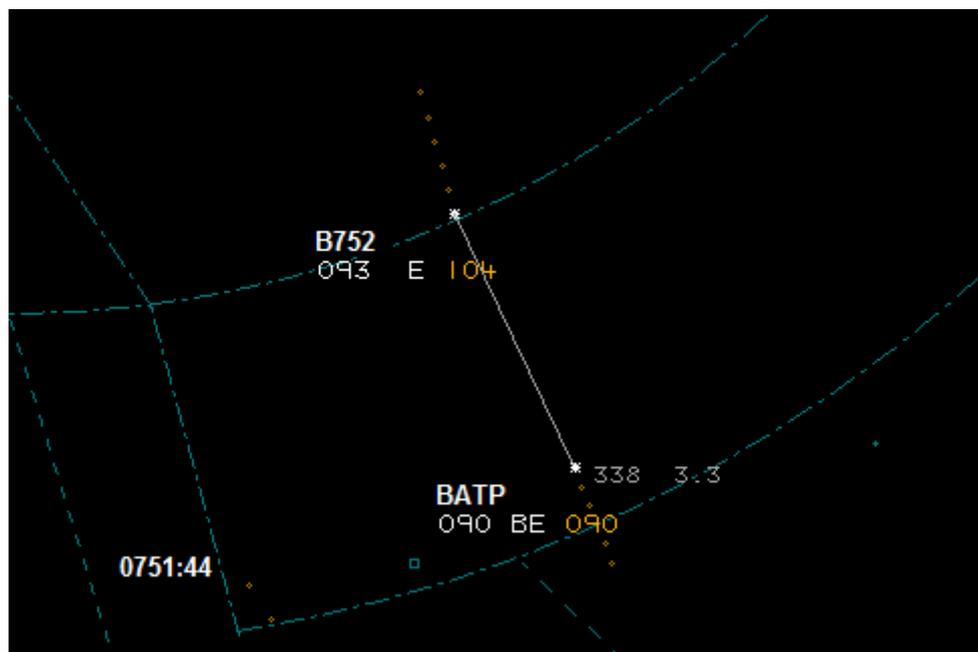
Figure 3.

The B757 pilot read back the instruction to stop the climb at FL80, stated that he had contact with the traffic, and asked for the heading again. The Midlands controller gave avoiding action again with a heading of 225°. The pilot of the B757 reported turning onto the heading at 0751:44 (Figure 3), having reached FL93. The Midlands controller instructed the B757 pilot to climb to FL190.

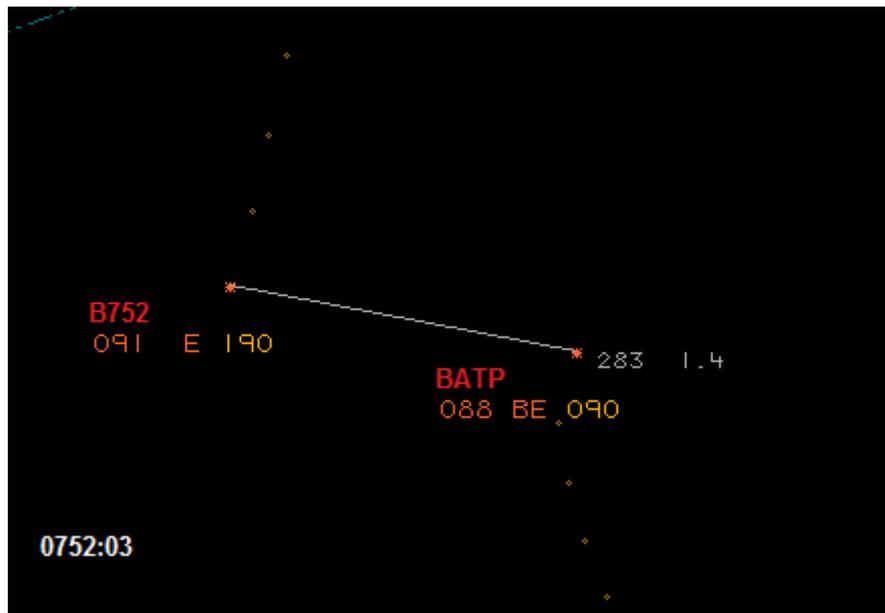
Figure 4.

The two aircraft continued to converge until 0752:03 (Figure 4), when CPA occurred (1.4nm horizontally and 300ft vertically). At the time the B757 was at FL91 and the ATP was at FL88. The ATP pilot subsequently reported clear of conflict.
