AIRPROX REPORT No 2014059

Date/Time: 7 May 2014 0834Z

Position: 5056N 00009W
(Hurstpierpoint)

Type: DA42 DA40

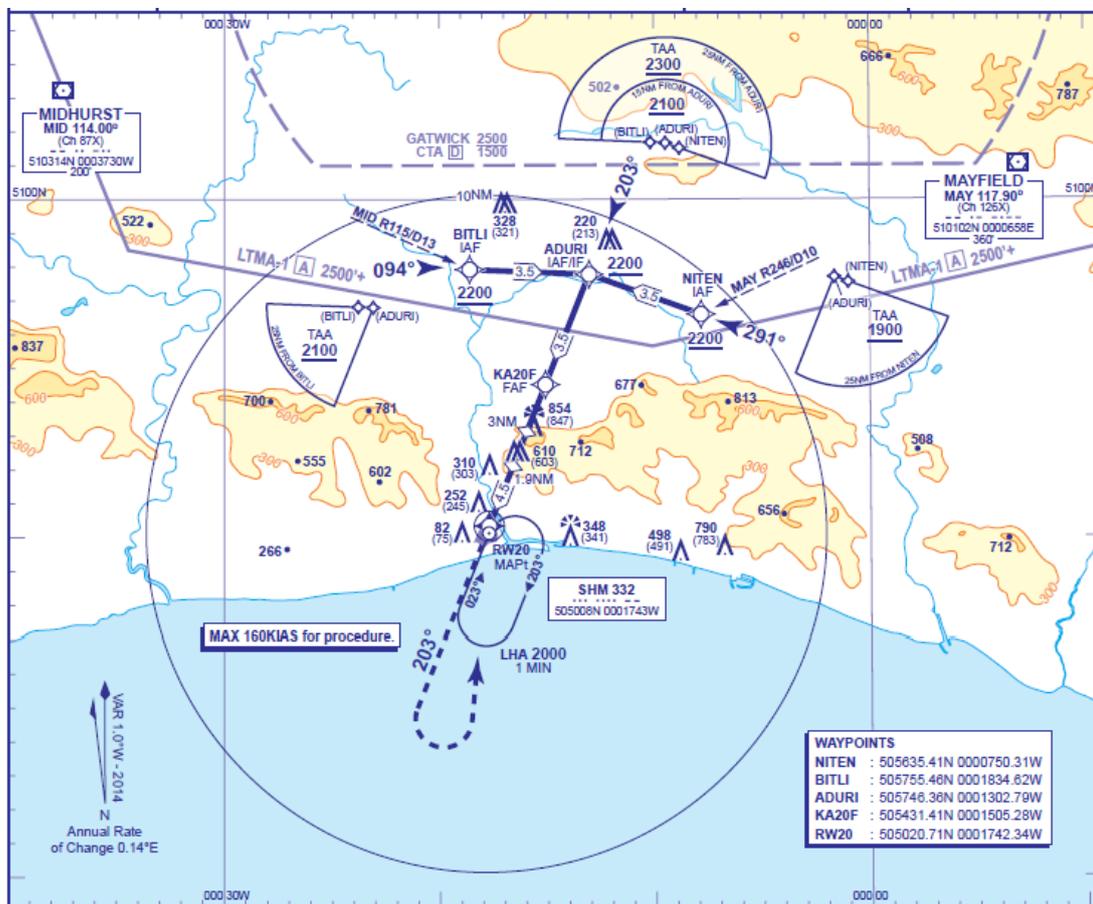
Figure 1: Shoreham Instrument Approach Chart RNAV (GNSS) RW20 (ACFT CAT A,B – ICAO)

The DA42 pilot was conducting an instrument training exercise at Shoreham Airport comprising a hold at the SHM NDB, followed by the RNAV approach via NITEN (IAF) for RW20 and was in receipt of a Procedural Service from Shoreham APP. An extract from the UK AIP, page AD 2-EGKA-8-4 dated 3rd April 2014, is reproduced in Figure 1 below:

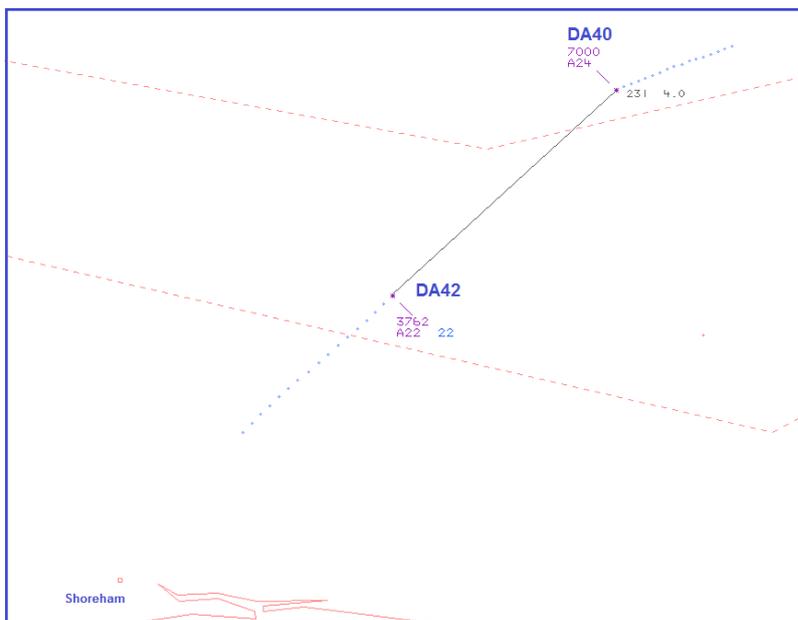
Figure 2 - Swanwick MRT at 0832:20

unverified]. The DA40 pilot acknowledged, “*Squawking er three seven six three copy the traffic and wilco [DA40 C/S]*”. Swanwick MRT showed the distance between the two aircraft as 4nm, see Figure 2 below:

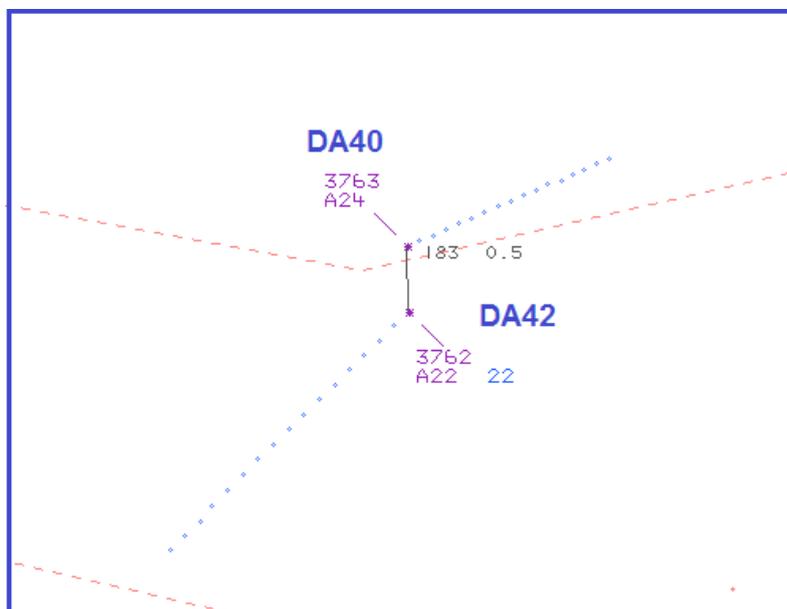
Figure 3 - Swanwick MRT at 0833:26

The controller then passed traffic information to the DA42 pilot, “[DA42 C/S] *traffic Diamond Star, two thousand four hundred feet routeing southwest-bound*”. This was acknowledged at 0833:26 by the DA42 pilot and the controller added, “*Ah your D F trace puts him off to your left-hand side*”. MRT showed the DA40 in DA42’s 10 o’clock position at 0.5nm, see Figure 3 below:

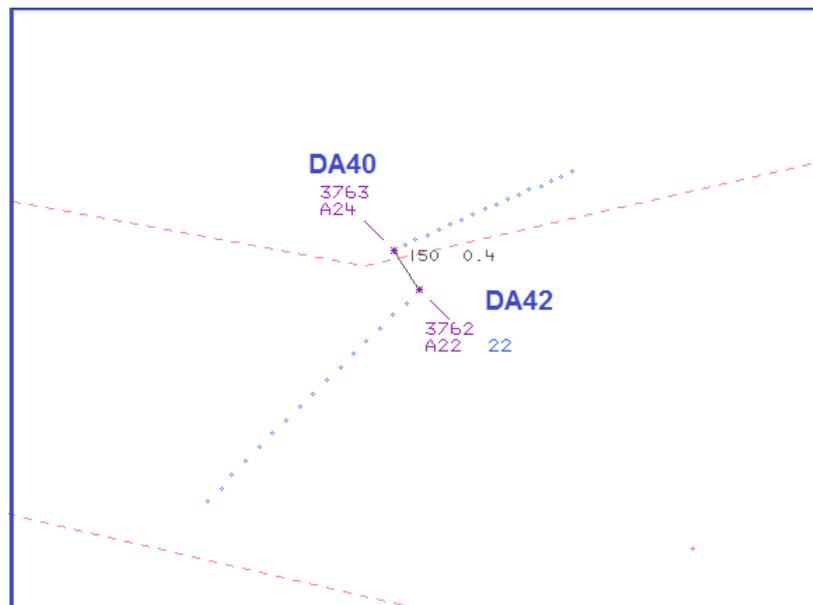
Figure 4 - Swanwick MRT at 0833:30

The DA42 pilot acknowledged, “*Roger*” and the DA40 pilot transmitted, “*and [DA40 C/S] visual gone behind us*”. CPA occurred at 0833:30 when the horizontal distance between the aircraft was 0.4nm and the vertical distance was 200ft, see Figure 4 below:

The Board agreed that the cause of the Airprox was a non-sighting by both pilots, and that, despite the separation of 0.4nm, safety margins had been much reduced because of the procedural nature of the DA42 pilot's approach under IFR.

<u>Cause:</u>	A non-sighting by both pilots.
<u>Degree of Risk:</u>	B
<u>ERC Score</u> ⁵ :	20
<u>Recommendation:</u>	The DA42 Operating Company considers reviewing the use of IF screens.
