AIRPROX REPORT No 2014063

Date/Time: 14 May 2014 1420Z

Position: 5139N 00116W
(Oxford AIAA)

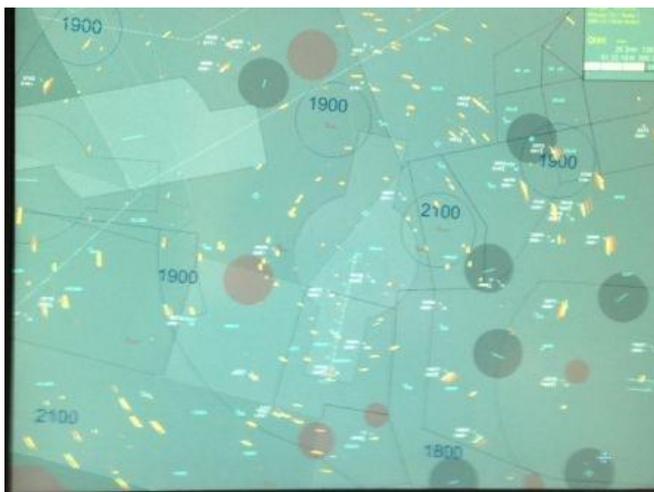
Figure 1: RAF Benson ATM primary radar display on the morning of 14 May 14

The specific incident was not captured on area radar replay due to no radar response from the glider. Figure 1 is the photo of the radar screen that the Supervisor sent to the Tutor operators.
