**AIRPROX REPORT No 2014074**

Date/Time: 31 May 2014 1150Z (Saturday)

Position: 5047N 00018W  
(Shoreham)

Airspace: Shoreham ATZ (Class: G)

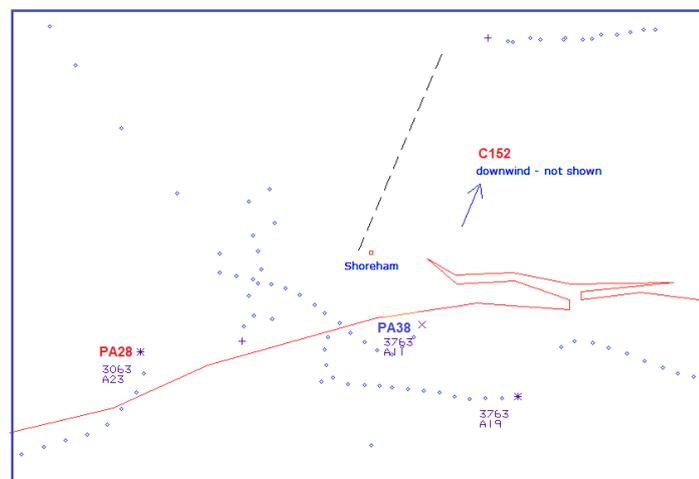
Figure 1 – Swanwick MRT at 1146:29

The PA28 continued towards the airfield and, at 1146:20, commenced a second left-hand orbit 2.3nm southwest of Shoreham, contacting Shoreham Tower at 1146:29. The Tower controller responded, *“(PA28)c/s Shoreham Tower continue crosswind and report downwind runway two zero lefthand circuit traffic is two aircraft ahead of you in the circuit”*. The PA28 pilot’s reply was garbled due to a crossed transmission from the PA38 reporting downwind. The Tower controller instructed the PA38 to report final number two following the C152 - Figure 1 (a representation of the runway 20 centreline has been added for clarity and it was noted that the PA28 pilot had selected the SSR code 3063 in error).

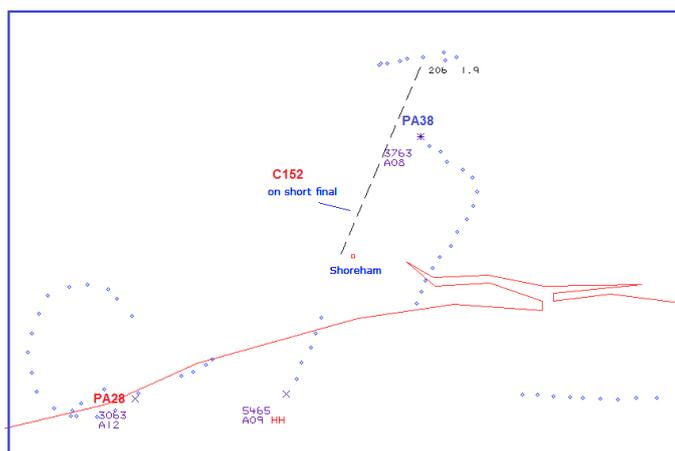
Figure 2 – Swanwick MRT at 1148:11

At 1147:12 the C152 was cleared for touch and go and the controller instructed an aircraft awaiting departure to hold position. At 1148:11 the PA28 had completed the orbit and the controller transmitted, *“(PA28)c/s I’ve lost visual with you report position”* and the PA28 pilot replied *“(PA28)c/s just er joining crosswind now”* – Figure 2.

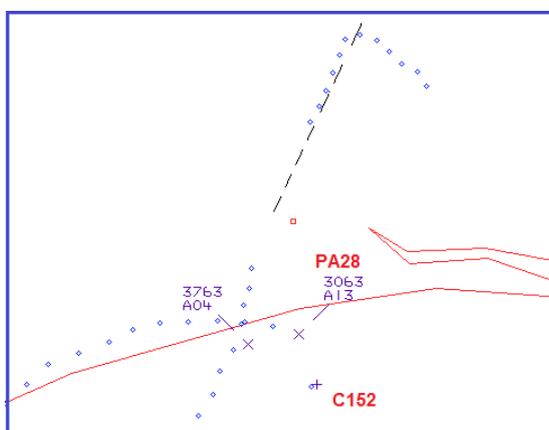
Figure 3 – Swanwick MRT at 1149:24

At 1149:24 radar recording showed the PA28 joining crosswind indicating 1300ft and an intermittent contact, which CAA ATSI considered was likely to have been the C152, turning from crosswind to downwind at 1100ft as reported by the C152 pilot – Figure 3.

[Note – radar recording does not show the C152 again but the projected paths would indicate that the PA28 then crossed the path of the C152 from left to right.]

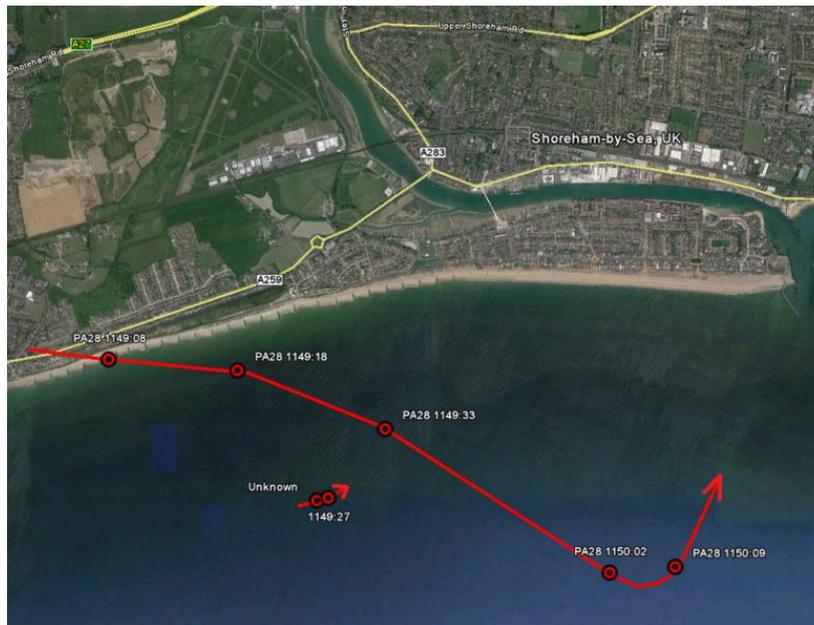
Extract from Google Earth showing the radar plots

An extract from the Google Earth mapping tool shows the C152 (labelled ‘unknown’) and the PA28 radar plots relative to the airfield and runway.
