AIRPROX REPORT No 2014077

Date/Time: 3 Jun 2014 1638Z

Position: 5101N 00301W
(15nm E MULIT)

Airspace: LON FIR (Class: G)

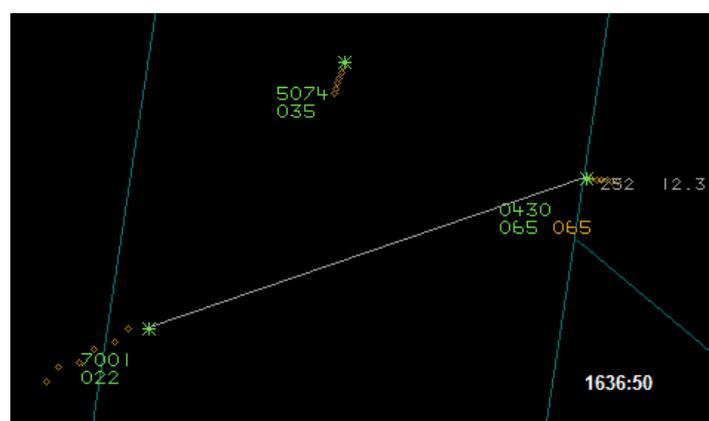
Figure 1.

At 1633:20, the DA42 contacted Exeter Radar maintaining FL65. The DA42 was given a squawk, identified and a Traffic Service was agreed. The DA42 requested an NDB hold and approach for RW26 at Exeter, and to enter controlled airspace at MULIT at FL70. The Exeter Radar controller co-ordinated with Cardiff, and the DA42 was cleared to enter controlled airspace at FL70. The Exeter Radar controller passed missed-approach instructions to the DA42. The conversation finished at 1636:50, at which point the Tornado was 12.3nm west-southwest of the DA42, squawking 7001 on a converging heading (Figure 1) at FL022.

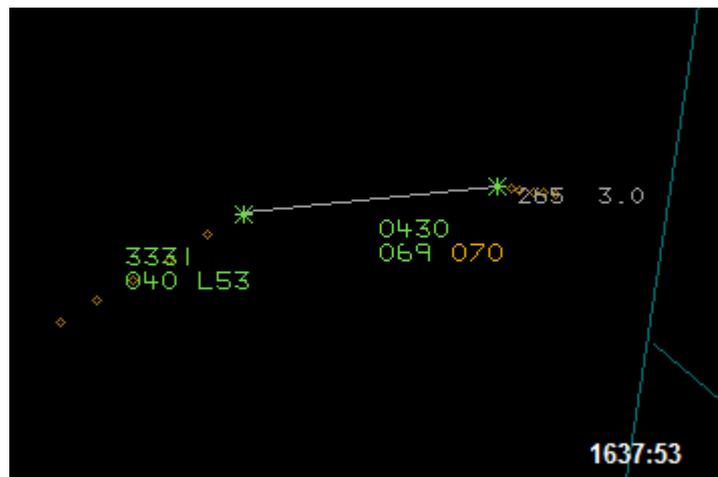
Figure 2.

The Tornado maintained its level, and changed the squawk to 3331 (Swanwick Military). At 1637:39 the Tornado was observed to climb and the Mode C changed from FL022 to FL029. At 1637:53 the Exeter Radar controller informed the DA42 of “*unknown traffic eleven o’clock three miles crossing left to right indicating flight level four five in the climb*” (Figure 2) which was acknowledged by the DA42.

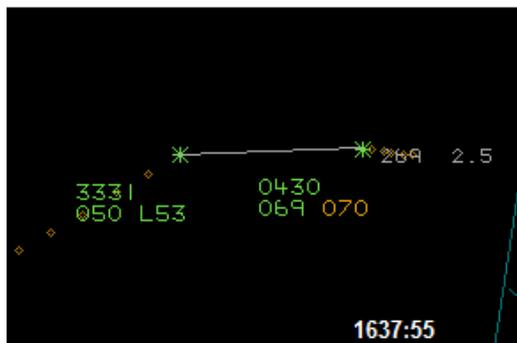
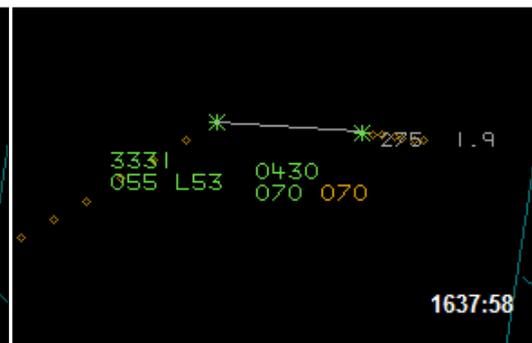
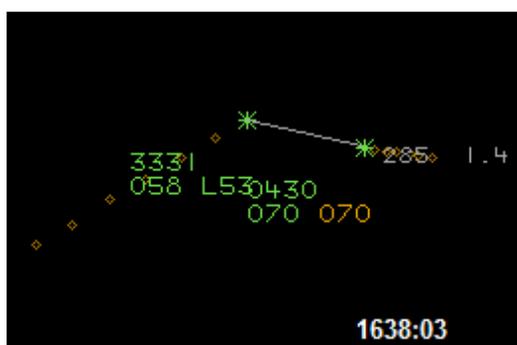
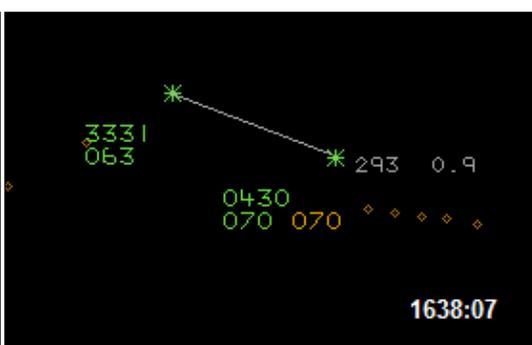
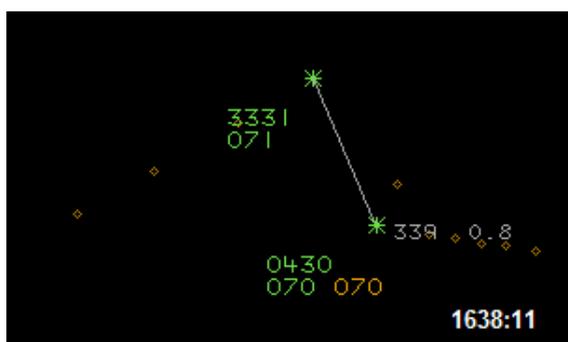
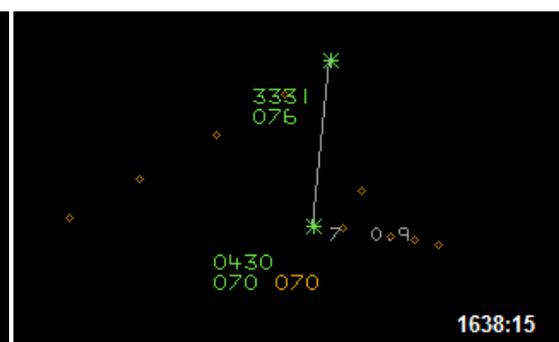
The next 6 updates of the radar showed the two aircraft converging (Figures 3 – 8) with CPA occurring at 1638:11. The Exeter radar controller immediately updated the traffic information, stating that the traffic was “*very high speed now just passing through your twelve o'clock range of two miles flight level five four*”. The DA42 replied “*visual yeah it’s quite close*”.

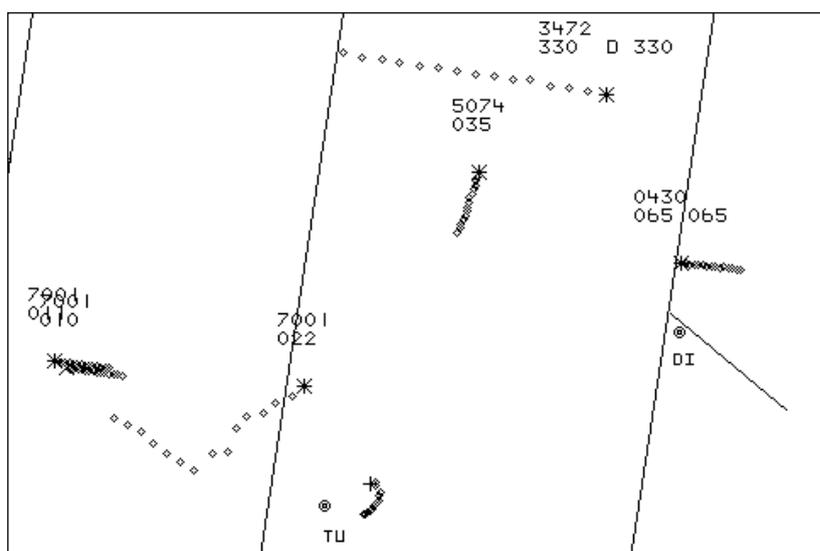
At 1636:47, the Tornado free-called 30nm west of Yeovilton climbing for the Swindon corridor. Prior to identification the controller ascertained that the crew required a Traffic Service.

Figure 1: Geometry as Tornado freecalled (Tornado squawk 7001; DA42 squawk 0430)

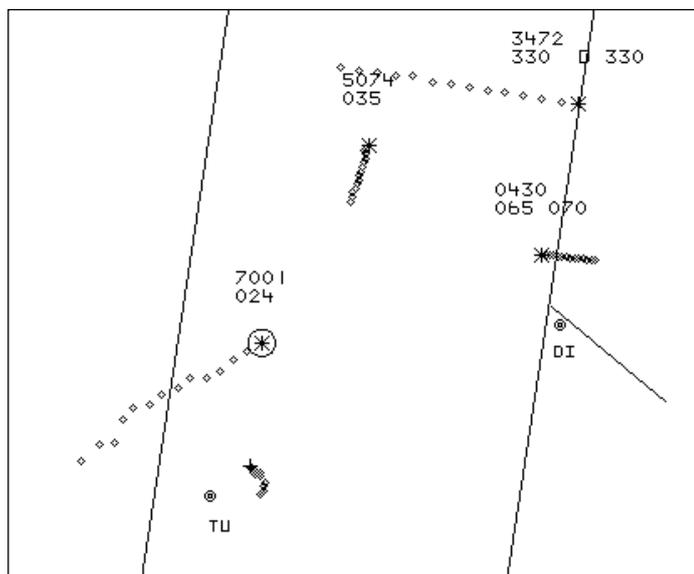
At 1637:09, the controller transmitted, “*traffic believed to be you, has traffic right 1 o’clock, 5 miles, crossing right to left, slow moving, indicating FL65, type unknown.*” The Tornado crew confirmed that they were looking for the traffic.

Figure 2: Traffic Information at 1637:09.

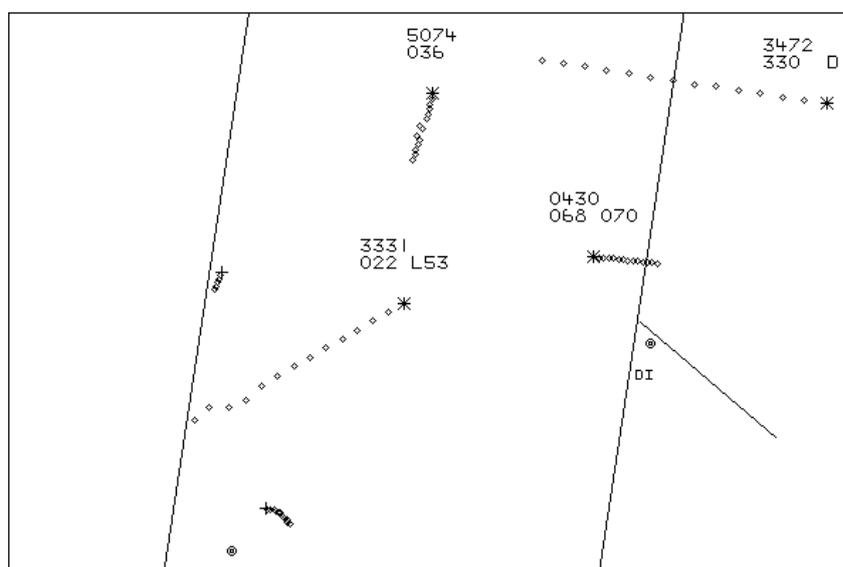
At 1637:37 the controller transmitted, as per Figure 3, “[Tornado callsign] *identified, traffic service [couple of clipped words] possible as you operate below my minimum safe altitude, previously called traffic, right 1 o’clock, 3 miles, crossing right to left, indicating FL68.*”

Figure 3: Traffic Information at 1637:37 (Tornado squawk 3331).

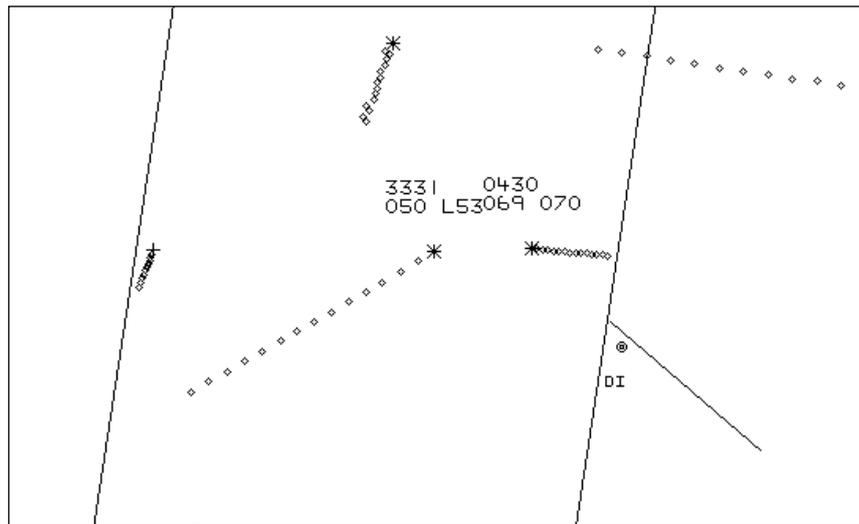
At 1637:56, the Tornado pilot replied with, “*Copy traffic, traffic service, [Tornado callsign] climbing for Swindon Westcott corridor.*”

Figure 4: Geometry at 1637:56.

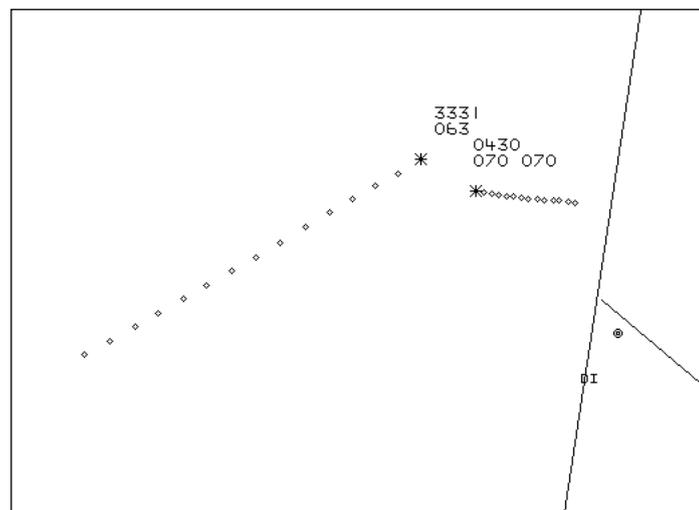
The radar replay at 1638:06 showed 1nm separation between aircraft, as per Figure 5. The DA42 had climbed from FL65 to FL70. The Tornado was climbing for the Swindon RVC at FL 230.

Figure 5: Geometry at 1638:06.

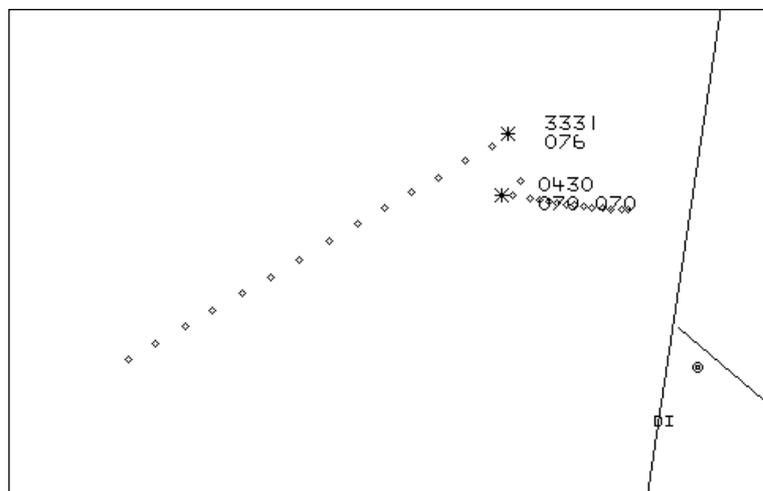
The CPA was placed between 1638:06 with 400ft height separation and 1nm lateral separation, as per Figure 5, and 1638:14 with 0.9nm with 600 ft separation, as per Figure 6.

Figure 6: CPA at 1638:14.
