AIRPROX REPORT No 2014088**Date/Time:** 15 Jun 2014 1426Z (Sunday)**Position:** 5250N 00159W
(4nm W of Tatenhill)**Airspace:** London FIR (Class: G)**Aircraft 1** **Aircraft 2****Type:** Quantum 15 Grumman AA5
Microlight**Operator:** Civ Pte Civ Pte**Alt/FL:** 1500ft 1600ft
QNH (1028hPa) QNH (NK hPa)**Conditions:** VMC VMC**Visibility:** 12km >10km**Reported Separation:**

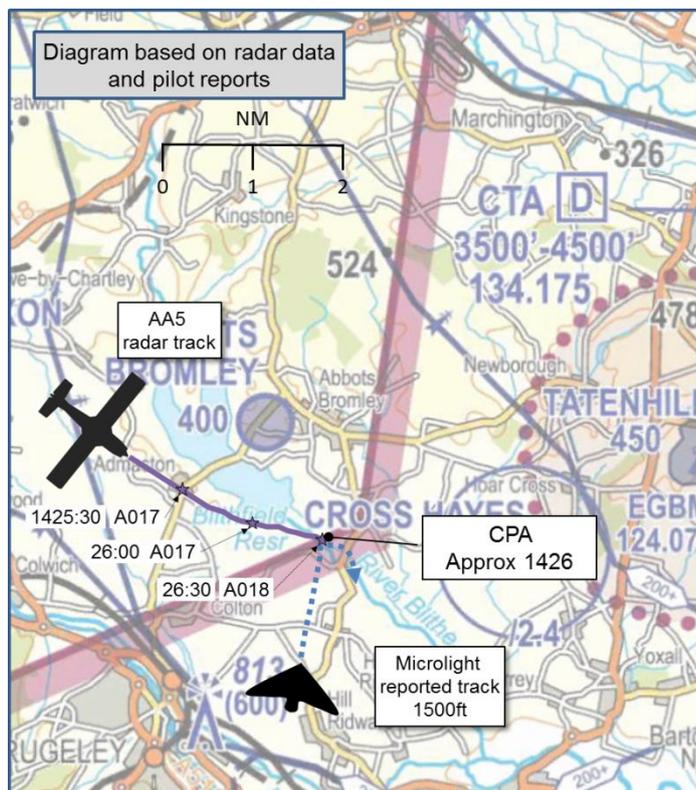
The aircraft were converging, and the microlight was on the right of the AA5, so the AA5 pilot was required to give way²

An Airprox was reported 4nm to the west of Tatenhill between a Quantum 15 microlight and a Grumman AA5 in Class G airspace. The microlight pilot was not in receipt of an ATS³; the AA5 pilot was in receipt of an A/G service from Tatenhill Radio. The CPA was not recorded on radar but the microlight pilot reports it as 50-70ft V/30-50m H and the AA5 pilot reports it as 200ft V/0ft H.
