## AIRPROX REPORT No 2014105

Date/Time: 8 Jul 2014 0930Z

Position: 5354N 00022W  
(Beverley/Linley Hill)

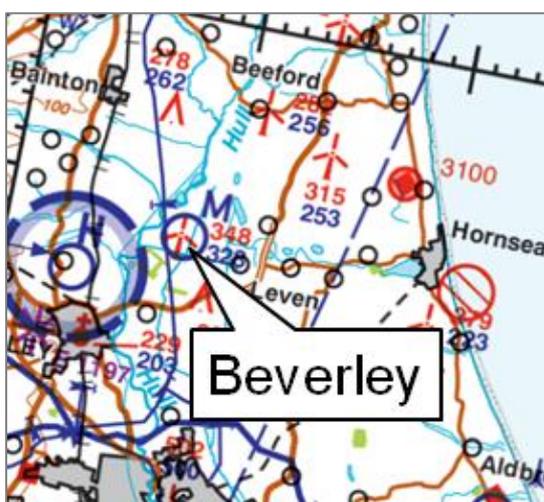
Military Low Flying Chart

The UK Military Low-Flying Chart depicts Beverley airfield as a 'Microlight Site' with an associated 'wind-farm'. The UK CAA VFR Chart depicts Beverley airfield as an 'Aerodrome – Civil, limited or no facilities and where flying training may be taking place', with an annotation highlighting 'Intense Microlight Activity' in the area.

The Board also commented on the apparent disparity in information between the UK CAA VFR chart and the Military Low Flying chart, in this case with the former emphasising intense microlight activity in the area of the Airprox and the latter omitting that information. The Board were glad to be advised that a review of information on the Military Low Flying chart was currently being undertaken in order to harmonise the information between this and the CAA charting.

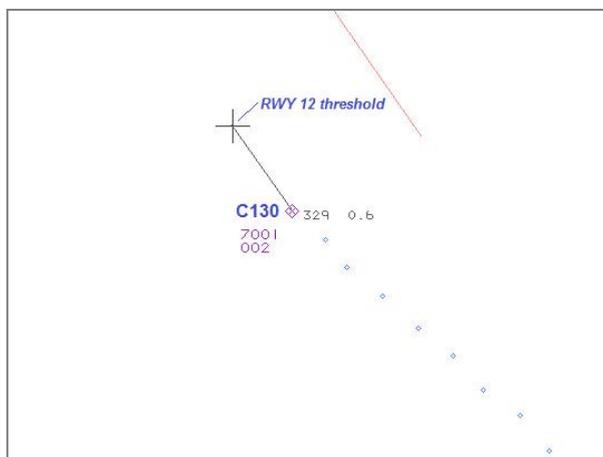
Figure 1: Swanwick MRT at 0929:34

The Microlight was not shown on the radar recording but, at 0929:34, the C130 was shown 0.6nm southeast of the Beverley's RW12 threshold, indicating FL003 (approximately 300ft on QNH 1014hPa), see Figure 1.

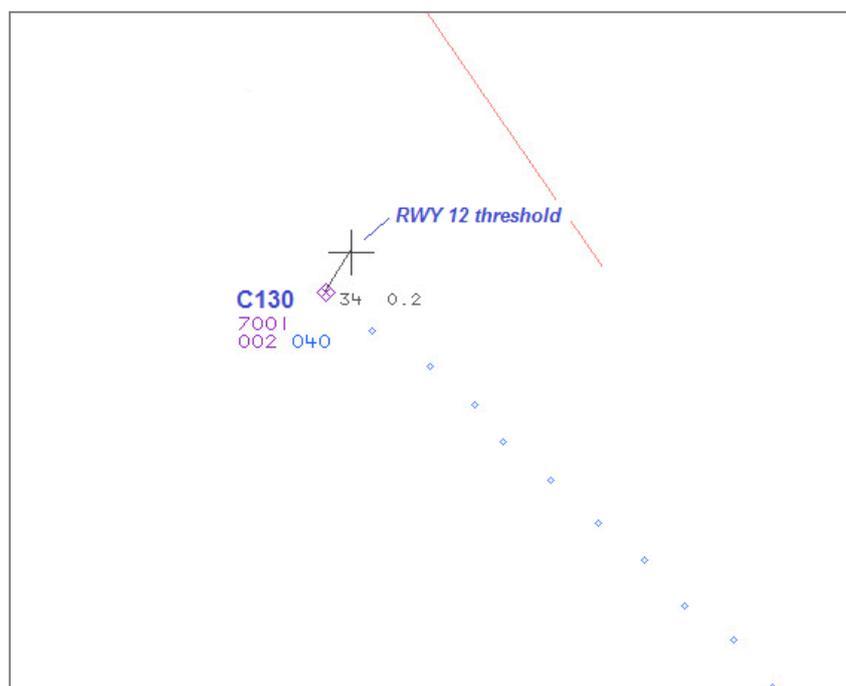
Figure 2: Swanwick MRT at 0929:42

The C130 pilot continued on a northwesterly track and passed 0.2nm southwest of the RW12 threshold, indicating FL002 (200ft), see Figure 2.

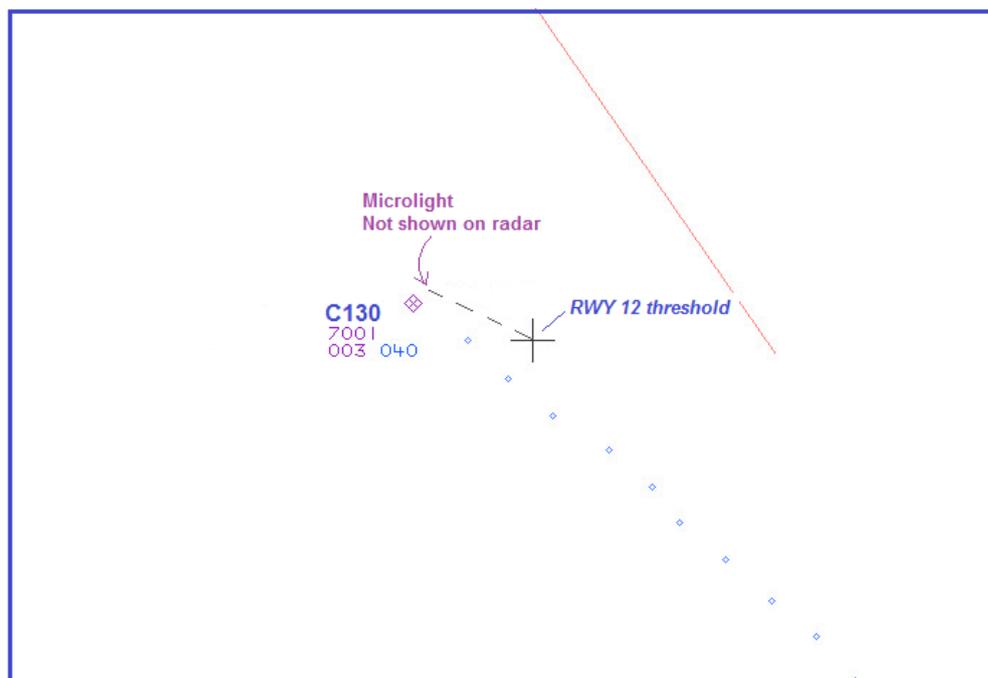
Figure 3: Swanwick MRT at 0929:50

At 0929:50, the C130 passed 0.1nm southwest of the Microlight pilot's reported position indicating FL003 (300ft), see Figure 3.
