AIRPROX REPORT No 2014143

Date/Time: 18 Aug 2014 1321Z

Position: 5137N 00109W
(2nm W Benson)

Airspace: Benson ATZ (Class: G)

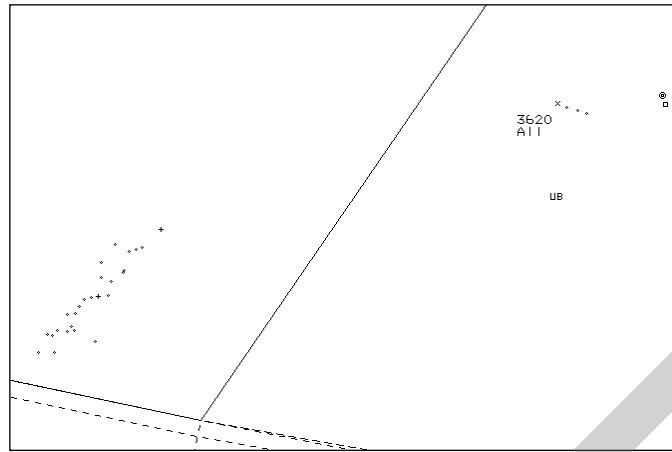
The Airprox occurred between a Puma and four gliders. The Puma was in the process of switching frequencies between Benson Tower and Benson Approach. At 1421:26 (Figure 1), Approach confirmed to the Puma, "*Good afternoon, Basic Service, VFR departure approved, squawk ident*".

Figure 1: Basic Service applied at 1421:26 (Puma squawk 3620).

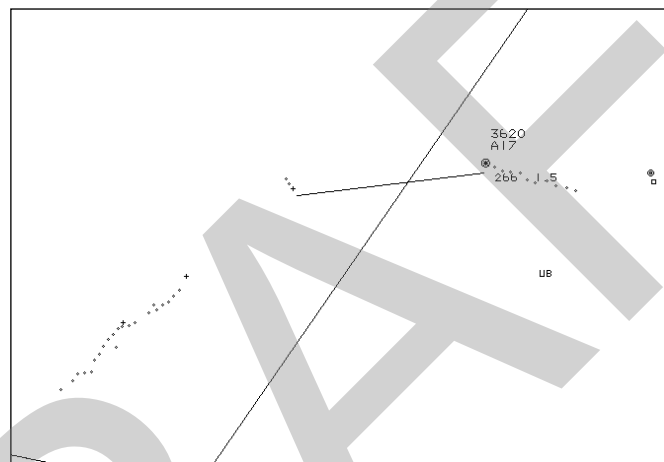
At 1421:56 (Figure 2), an intermittent contact, primary only, was detected on the Heathrow Radar.

Figure 2: Intermittent primary contact at 1421:56.

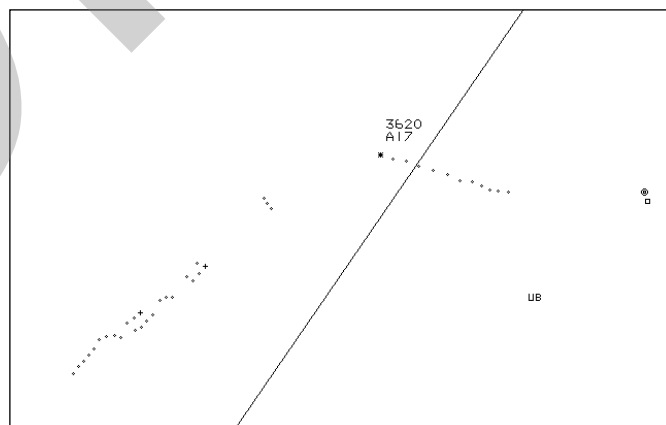
At 1422:25 (Figure 3), the Puma declared, "*Er Benson approach, for your information there is one glider approximately a quarter of a mile in our nine o'clock position soaring at altitude one thousand seven hundred feet*". This information was passed by Approach onto various Tutor callsigns and constant reports and updates were passed between controller and aircrew. The Puma recovered visually at 1431:02 and confirmed visual with three gliders to the east of the initials point.

Figure 3: Airprox declared at 1422:25.

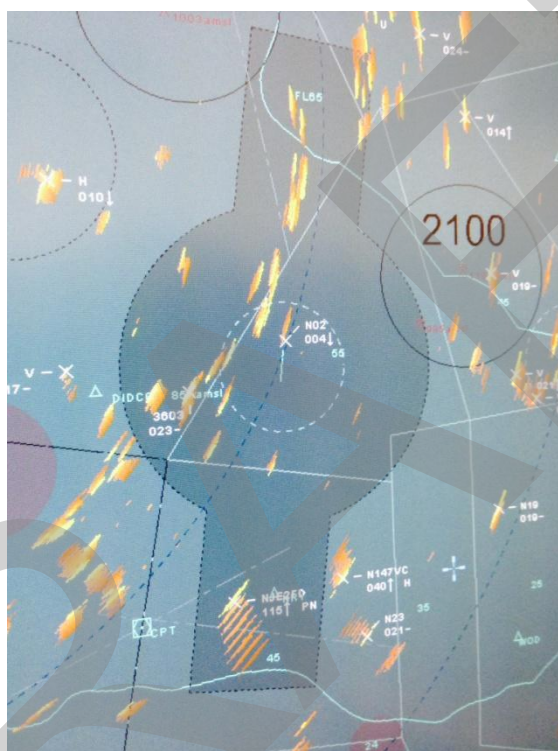
The radar picture at Figure 4 was taken on the day of the Airprox and demonstrates the glider activity within the Benson area; it was clear that movements to and from Benson would encounter gliders due to the scale and spread of the activity. The area to the north and west was congested with activity and the area to the east of Benson is restricted in terms of controlled airspace. The controllers had to cancel IFR approaches because of the traffic density and they had taken a pro-active deconfliction approach throughout the incident.

Figure 4: Radar picture taken at RAF Benson taken on the day of the Airprox.

Better procedures to advertise activity and provide a degree of conspicuity would assist Benson-based squadrons in planning to avoid the biggest collections of glider activity. Benson will continue to take the issue forward at the Oxford Airspace User's Working Group to share and promote information on mutual activities. To add a degree of situational awareness to Benson crews, and to aid in deconfliction at the planning stage, FLARM feeds are being considered to highlight glider activity and strengthen the barriers to Mid Air Collision.

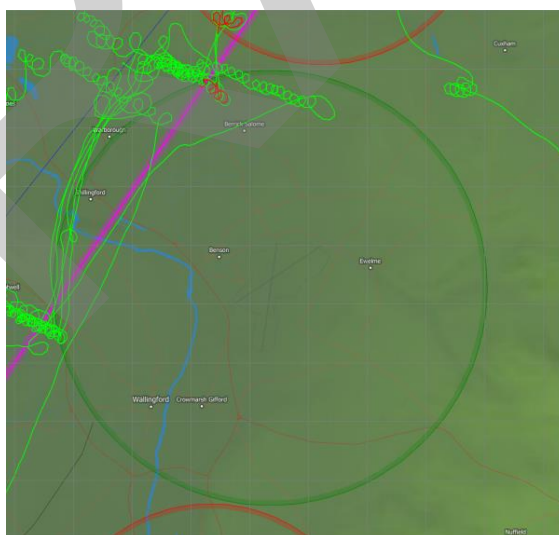
The logger traces of all participating gliders were located and examined; it is apparent that of these gliders only one actually penetrated the Benson ATZ (see Figure 5 – red indicates inside the ATZ, which is marked by a green circle) and this pilot has confirmed that he had established communications with Benson Tower. Moreover, the timing and position data confirms that this was not the glider involved in the Airprox.

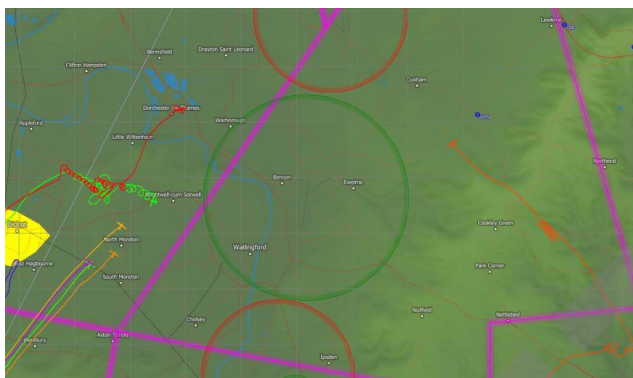
Figure 6 shows positions of participating gliders in the vicinity of Benson at time of the reported Airprox (13:21UTC). It seems likely that the glider circling to the west of Benson is the one seen by the Puma pilot. It is this pilot who has made the report above.
