AIRPROX REPORT No 2014143

Date/Time: 18 Aug 2014 1321Z

Position: 5137N 00109W
(2nm W Benson)

Type: Puma Nimbus

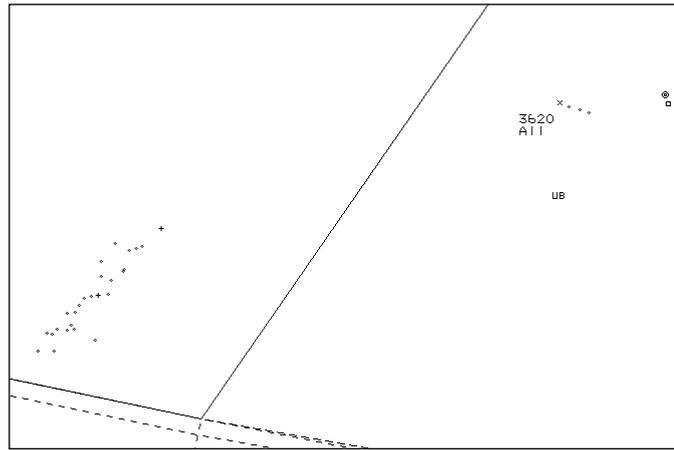
The Airprox occurred between a Puma and four gliders. The Puma was in the process of switching frequencies between Benson Tower and Benson Approach. At 1421:26 (Figure 1), Approach confirmed to the Puma, "*Good afternoon, Basic Service, VFR departure approved, squawk ident*".

Figure 1: Basic Service applied at 1421:26 (Puma squawk 3620).

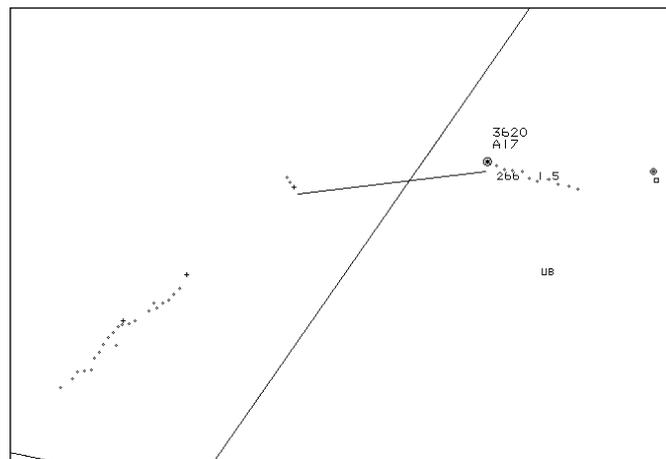
At 1421:56 (Figure 2), an intermittent contact, primary only, was detected on the Heathrow Radar.

Figure 2: Intermittent primary contact at 1421:56.

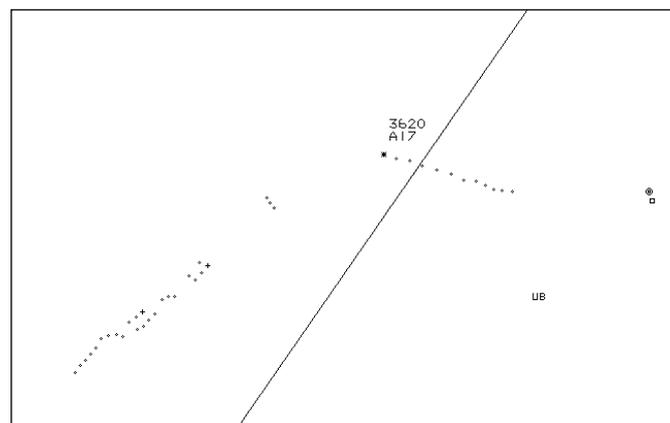
At 1422:25 (Figure 3), the Puma declared, “*Er Benson approach, for your information there is one glider approximately a quarter of a mile in our nine o'clock position soaring at altitude one thousand seven hundred feet*”. This information was passed by Approach onto various Tutor callsigns and constant reports and updates were passed between controller and aircrew. The Puma recovered visually at 1431:02 and confirmed visual with three gliders to the east of the initials point.

Figure 3: Airprox declared at 1422:25.

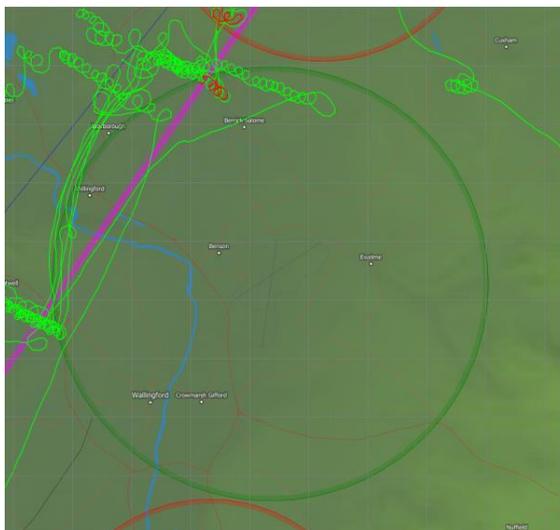
The logger traces of all participating gliders were located and examined; it is apparent that of these gliders only one actually penetrated the Benson ATZ (see Figure 5 – red indicates inside the ATZ, which is marked by a green circle) and this pilot has confirmed that he had established communications with Benson Tower. Moreover, the timing and position data confirms that this was not the glider involved in the Airprox.

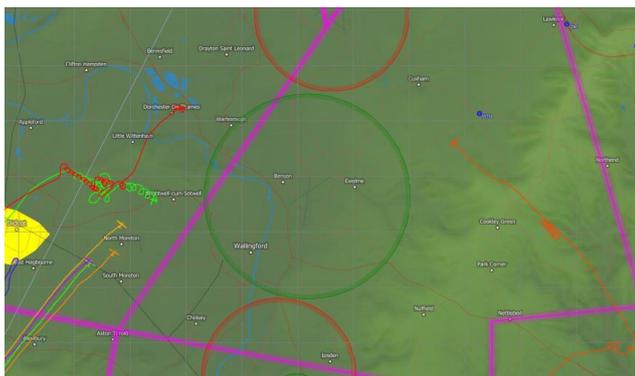
Figure 6 shows positions of participating gliders in the vicinity of Benson at time of the reported Airprox (13:21UTC). It seems likely that the glider circling to the west of Benson is the one seen by the Puma pilot. It is this pilot who has made the report above.
