## **AIRPROX REPORT No 2014155**

Date/Time: 28 Aug 2014 1056Z

Position: 5154N 00212W  
(1.3nm W Gloucestershire  
Airport- elevation 101ft)

Airspace: Gloucester ATZ (Class: G)

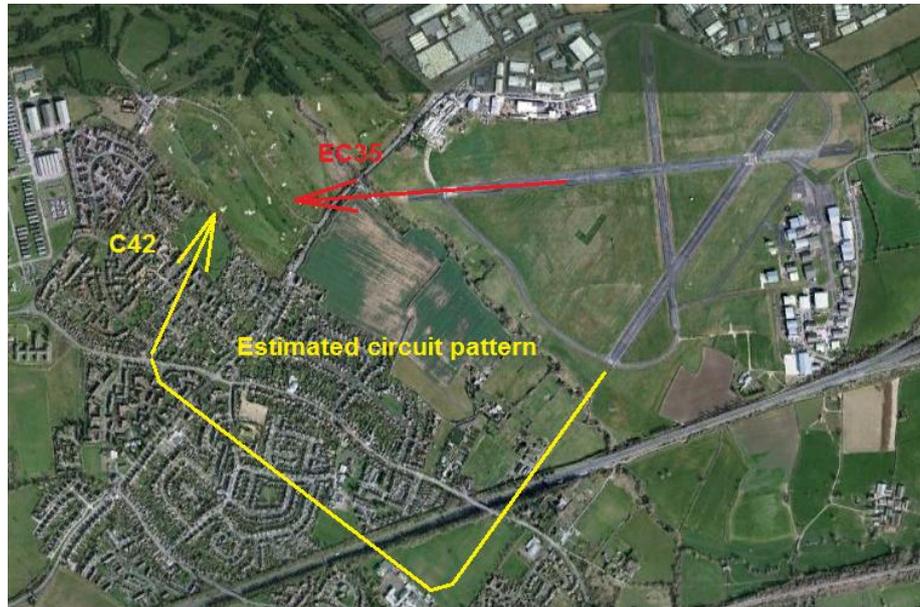
For illustrative purposes, an extract from the Google Earth mapping tool shows the airfield and estimated circuit patterns of the two aircraft. (Figure 1.)

Figure 1 – Google Earth extract showing estimated circuit pattern

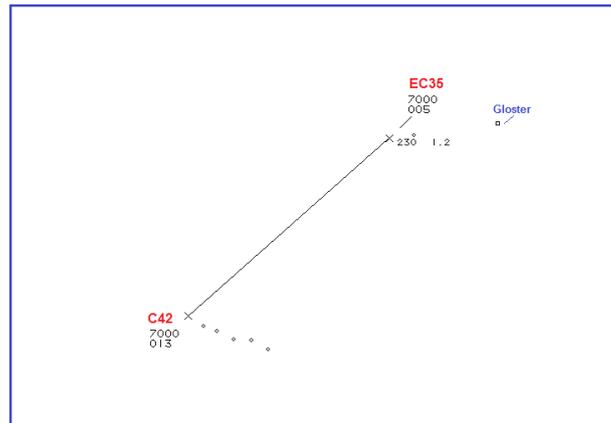
At 1055:10, the EC135 appeared on the radar recording. The distance between the two aircraft was 1.2nm. (Figure 2.)

Figure 2 – Swanwick MRT at 1055:10

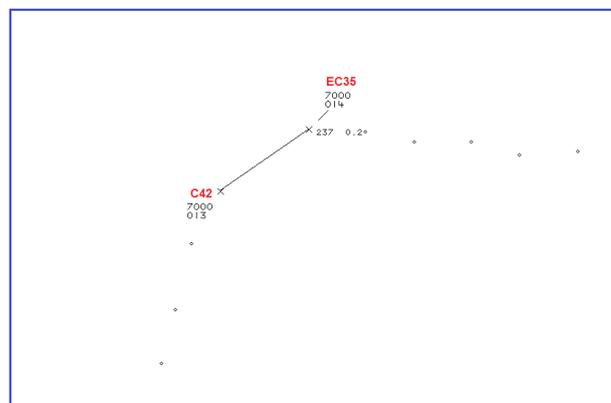
The aircraft continued to converge until, at 1055:42, the distance between them was 0.2nm. The EC135 was indicating FL014 and the C42 FL013. (Figure 3.)

Figure 3 – Swanwick MRT at 1055:42

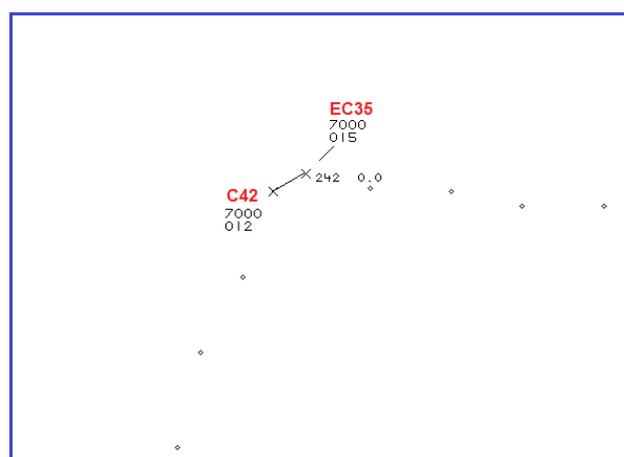
The next sweep of the radar, at 1055:46, showed the C42 at FL012 and the EC135 at FL015. The distance between the two aircraft was less than 0.1nm. (Figure 4.)

Figure 4 – Swanwick MRT at 1055:46

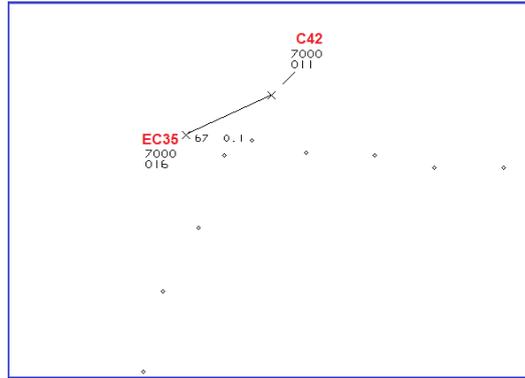
The CPA is estimated to have occurred shortly afterwards, at 1055:47, when the EC135 passed 300ft above the C42. The next sweep of the radar showed the two aircraft diverging at a range of 0.1nm and vertical separation of 500ft. (Figure 5.)

Figure 5 – Swanwick MRT at 1055:50
