AIRPROX REPORT No 2014170

Date/Time: 11 Sep 2014 1213Z

Position: 5137N 00022W
(London)

Type: SK76 Falcon 900

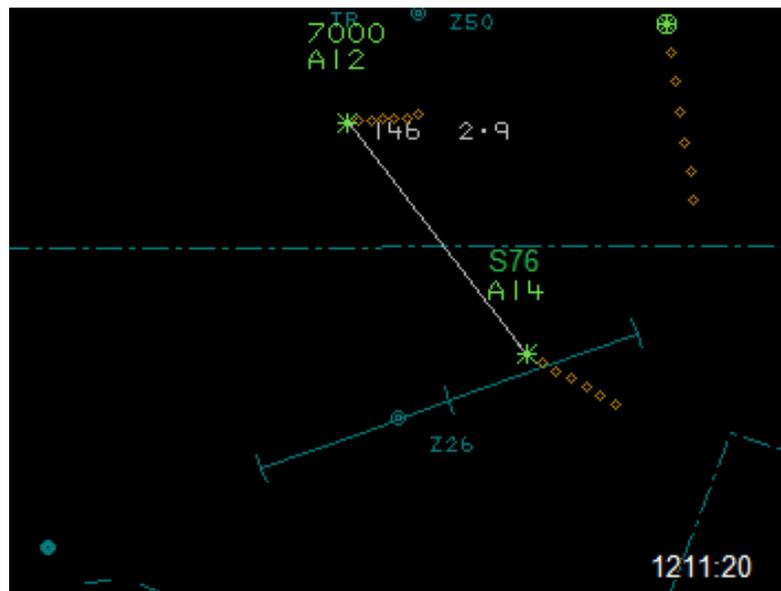
At 1208:28, the SK76 pilot contacted SVFR, passing 500ft, and was instructed to route via Brent then northwest bound and was re-cleared not above 1500ft. At 1211:06, the SK76 pilot requested a climb to 2500ft due to TCAS traffic in the pilot's 12 o'clock (squawking 7000 in Figure 1 – Traffic (A)). The SVFR controller instructed the SK76 pilot to standby while he talked to Northolt and advised the SK76 pilot of "traffic observed in your twelve o'clock right to left westbound indicating one thousand two hundred feet range of two and a half miles" (Figure 1).

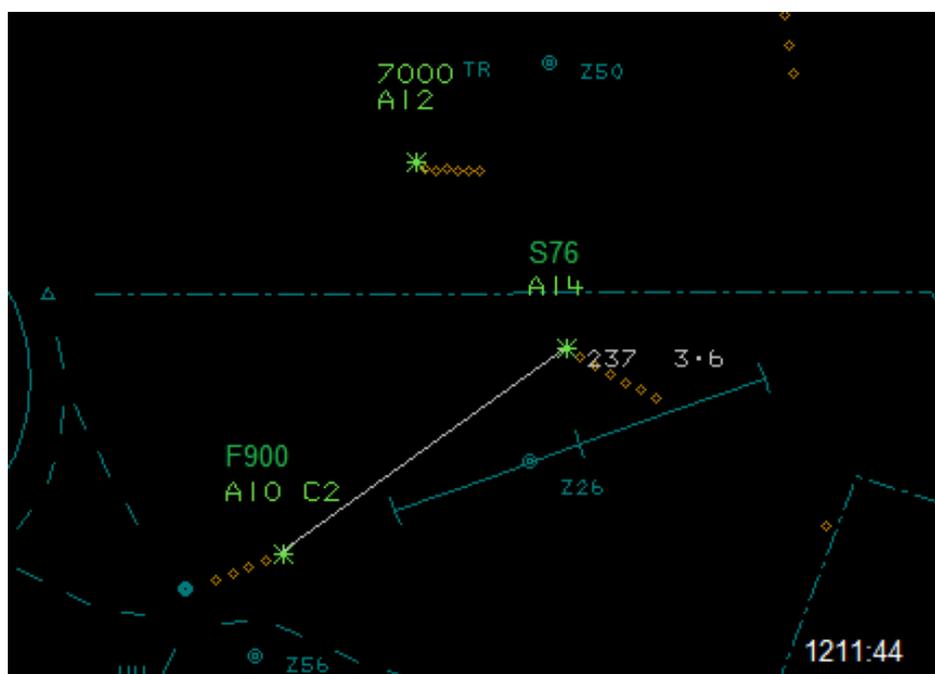
Figure 2

The SVFR controller informed the SK76 pilot that there was traffic leaving the Northolt zone and instructed him to wait until he was outside controlled airspace to climb. The SVFR controller informed the SK76 pilot that the traffic was southwest of him by 4nm at 700ft climbing (Figure 2). The SK76 pilot replied that the traffic was copied and asked “*but er what about the traffic twelve o’clock two hundred below*”. The controller replied that the traffic was outside controlled airspace and the traffic he had called was inside.

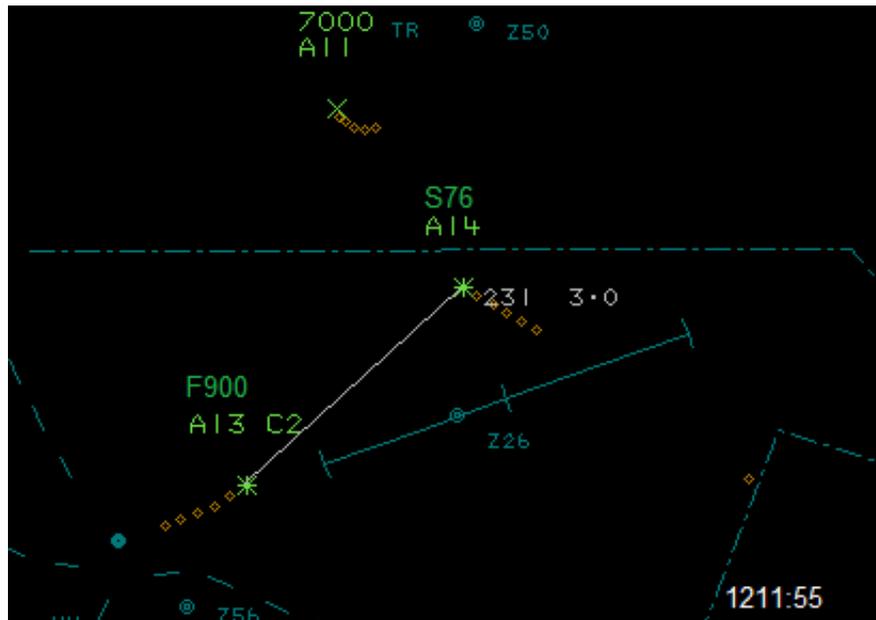
Figure 3

At 1211:55, the SK76 pilot reported that they were just crossing the [London CTR] boundary in the climb to 2400ft (Figure 3). The SVFR controller replied that the previously mentioned traffic from Northolt was southwest by 2nm at 1600ft, turning northbound. Separation was lost at 1211:58 when the SK76 was indicating 1500ft and the Falcon pilot was climbing through 1400ft, 2.8nm apart and inside the Class A airspace of the London CTR.

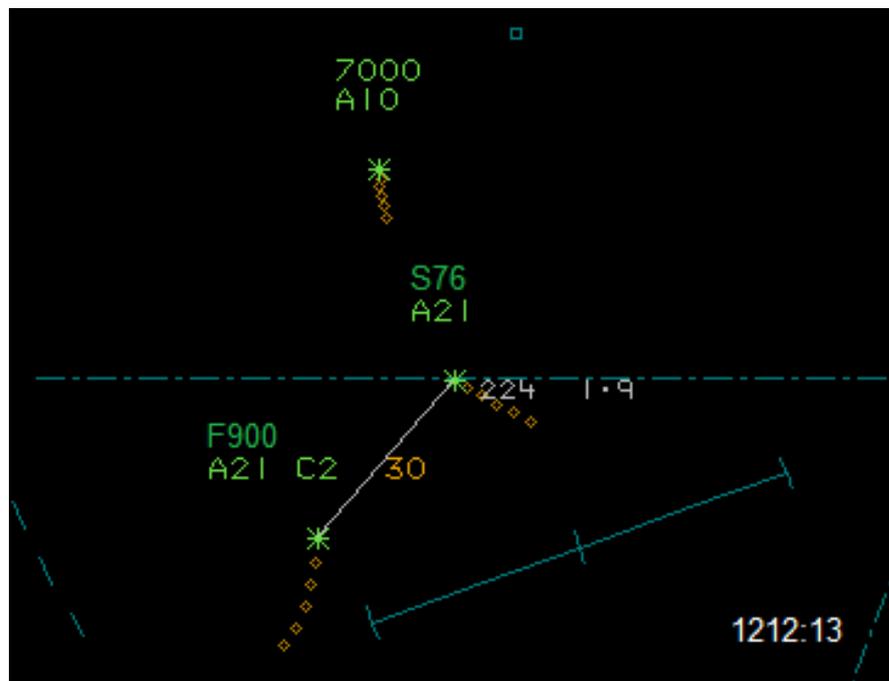
Figure 4

The SK76 pilot asked if the Falcon had been “*deconflicted from us*” and was informed by the SVFR controller that the Falcon pilot was climbing above but if the SK76 climbed it may cause a TCAS alert. The SK76 pilot acknowledged the transmission and stated that they were visual with the traffic. The SVFR controller changed the service to a Traffic Service. CPA inside controlled airspace, co-altitude at 1.9nm horizontal separation, occurred at 1212:13 (Figure 4).

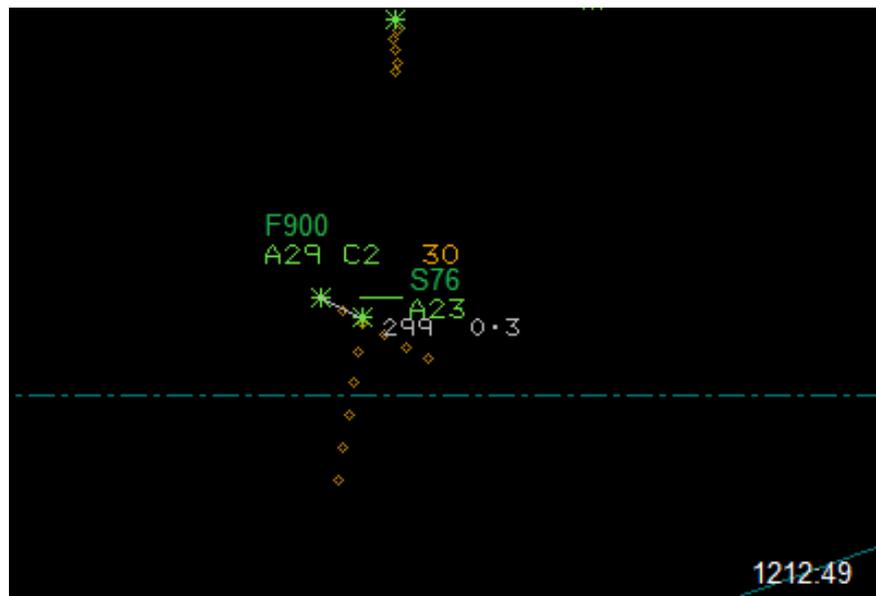
Figure 5

CPA outside controlled airspace, 600ft vertical and 0.3nm horizontal separation, occurred at 1212:49 (Figure 5).

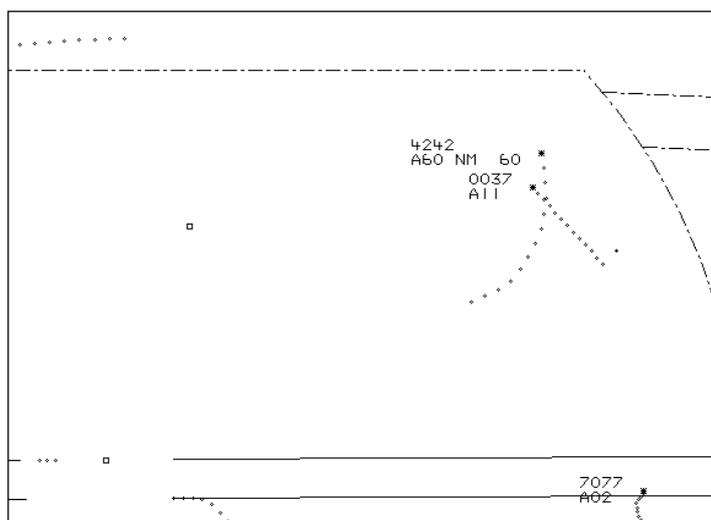
At 1210:29 (Figure 2), Approach called Tower to approve the release on the Falcon, “*Approach, [Falcon C/S] is Clacton Five-Xray, departure approved.*”

Figure 2: Falcon released by Approach at 1210:29, SK76 squawking 0037

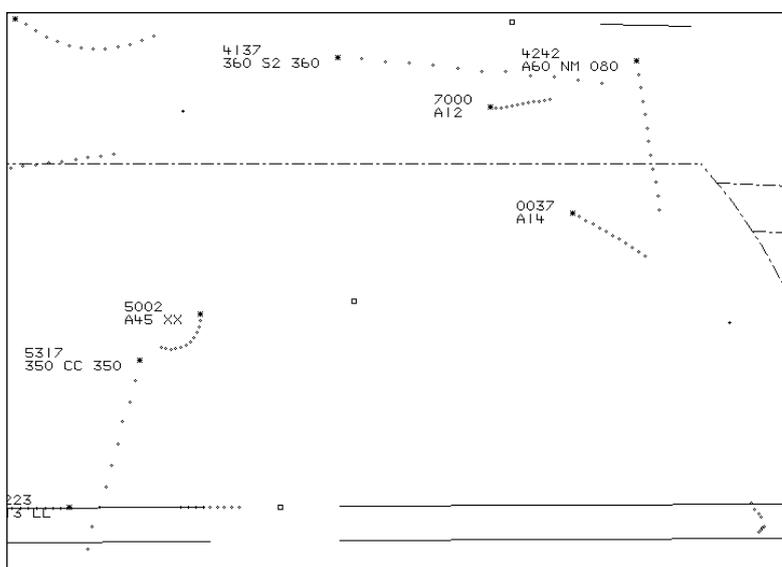
The Falcon pilot was cleared for take-off by Northolt Tower at 1210:43 and, at approximately 1211:07, the SK76 pilot requested, “[SK76 C/S] *request further climb, request altitude 2500 feet due to TCAS traffic 12 o’clock*”. Heathrow Radar responded with, “*Standby, I just need to talk to Northolt. There is traffic observed in your 12 o’clock, right to left westbound, indicating 1200 feet, range 2 and a half miles.*” At 1211:14, Approach called Tower to enquire, “*Approach, is he lined up ready to go is he?*” Tower replied at 1211:16 with, “*He is going.*” Approach instructed at 1211:23 (Figure 3), “*If you could ask him to make an early left turn please?*”

Figure 3: At 1211:23 as Approach requested an early left turn on the Falcon

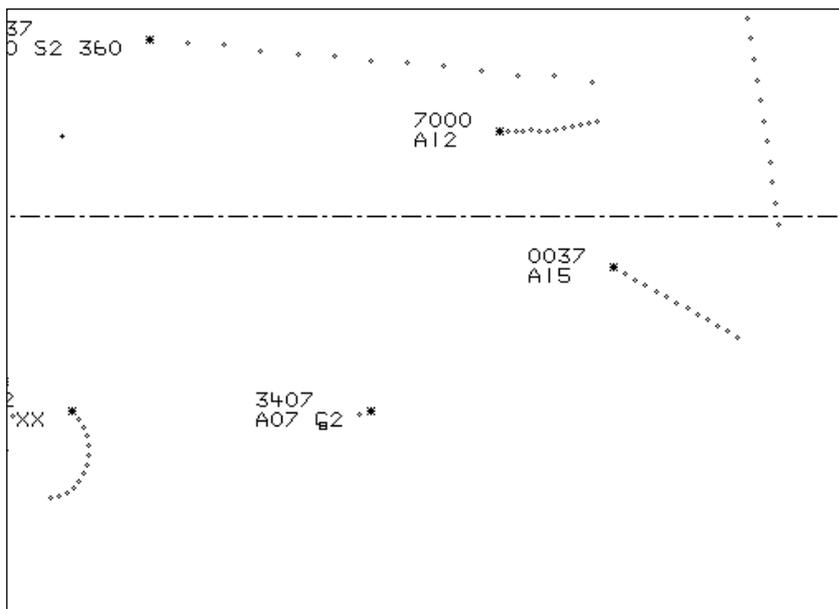
At 1211:38 (Figure 4), Tower requested, “[Falcon C/S] *are you able to initiate an early left turn? Traffic northeast four miles tracking northwest, indicating four feet above.*” The Falcon pilot replied with, “*looking out*”. At approximately 1211:35, Heathrow Radar called Northolt Approach to request, “*Can I go to two point four with the [SK76 C/S] now?*” Northolt Approach replied with, “*I’ve just got one lifting now, making an early left turn, if you can wait.*” Heathrow Radar replied with, “*Yeah, will do.*” At approximately 1211:41, Heathrow Radar transmitted, “[SK76 C/S] *there is traffic leaving the Northolt zone, so just wait until you’re outside CAS, its south-west of you by 4 miles at 700 feet climbing out.*” The controller and SK76 pilot entered into dialogue about the respective sets of traffic.

Figure 4: At 1211:38 with Traffic Information and early left turn request (Falcon squawk 3407)

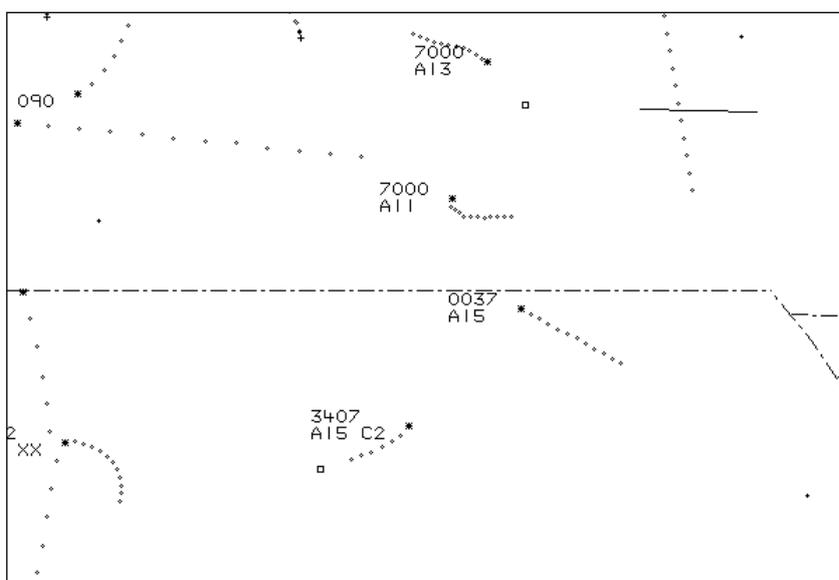
At 1212:00 (Figure 5), Tower updated information, “[Falcon C/S] *the traffic northeast three miles, tracking northwest, one hundred feet below.*” The Falcon pilot again responded with, “*looking out*”.

Figure 5: Traffic Information at 1212:00

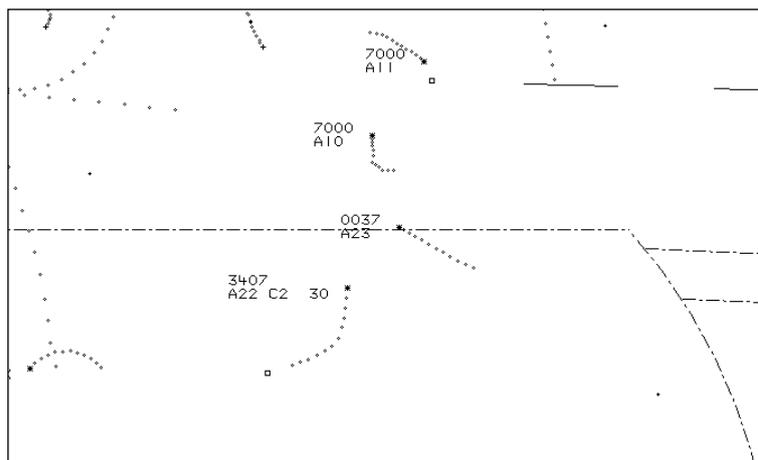
At 1212:14, Tower requested, “[Falcon C/S] *the traffic...are you able to expedite climb?*” Tower added at 1212:20 (Figure 6), “[Falcon C/S] *traffic right one o’clock two miles, crossing right left, same height.*” At this point, the SK76 was crossing the CTR boundary and Mode C indicated 2300ft on QNH 1022 hPa.

Figure 6: Traffic Information at 1212:20

The radar reply indicated that the SK76 pilot climbed whilst inside the CTR; Figure 6 shows the SK76 crossing the CTR boundary with a Mode C altitude of 2300ft on the radar replay pressure of 1022hPa. The SK76 pilot had NOTAM'd the flight and could rightly assume that all parties were aware of his presence. The pilot was aware of the separation standards in controlled airspace and was looking ahead to Class G to see what was outside the CTR in the unknown traffic environment. The pilot mentioned the first confliction at 12 o'clock, 2nm, same altitude, and this decreased to half a mile, co-altitude. It is evident that the SK76 pilot was keen to climb above the confliction on TCAS and when the Falcon first appeared on TCAS at 1 nm, an emergency descent was planned. The Falcon was then seen at half a mile and the avoiding action descent was not acted upon as the Falcon passed overhead. During the two TCAS alarms, the crew would have spent some time responding to search, identify and then form a plan to evade on two separate tracks.

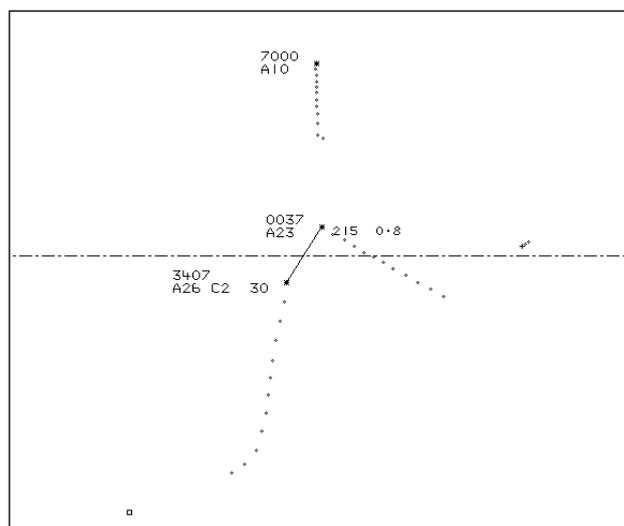
At 1212:26, Tower requested, “[Falcon C/S] *stop your climb please.*” Approach called Tower at 1212:32 and Tower confirmed that Traffic Information was being passed. At 1212:37 (Figure 7), Tower requested, “[Falcon C/S] *traffic [stepped on] confirm visual?*” The Falcon pilot replied immediately at 1212:39 with, “*Affirm visual, it’s a helicopter.*”

Figure 7: At 1212:37 as Tower requested if the Falcon pilot was visual

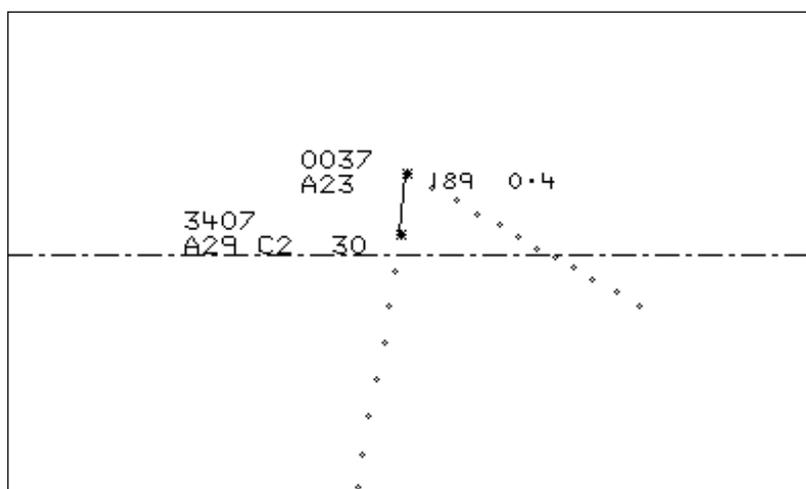
The CPA was approximately between 1212:44 and 1212:48 with 0.3nm horizontal separation and 600ft vertical separation (Figure 8).

Figure 8: Approximate CPA at 1212:44
