AIRPROX REPORT No 2014172**Date/Time:** 13 Sep 2014 1430Z (Saturday)**Position:** 5153N 00209W
(1nm SE of Gloucestershire Airport)**Airspace:** Gloucestershire ATZ (**Class:** G)**Aircraft 1** **Aircraft 2****Type:** Ikarus C42 Cessna C182**Operator:** Civ Trg Civ Pte**Alt/FL:** 1000ft 2000ft
QFE NK**Conditions:** VMC VMC**Visibility:** >10km NK**Reported Separation:**

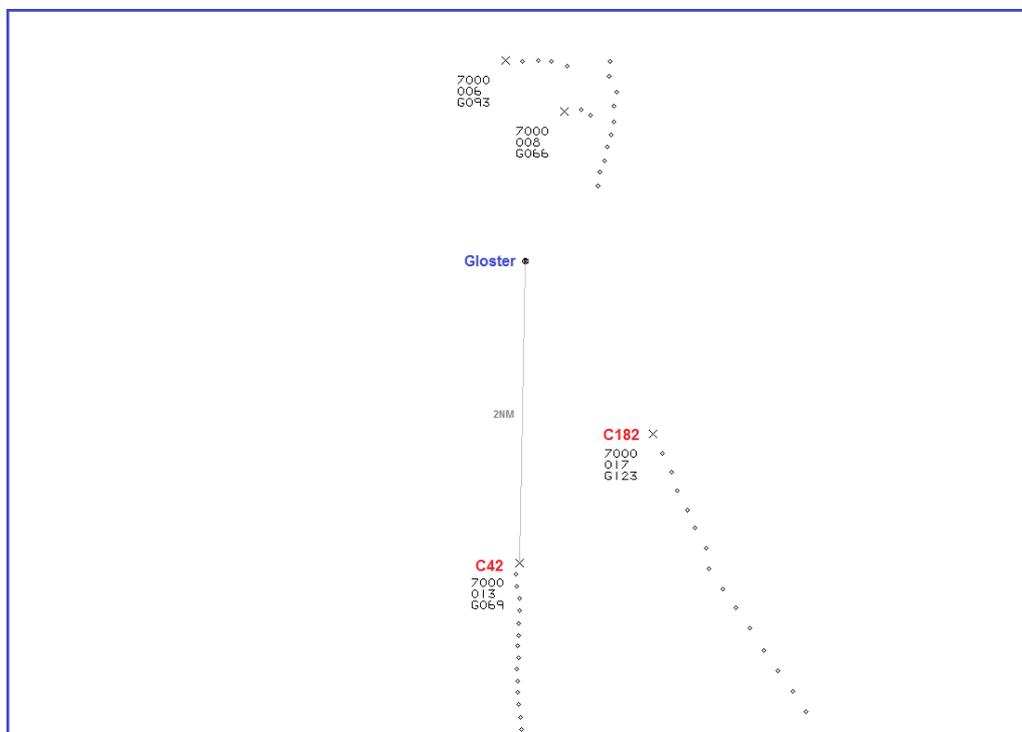
Figure 1 – Swanwick MRT at 1429:00

At 1429:00 radar showed the C42's position 2nm south of Gloster at FL013, with groundspeed (G/S) of 069kts. The C182 was 1.4nm southeast of Gloster at FL017 with ground-speed of 123kts – Figure 1.

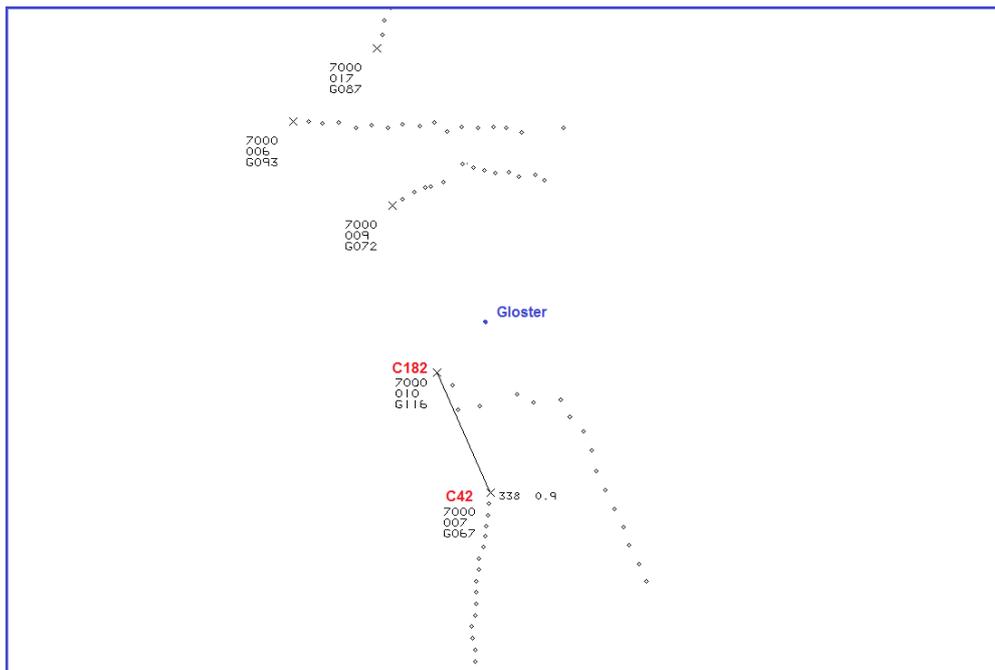
Figure 2 – Swanwick MRT at 1429:42

At 1429:42 the C182 was shown to have made a left turn followed by a right turn – Figure 2.

C42	<i>"Er (C42) c/s that descending Cessna appears to be in a right-hand turn er is he going the wrong way round the circuit"</i>
C182	<i>"Roger apologies (C182) c/s"</i>
Tower	<i>"(C182) c/s roger if you reposition to the dead-side traffic descending at the moment is an Ikarus (C42)"</i>

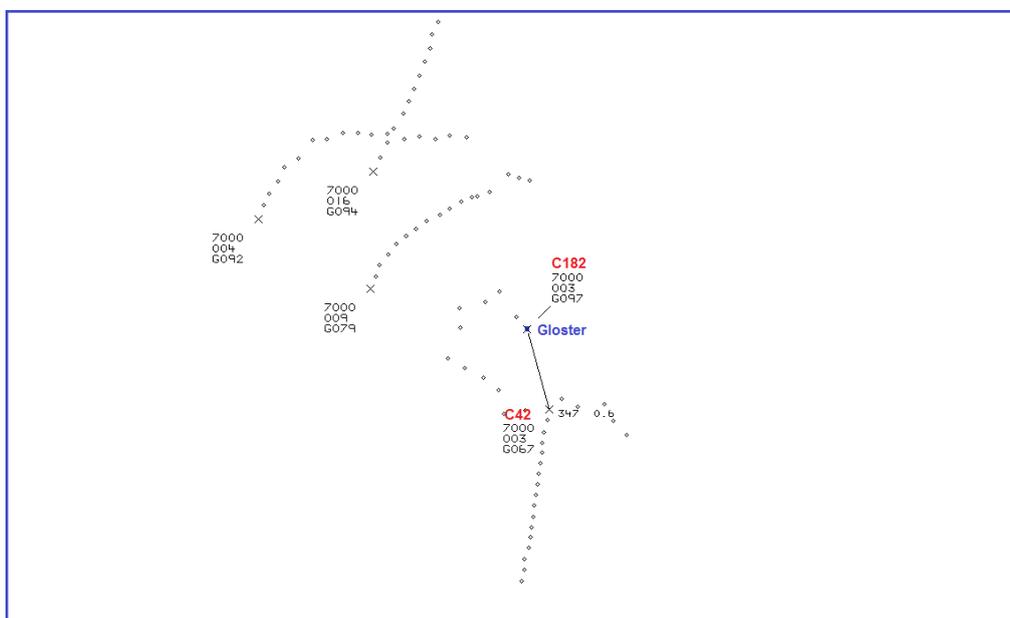
Figure 3 – Swanwick MRT at 1430:14

At 1430:14 the C182 had turned through 180 degrees and was overhead the airfield on a reciprocal track to the C42. Both aircraft were indicating FL003 (height 600ft on QNH 1024hPa) at a range of 0.6nm – Figure 3.

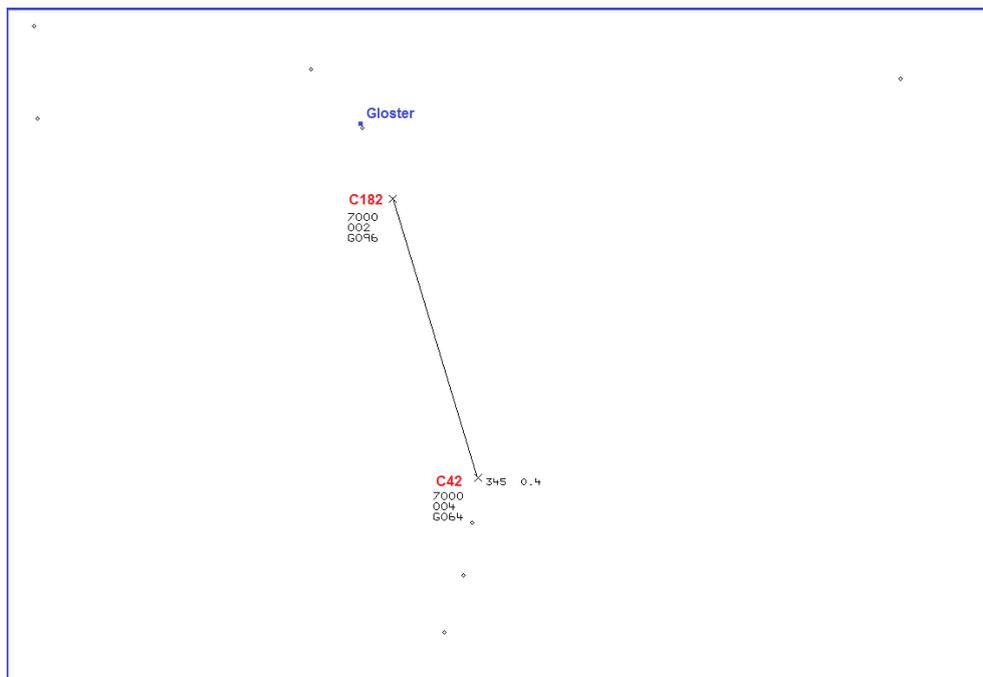
Figure 4 – Swanwick MRT at 1430:18

The next sweep of the radar (1430:18) showed the horizontal distance as 0.4nm with the C182 100ft below the C42 – Figure 4.

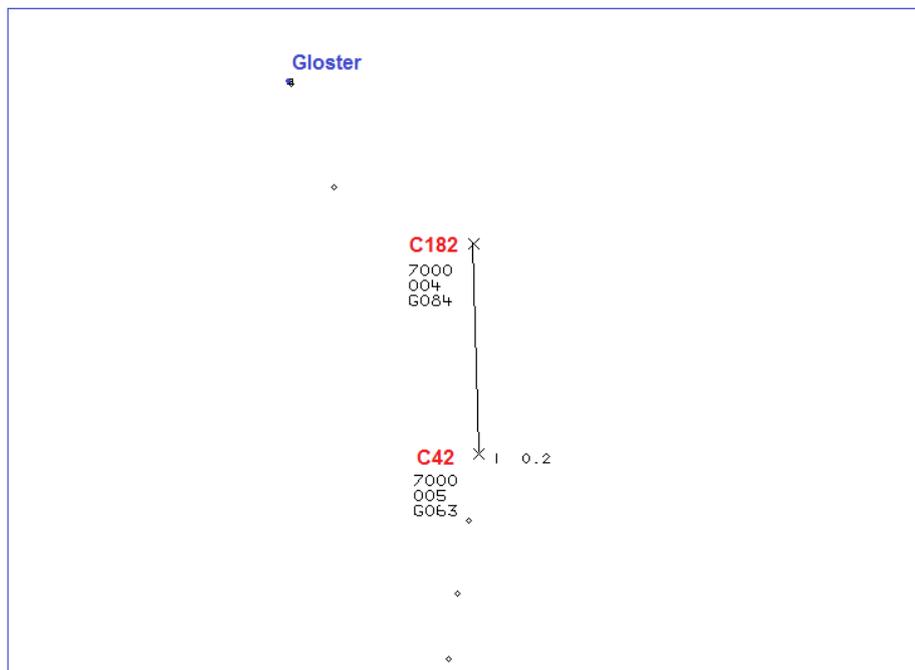
Figure 5 – Swanwick MRT at 1430:26

At 1430:26 (CPA) the C42 pilot reported “(C42)c/s the Cessna appears to be turning er directly in front of us into the circuit so he looks like he’s number one now”. This was acknowledged by the Tower controller. The C182 is shown tracking northeast, in the C42’s 12 o’clock, at range of 0.2nm and 100ft below – Figure 5.

Cause: The C182 pilot flew into conflict with the C42 having mistakenly joined for the reciprocal runway.

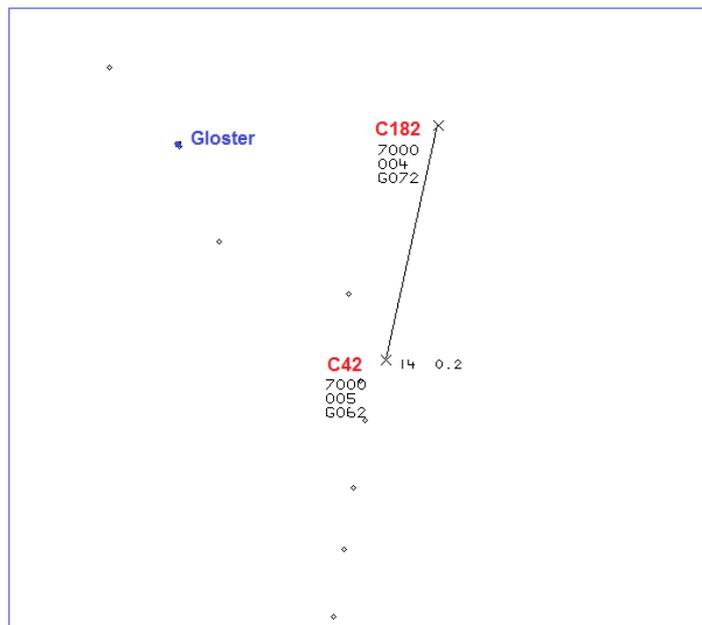
Figure 6 – Swanwick MRT at 1430:34

At 1430:34 The C182 continued the turn north - Figure 6.
