AIRPROX REPORT No 2014177**Date/Time:** 6 Sep 2014 1433Z (Saturday)**Position:** 5154N 00105W
(1nm NE of Bicester Glider Site)**Airspace:** London FIR (Class: G)**Aircraft 1** **Aircraft 2****Type:** DR400 Beech A36
+ Glider Bonanza**Operator:** Civ Club Civ Pte**Alt/FL:** 2300ft 2100ft
agl (1014hPa) QNH**Conditions:** VMC VMC**Visibility:** 20nm 10km**Reported Separation:**
0ft V/50-100ft H 200ft V/200m H**Recorded Separation:**

**PART A: SUMMARY OF INFORMATION REPORTED TO UKAB**

An Airprox was reported around 1nm to the northeast of Bicester gliding site, in Class G airspace, between a Beech A36 Bonanza and a DR400 tug, which was towing an ASK21 glider.

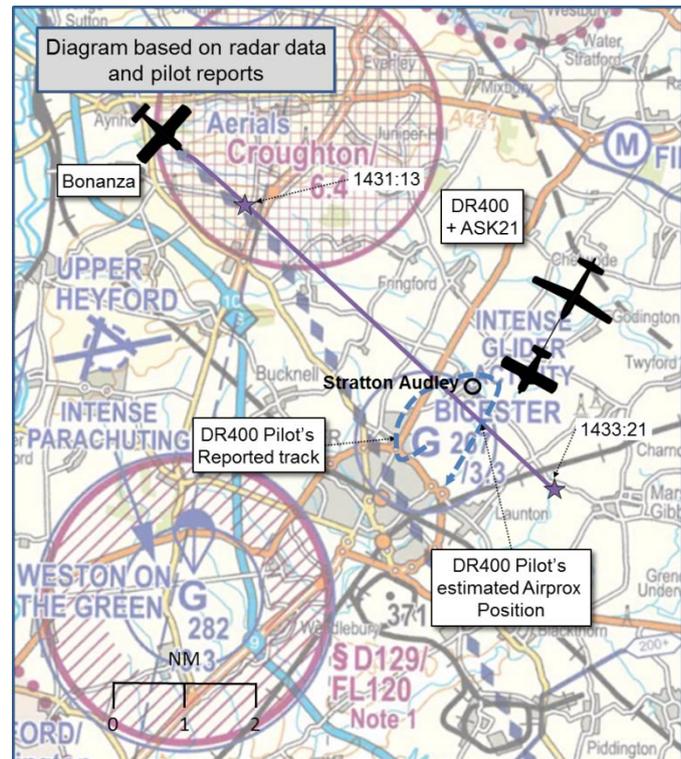
The Bonanza can be seen clearly on the radar recording, routing to the northeast of Bicester glider site and to the southwest of Stratton Audley. The DR400 pilot's description of his routing indicates that the Airprox occurred just to the west or southwest of Stratton Audley.

<u>Cause:</u>	The Bonanza pilot flew into conflict with the DR400 tug and glider whilst in close proximity to a promulgated and active gliding site.
<u>Degree of Risk:</u>	B.
<u>ERC Score⁴:</u>	20.
