An Airprox was reported on 1st October 2014 at 1940 between a Voyager and a C182. The Voyager was under IFR and in VMC, receiving an ATS from Brize, and he received Traffic Information on the C182 which was operating outside the CTR. The C182 was on a VFR flight and receiving a Basic Service from Oxford, he also received Traffic Information.

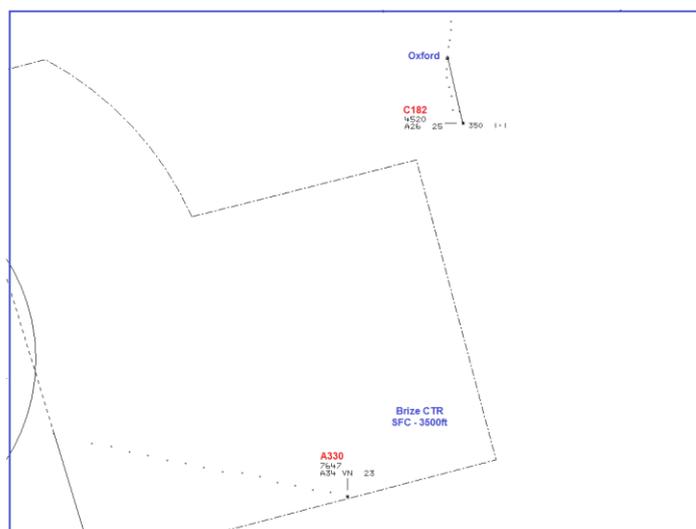
At 1938:52 the area radar recording showed the Voyager overhead Brize Norton at 5600ft turning onto an easterly track. The C182 was 3.2nm north of Oxford at 2500ft. The C182 pilot reported overhead Oxford at 1939:48. The Voyager was within the Brize Norton Zone Class D airspace and the Voyager pilot's written report indicated that he was in receipt of a Radar Control Service. At 1940:43 the Voyager was shown leaving Class D airspace. The C182 was 1.1nm south of Oxford turning onto a south-south-easterly track – Figure 1.

Figure 1 – Swanwick MRT at 1940:43 (A330 = Voyager)

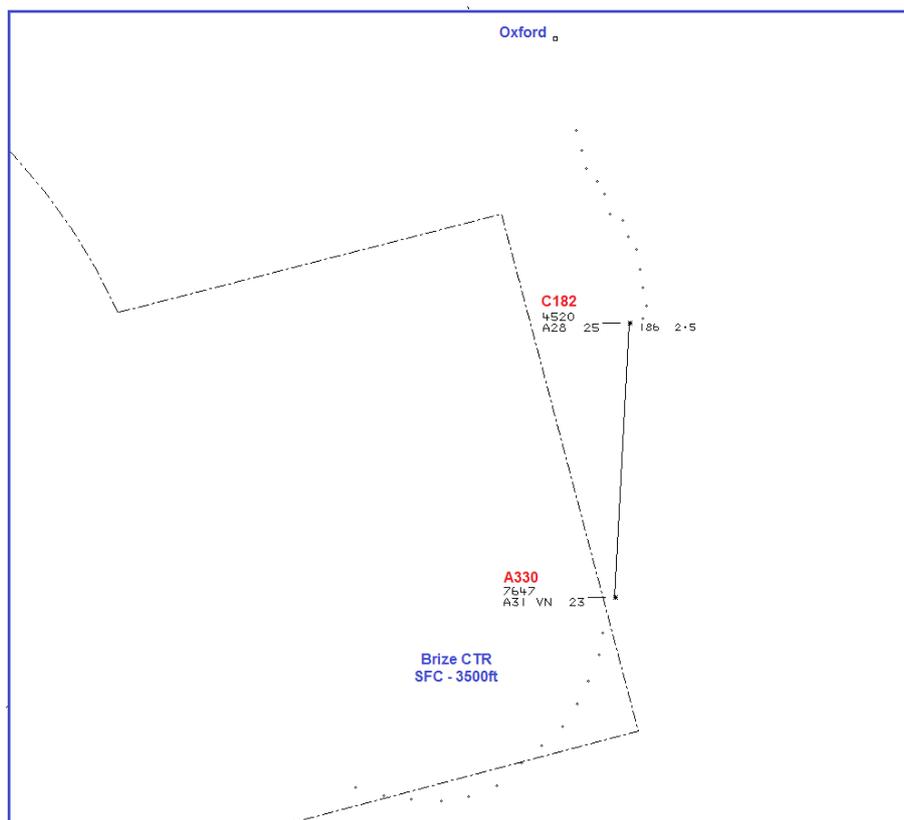
At 1941:33 the Voyager was in a left turn and was shown to have crossed the edge of the Brize Control Zone before again leaving controlled airspace. It was not clear what level of service the Voyager was receiving outside controlled airspace. The distance between the two aircraft was 2.5nm. The C182 pilot's written report indicated that he had sighted the other aircraft in his 12 o'clock outside of the Brize Norton Zone and commenced a right avoiding turn – Figure 2.

Figure 2 – Swanwick MRT at 1941:33 (A330 = Voyager)

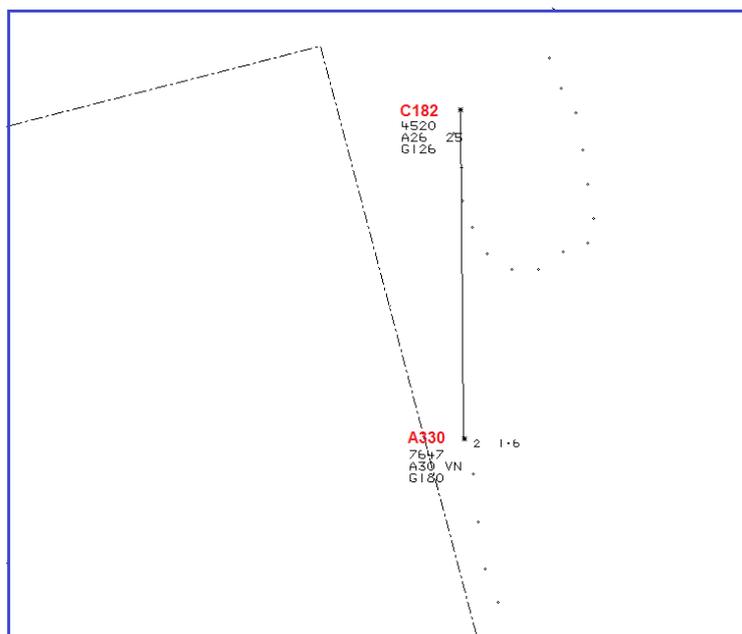
At 1942:03 the distance between the two aircraft was 1.6nm horizontally and 400ft vertically.

Figure 3 – Swanwick MRT at 1942:03 (A330 = Voyager)

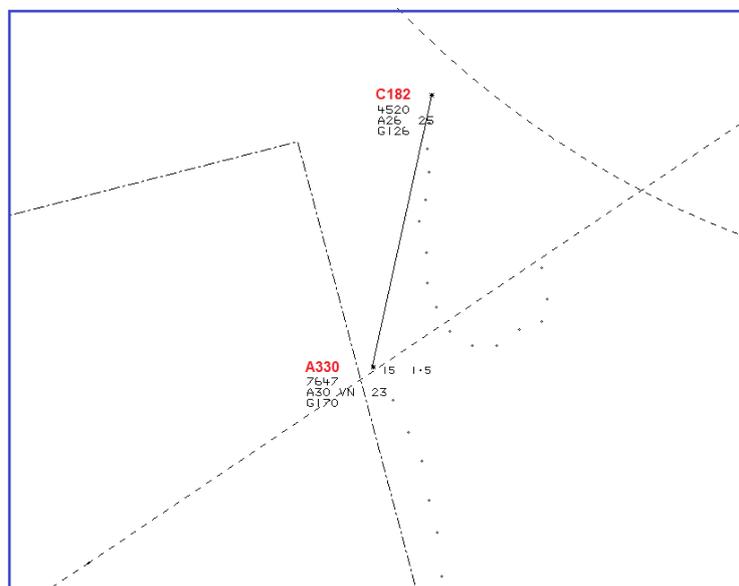
At 1942:19 the Voyager commenced a left turn. The distance between the two aircraft at CPA was 1.5nm horizontally and 400ft vertically – Figure 4.

Figure 3 – Swanwick MRT at 1942:19(A330 = Voyager)

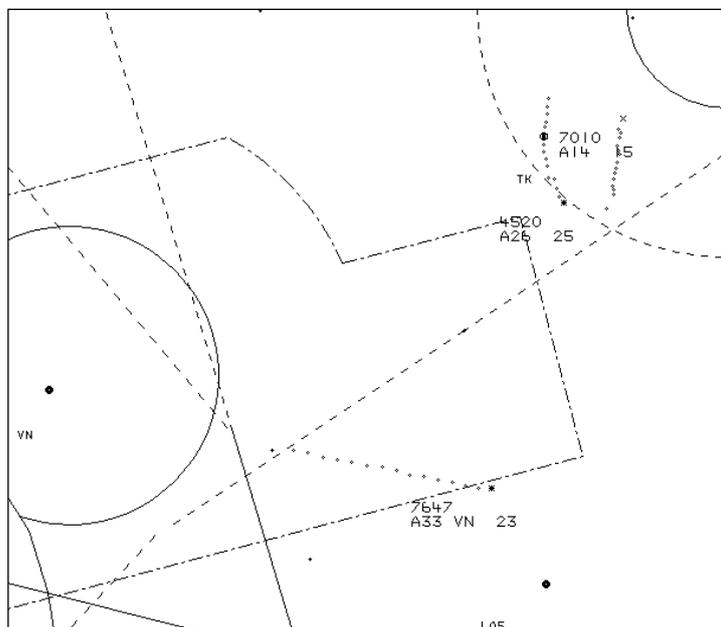
At 1936:16 the Voyager was placed under a Traffic Service on the request of the crew. At 1940:51 (Figure 1), Director called, “[Voyager c/s] as you turn traffic north east five miles tracking south east outside controlled airspace seven hundred feet below an Oxford outbound.”

Figure 1: Traffic Information at 1940:51 (Voyager squawk 7647; C182 squawk 4520).

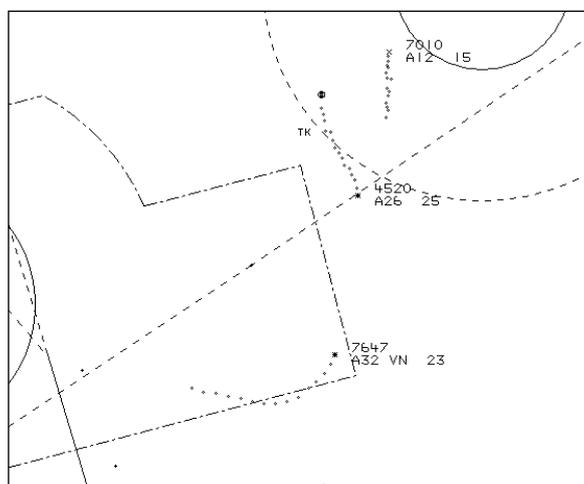
At 1941:19 (Figure 2), Director informed, “[Voyager c/s] previously called traffic north east three miles tracking south five hundred feet below outside controlled airspace.”

Figure 2: Traffic Information at 1941:19.

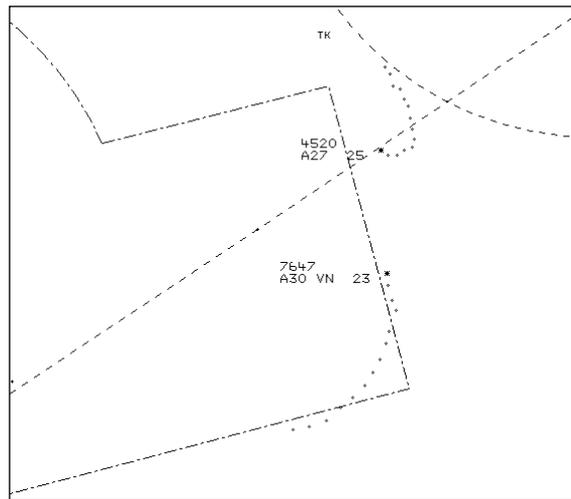
At 1941:45 (Figure 3), Director updated with, “[Voyager c/s] previously called traffic twelve o’clock two miles now tracking north four hundred feet below.” The pilot responded with, “was visual, just lost him.”

Figure 3: Traffic Information at 1941:45.

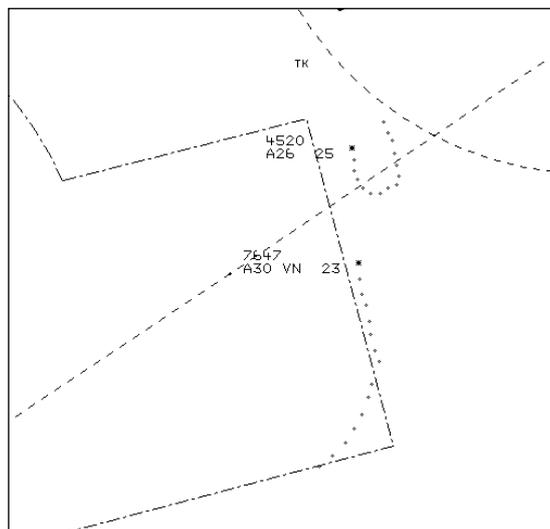
At 1941: 58 (Figure 4), Director responded with, “Two miles in your twelve o’clock tracking north four hundred feet below.”

Figure 4: Traffic Information at 1941:59.

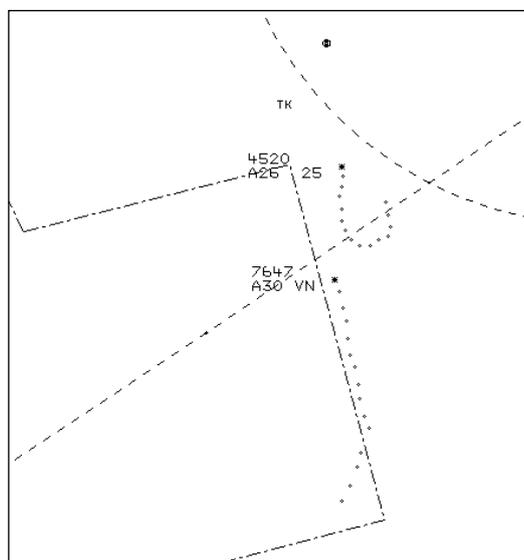
The CPA was at 1942:12 (Figure 5) at 400 feet and 1.5nm.

Figure 5: CPA at 1942:12.
