An Airprox was reported when a Merlin and an EC135 flew into proximity at about 1633 on Tuesday 11th November 2014. Both pilots were operating under VFR in VMC, the Merlin pilot in receipt of a Basic Service from Benson Approach and the EC135 pilot in receipt of a Basic Service from Benson Zone.

PART B: SUMMARY OF THE BOARD'S DISCUSSIONS

PART C: ASSESSMENT OF CAUSE AND RISK

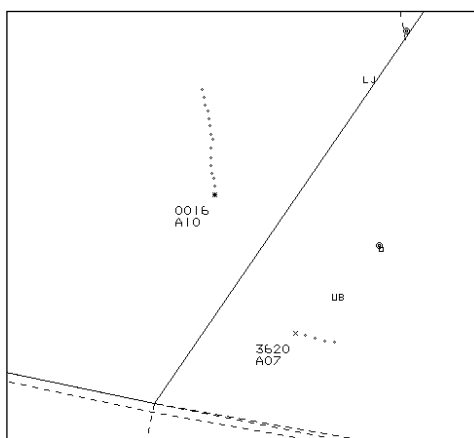
At 1632:21, Approach passed Traffic Information, “[Helimed C/S] traffic south three miles tracking west, indicating three hundred feet below, believed to be the heli...it’s believed to be a Merlin.” At 1632:30 (Figure 3), the Helimed pilot called visual.

Figure 3: Helimed calls visual at 1632:30

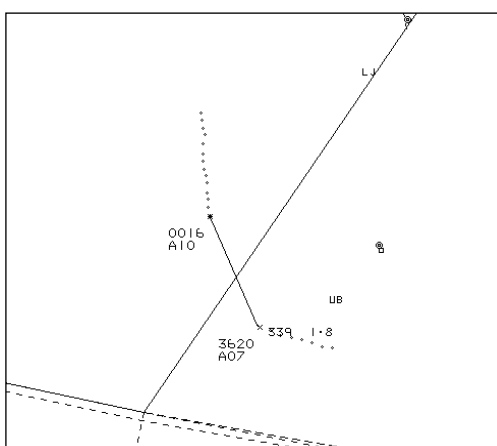
At 1632:46 (Figure 4), the Merlin pilot called Approach for a Basic Service. At this point, the Merlin faded from radar coverage with 1.8nm horizontal separation from the EC135. The Basic Service was applied at 1632:57.

Figure 4: Merlin requested a Basic Service at 1632:46
