AIRPROX REPORT No 2015020

Date: 17 Feb 2015 Time: 1459Z Position: 5251N 00015W Location: 8nm SE Cranwell

PART A: SUMMARY OF INFORMATION REPORTED TO UKAB

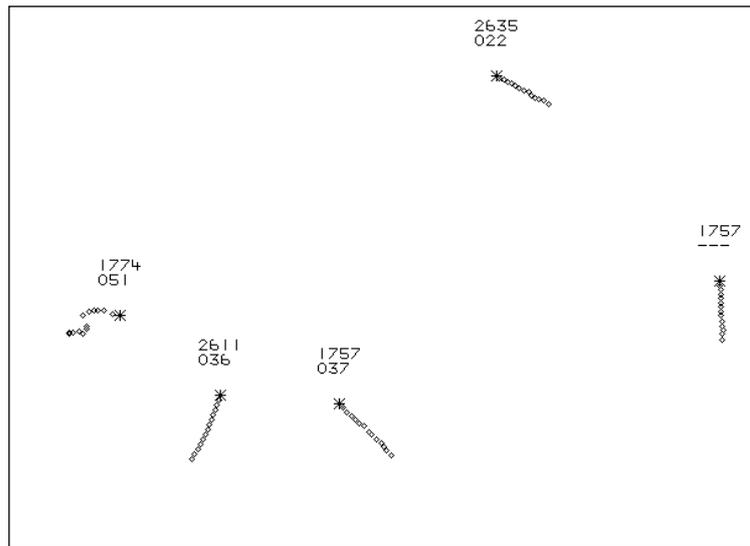
Figure 1: 1458:13 (Tutor squawking 2611; PA28 squawking 1757).

The incident occurred between a Tutor under a Traffic Service with RAF Cranwell and a PA28 under a Basic Service with RAF Coningsby. At 1458:13 (Figure 1), the tracks were on a converging heading at similar altitudes.

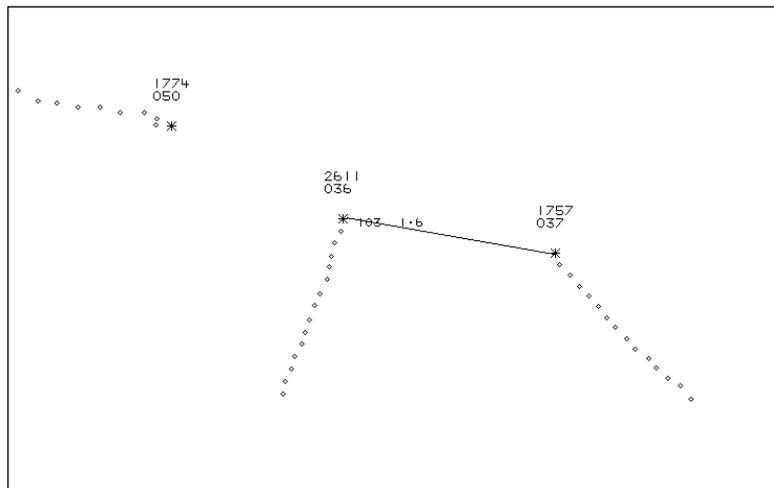
Figure 2: Geometry at 1458:39.

At 1458:39 (Figure 2), the Airprox aircraft had 1.6nm horizontal separation.

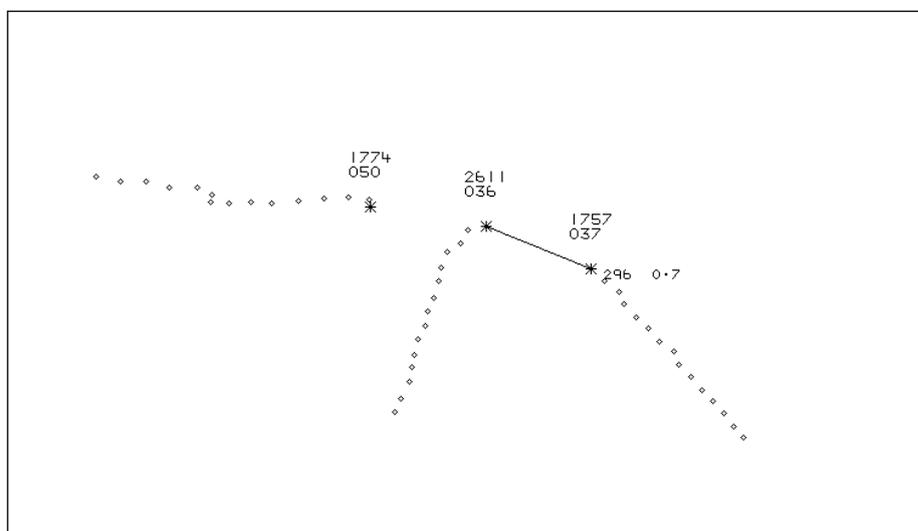
Figure 3: Geometry at 1459:07.

The Tutor had initiated the right hand turn by 1459:07 (Figure 3).

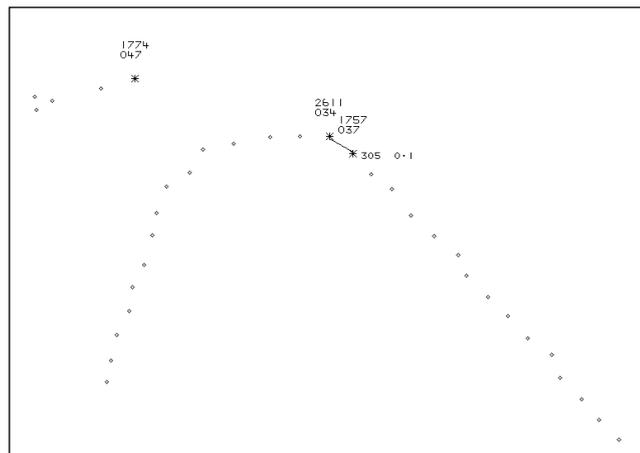
Figure 4: CPA at 1459:19.

The CPA was estimated at 1458:19 (Figure 4) with 0.1nm horizontal separation and 300ft vertically.

Cause: A late sighting by the Tutor pilot and a probable non-sighting by the PA28 pilot.

Contributory Factor(s): The Cranwell controller did not limit the Traffic Service.

Degree of Risk: B.
