AIRPROX REPORT No 2015068

Date: 27 Apr 2015 Time: 1256Z Position: 5212N 00008W Location: 1.2nm NNW Gransden Lodge

PART A: SUMMARY OF INFORMATION REPORTED TO UKAB

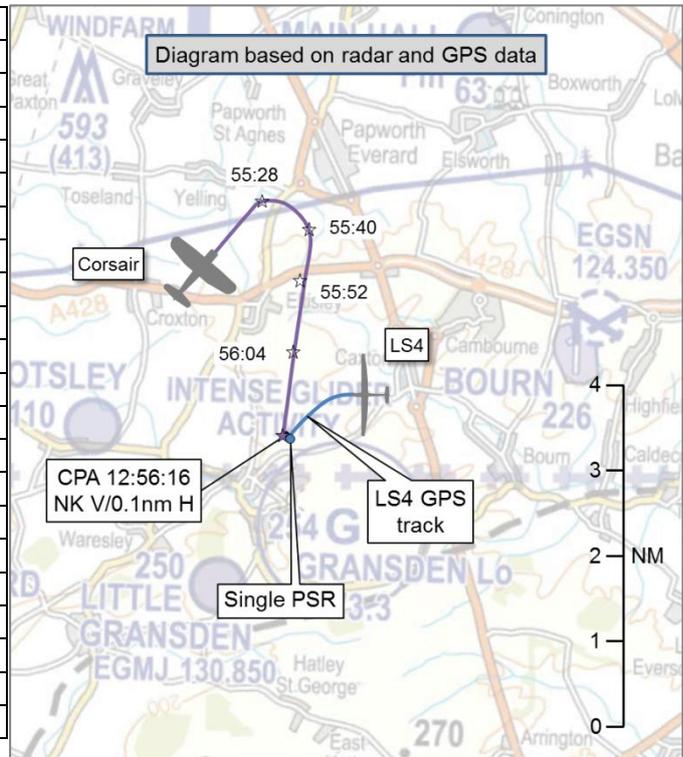
Recorded	Aircraft 1	Aircraft 2
Aircraft	LS4 Glider	F4U Corsair
Operator	Civ Pte	Civ Comm
Airspace	London FIR	London FIR
Class	G	G
Rules	VFR	VFR
Service	None	None
Altitude/FL	3500ft	No Mode C
Transponder	Not Fitted	A
Reported		
Colours	White	Blue/Yellow
Lighting	None	NK
Conditions	VMC	VMC
Visibility	15km	50km
Altitude/FL	3700ft	5000ft
Altimeter	QNH (NK hPa)	NK
Heading	220°	Turning right
Speed	55kt	230kt
ACAS/TAS	FLARM	Not fitted
Separation		
Reported	0ft V/200m H	100ft V/400m H
Recorded	NK V/0.1nm H
