AIRPROX REPORT No 2015081

Date: 5 Jun 2015 Time: 1115Z Position: 5306N 00231W Location: 2nm W Crew

PART A: SUMMARY OF INFORMATION REPORTED TO UKAB

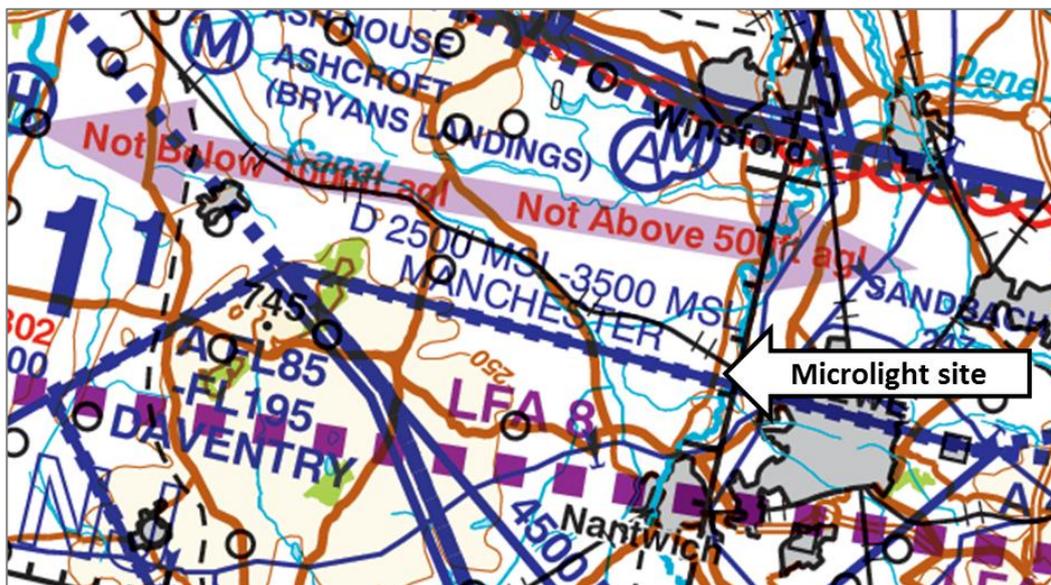
UK Low Flying Chart – Flow Arrow Depiction

The Lynx and Rans pilots shared an equal responsibility for collision avoidance and not to operate in such proximity to other aircraft as to create a collision hazard². If the incident geometry is considered as converging then the Lynx pilot was required to give way to the Rans S-6³. If the incident geometry is considered as overtaking then the Rans S-6 pilot had right of way and the Lynx pilot was required to keep out of the way of the other aircraft by altering course to the right⁴. The low-flying system in the area of the Airprox has a flow arrow, as depicted below, with eastbound aircraft required to remain below 500ft agl, and westbound aircraft above 1000ft agl. Flow arrows are a part of the UK Military Low Flying System (UKMLFS), and are applicable only to pilots flying under military regulations. Information pertaining to the UKMLFS is available in the

CAA Safety Sense Leaflet 18 – Military Low Flying, although this does not include flow arrow height information.

For his part, the Rans pilot had just taken off and, with the Lynx above and behind him, would not have been able to visually acquire it in his high-wing aircraft. Members commented that the Rans pilot did not seem to be aware of the flow arrow in the vicinity of his airfield, with the associated requirement for eastbound military traffic to remain below 500ft agl. Had he been aware of this flow arrow, some members opined that he might have been extra vigilant in his lookout before getting airborne. It was noted that the Board had previously recommended to both the CAA⁵ and HQ Air Command⁶ that GA education with regard to understanding of the implications of flow arrows be reviewed. Both recommendations had been accepted and actioned through articles in flight safety publications. A military member further stated that the UKMLFS flow arrow layout was available in the UK AIP⁷ although it was also noted that the height requirements for bi-directional flow were not included.
