**AIRPROX REPORT No 2015088**

Date: 10 Jun 2015 Time: 1520Z Position: 5151N 00129W Location: 5nm W Oxford Airport

**PART A: SUMMARY OF INFORMATION REPORTED TO UKAB**

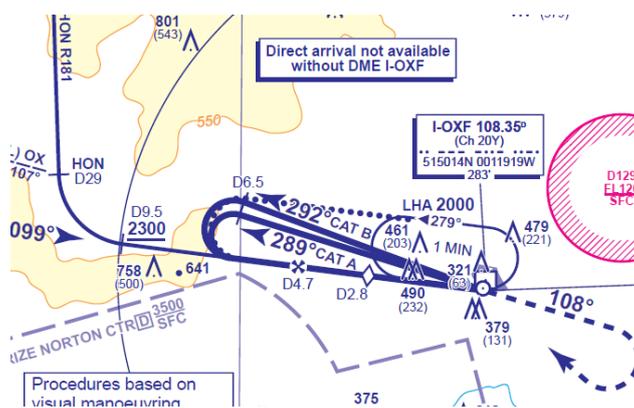
Figure 1 NDB(L)/DME 099.

ATSI had access to both pilot reports, the Swanwick Radar recording and recordings of the relevant radio frequencies. The C182 pilot had taken off from Oxford on a training flight. Initially the C182 pilot had departed to the east on a Traffic Service from Oxford Radar. After announcing an intention to carry out general manoeuvring to the east for approximately 10 minutes, the service was changed to a Basic Service. At 1459:10, the C182 (code 4506) pilot called Oxford for a rejoin to hold, followed by an instrument approach. A Traffic Service was agreed although the C182 pilot was advised that Traffic Information in the overhead would be limited. At 1515:10, the C182 pilot commenced an NDB/DME 099 approach which involved tracking to the west before making a base turn and returning to Oxford (Figure 1).

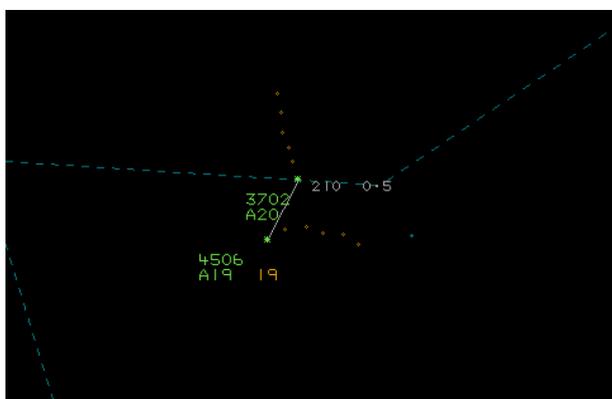
Figure 2 (Swanwick MRT 1519:42).

The PA28 was observed on radar approaching from the north indicating 2000ft (code 3702 – Brize Radar). At 1519:42, as the C182 pilot commenced the base turn (to the left), the C182 crossed the path of the PA28 from east to west at a range of approximately 0.5nm and 100ft below (Figure 2). [UKAB Note: this was probably when the PA28 pilot saw the C182].

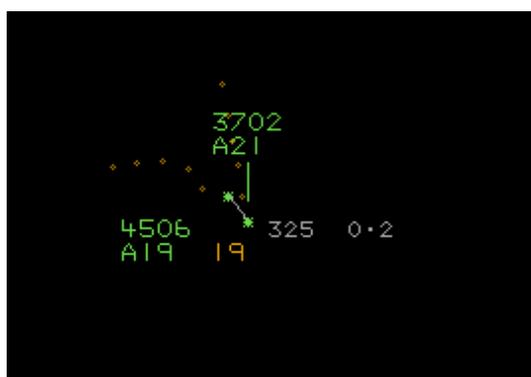
Figure 3 (Swanwick MRT at 1520:49).

At 1520:49 CPA occurred – 0.2nm and 200ft (Figure 3).

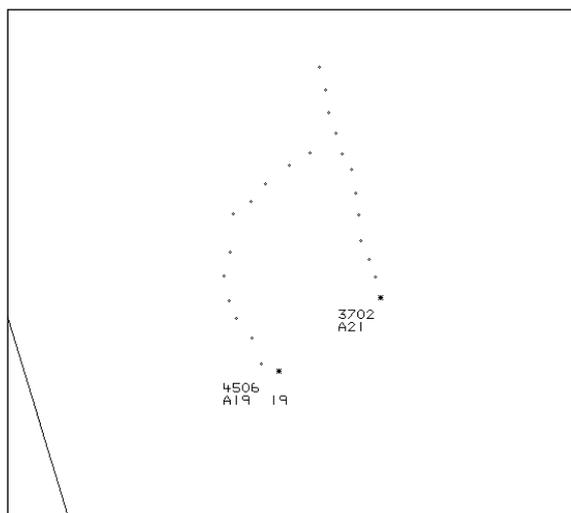
Figure 4: Geometry at 1520:25 (Cessna squawk 4506; PA28 squawk 3702).

The PA28 pilot was provided with a Zone transit at 1518:41 with no altitude restriction. The geometry at Figure 4 at 1520:25 demonstrates that the Cessna 182 had previously crossed the path of the PA28 prior to turning left, closing the geometry with the PA28.

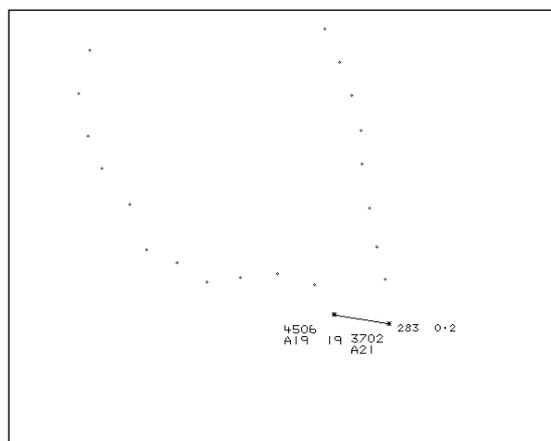
Figure 5: CPA at 1520:42.

The CPA was at 1520:42 (Figure 2) with 200ft vertical and 0.2nm horizontal separation.
