AIRPROX REPORT No 2015090

Date: 4 Jun 2015 Time: 1009Z Position: 5155N 00209W Location: Gloucestershire

PART A: SUMMARY OF INFORMATION REPORTED TO UKAB

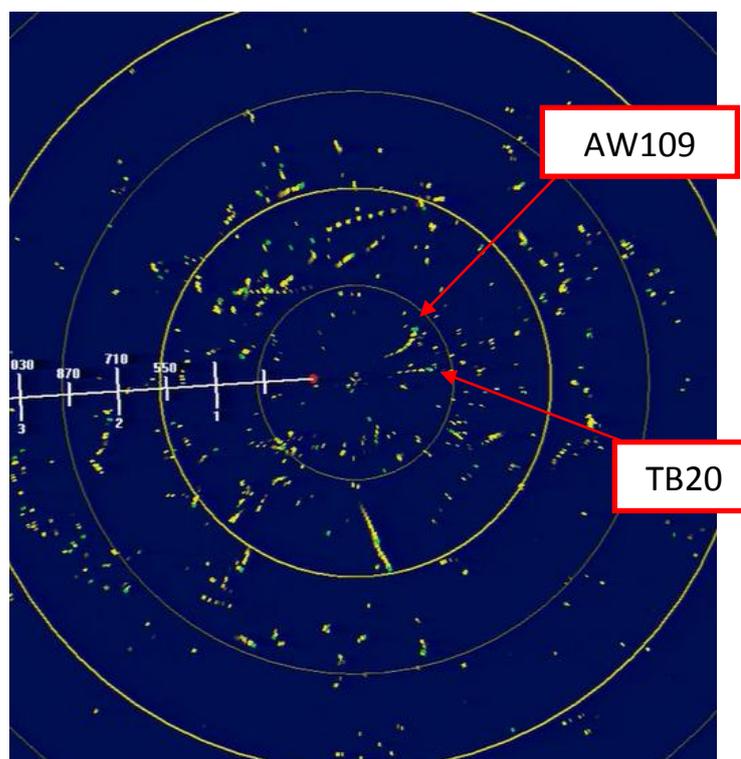
Figure 1 – 1008:23 (1NM Range Rings)

Prior to departure, the TB20 had been given Traffic Information on traffic descending on the deadside from an overhead join, and also advised that the left-hand helicopter circuit was active. In a continuation of the same transmission the TB20 was then cleared for take-off with a left turn-out to the west. The TB20 pilot acknowledged the clearance for take-off but not the Traffic Information. The AW109 had already completed a practice auto-rotation in the helicopter circuit to the north of RW09 and, at 1008:23 (Figure 1), was observed making a left turn into the circuit again, ahead of the TB20 which departed straight-ahead.

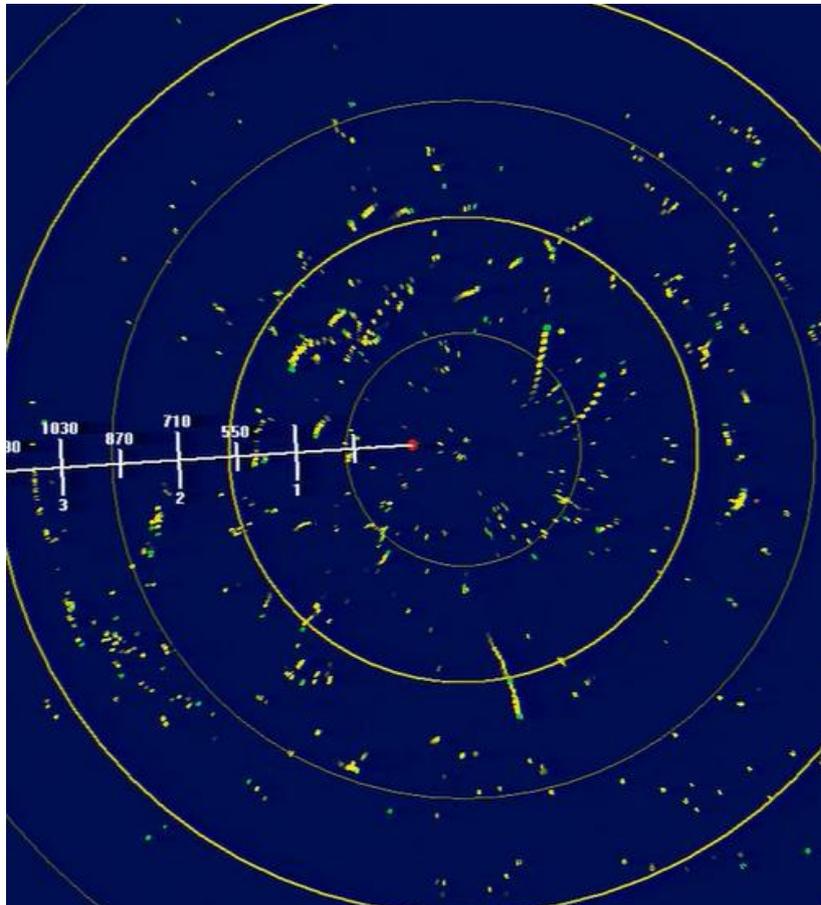
Figure 2 – 1008:46

At 1008:46 the AW109 was established in the crosswind left-hand position. The TB20 was also in a left-turn, outside the AW109 (Figure 2). Figure 2.1 shows the Swanwick MRT radar for the TB20 at approximately the same time.

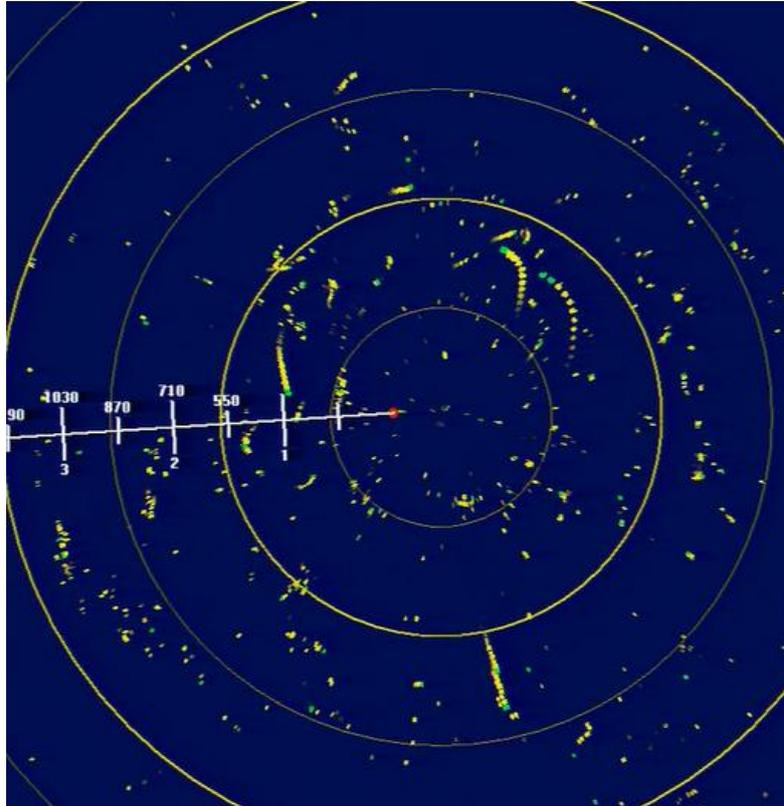
Figure 3 – 1009:09

At 1009:09 the AW109 commenced a left-turn into the downwind position. The TB20 also commenced a left turn for the west, turning inside the AW109 and at a relatively higher speed (Figure 3).

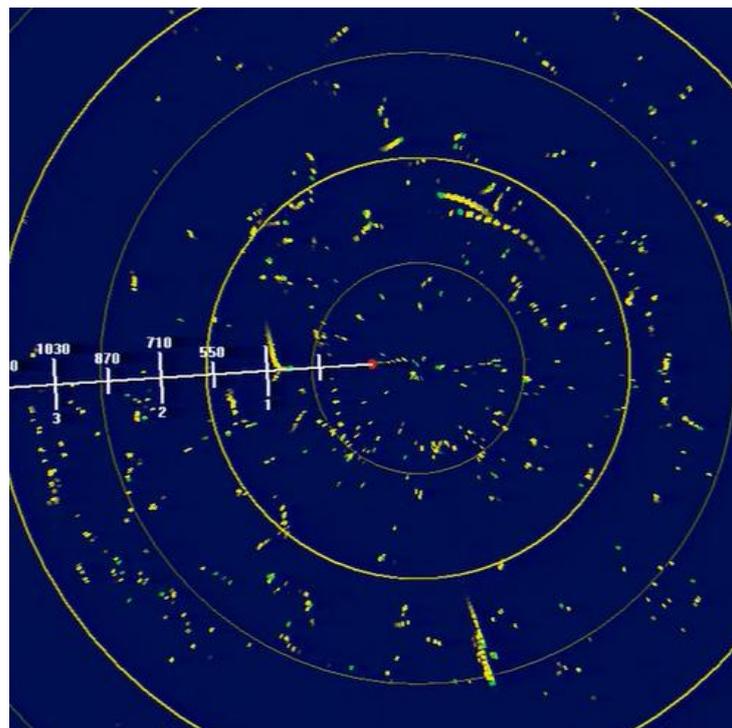
Figure 4 – 1009:27

Figure 4, (1009:27) shows the TB20 completing the turn inside the AW109 as it started to overhaul the helicopter.

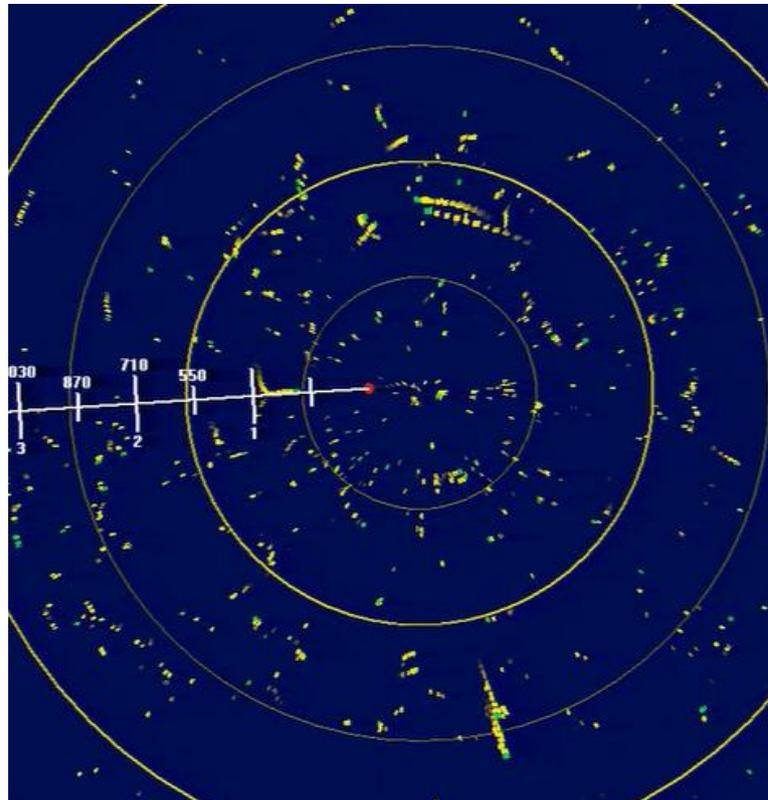
Figure 5 – 1009:37

At 1009:37, the TB20 was established on a west north-westerly track and had started to converge with the AW109 which was on a more westerly track. Swanwick MRT recordings show the TB20 was passing FL010 (Figure 5.1). There was no level information for the helicopter at this point. Prior to being transferred to the approach frequency, the TB20 was given further Traffic Information on the AW109, specifying the position of the AW109 as being on the downwind leg and climbing to 2000ft. The TB20 pilot acknowledged the instruction to contact Approach but again did not acknowledge the traffic information.

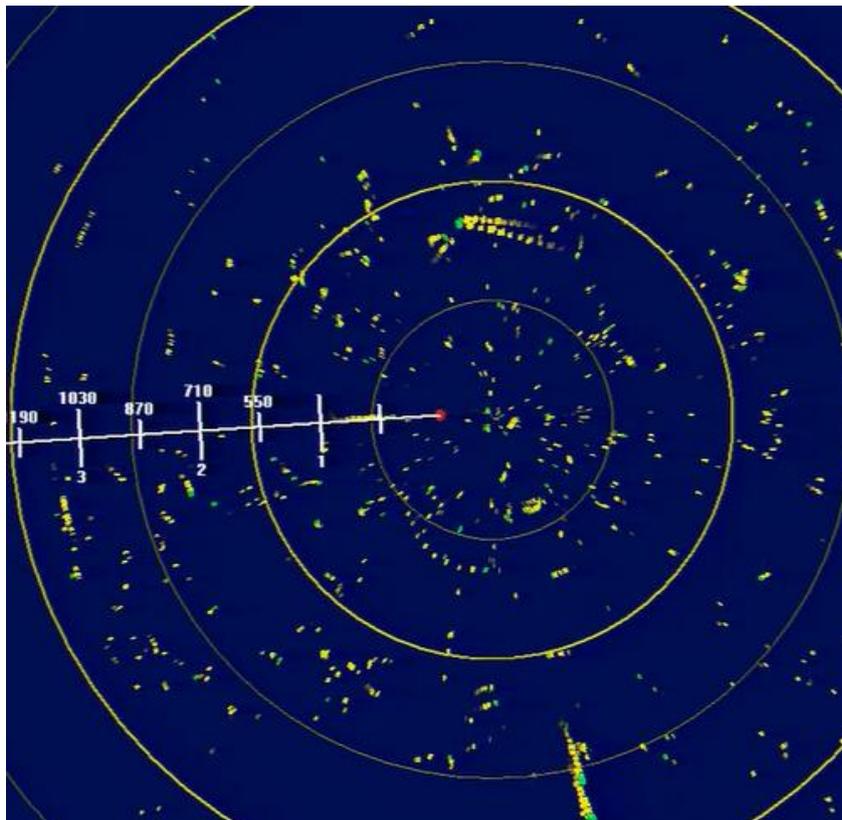
Figure 6 – 1009:48

At 1009:48, the contacts merged (Figure 6).

The Board then discussed the cause of the Airprox, and it was quickly agreed that ATC had allowed the aircraft to climb into conflict without passing timely Traffic Information to either pilot. The Board discussed a number of factors that may have been contributory but, in the end, decided that the root contributory factor was that the TB20 pilot had been transferred to Approach whilst in conflict with the AW109. Turning to the risk, it was agreed that because neither pilot effectively saw the confliction until CPA, any action taken had not materially affected the outcome. Therefore the risk was assessed as category A, although the incident had stopped short of actual collision, chance had played a major part in events.

<u>Cause:</u>	ATC allowed the aircraft to climb into conflict without passing timely Traffic Information to either pilot.
<u>Contributory Factor:</u>	The TB20 pilot was transferred to Approach whilst in conflict with the AW109.
<u>Degree of Risk:</u>	A.
<u>Recommendation:</u>	Gloucester review airfield and ATC procedures with regard to ensuring safe and orderly flow of traffic.
