AIRPROX REPORT No 2015105

Date: 10 Jul 2015 Time: 0838Z Position: 5048N 0011W Location: Gosport

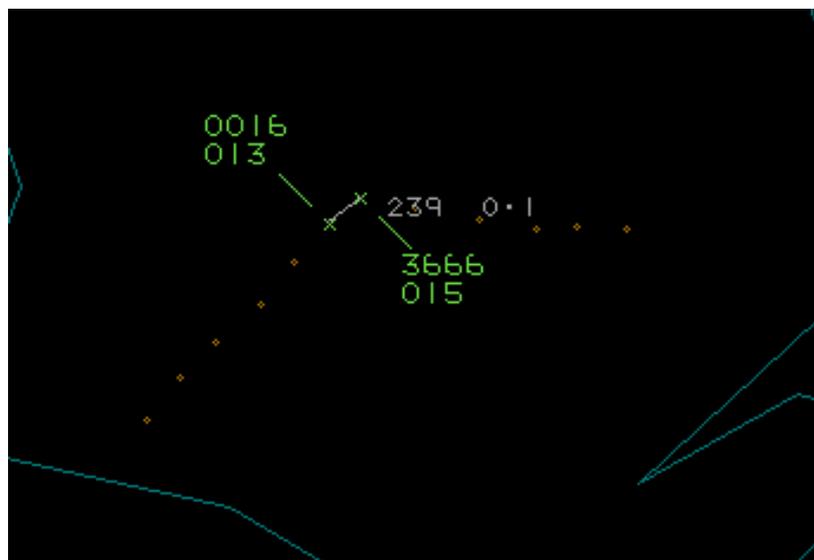
- At 0834:12 the pilot of the EC135 established communication with Solent Radar and a Basic Service was agreed. The aircraft had just left the Isle of Wight and was tracking northbound towards a Portsmouth hospital at 1300ft.
- At 0836:32 the pilot of the C172 established communication with Solent Radar, as he reported passing the Spinnaker Tower at Portsmouth. A Basic Service was agreed as the aircraft tracked westbound at 1500ft.
- At 0838:15 CPA occurred (Figure 1).

Figure 1 – CPA - Swanwick MRT at 0838:15
