**AIRPROX REPORT No 2015130**

Date: 6 Aug 2015 Time: 1308Z Position: 5119N 00001E Location: Biggin Hill Airport

**PART A: SUMMARY OF INFORMATION REPORTED TO UKAB**

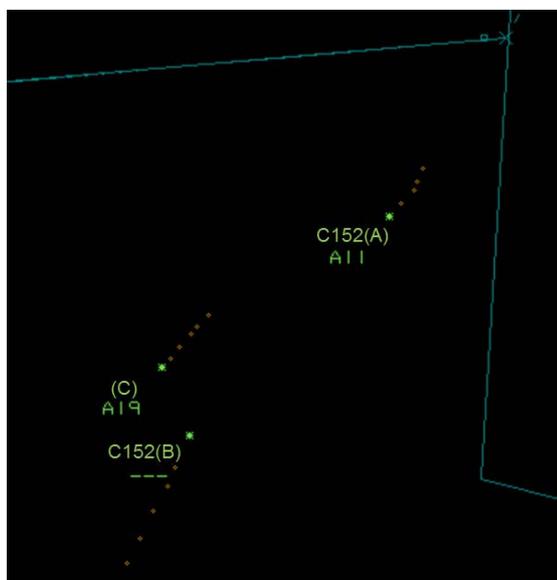
Figure 1: Swanwick MRT at 1307:01

At 1306:24 (on completion of the touch and go) the C152(A) pilot was instructed to continue on the runway heading and given Traffic Information about the inbound C152(B). At 1307:01, the C152(A) pilot was instructed to turn crosswind, Figure 1.

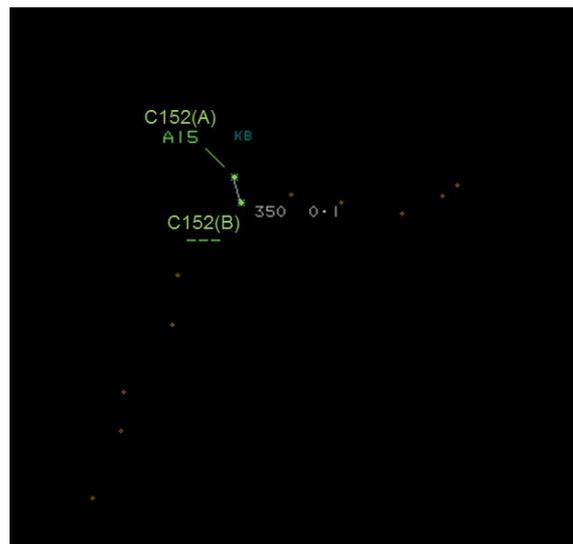
Figure 2: Swanwick MRT at 1307:42

Content that the C152(B) pilot was visual with the C152(A) the controller continued with other traffic. CPA occurred at 1307:42, Figure 2.

The Board noted that the 2 aircraft had been very close to each other at the time of the Airprox. Radar recordings showed that they were less than 0.1nm apart horizontally, although it was not possible to positively determine the vertical separation because C152 (B) was not equipped with SSR Mode C. However, the Board noted that the C152 (A) pilot had reported a vertical separation of 30-50ft as C152 (B) descended across their path; the Board also noted that C152 (B) pilot had not seen C152 (A) at all. Accordingly, the Board quickly decided that separation had been reduced to the minimum and, because neither pilot had effectively seen the other before CPA, luck had played a major part in the incident. Consequently, the Board decided that the Airprox should be categorised as risk Category A.
