**AIRPROX REPORT No 2015145**

Date: 7 Sep 2015 Time: 1516Z Position: 5145N 00212W Location: IVO Stroud

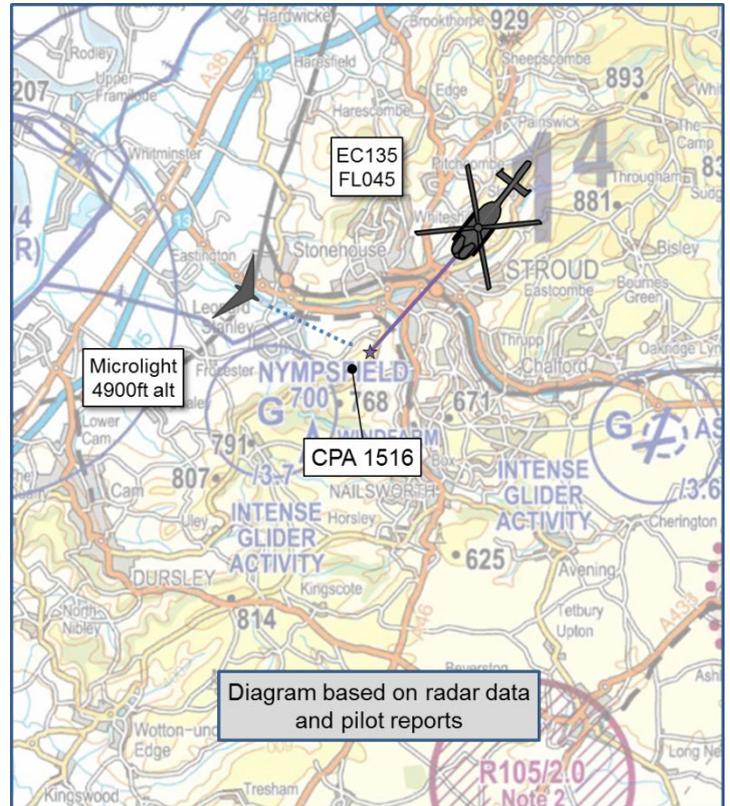
**THE QUIK GT450 MICROLIGHT PILOT** reports that, whilst flying straight and level, he saw a large yellow helicopter pass from left to right at the same level. There was no risk of collision, but he was concerned about flying through the wake of such a large helicopter and so took avoiding action by entering a steep climbing turn to the left. The helicopter did not appear to deviate from its course.

**THE EC135 PILOT** reports that some time had passed since the incident and so his recollection of event was not perfect. He recalled flying at between 4000-6000ft and receiving a Traffic Service from either Brize Norton or Birmingham. They passed Traffic Information on conflicting traffic to his right; he saw the traffic about a mile away, assessed he would pass in front of it and that no avoiding action was necessary. At no time did he think there was a risk of conflict, as he passed the traffic he remembered it turning left.

**Cause:** The EC135 pilot flew close enough to the GT450 to cause its pilot concern.
