AIRPROX REPORT No 2015147

Date: 20 Aug 2015 Time: 1750Z Position: 5210N 00106W Location: Maidford, Northants

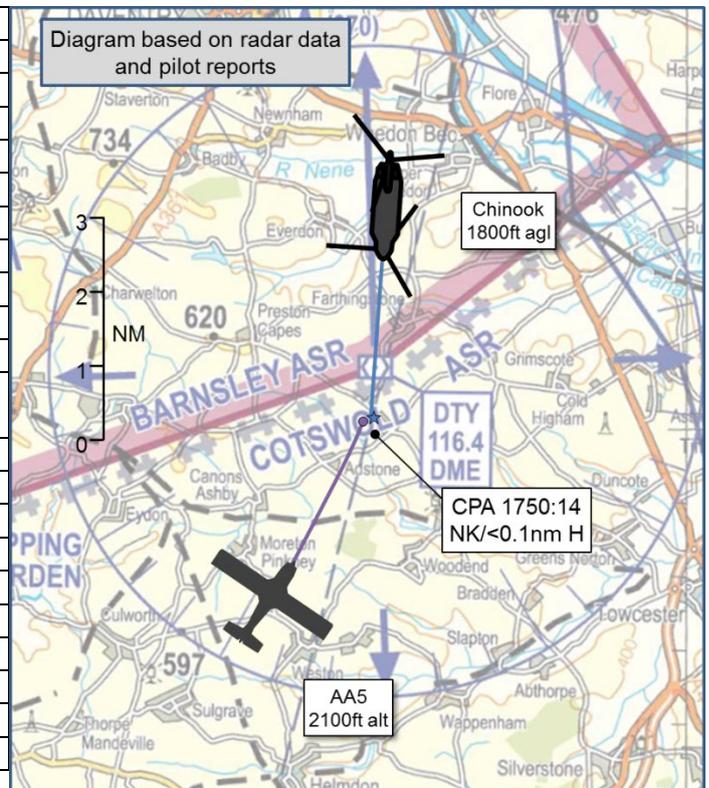
THE CHINOOK PILOT reports he was transiting at 1800ft agl when he became aware of a blue and white aircraft, with lettering down the side, in his 1 o'clock. Both aircraft turned left to avoid, and it passed approximately 50-100m away on his right-hand side.

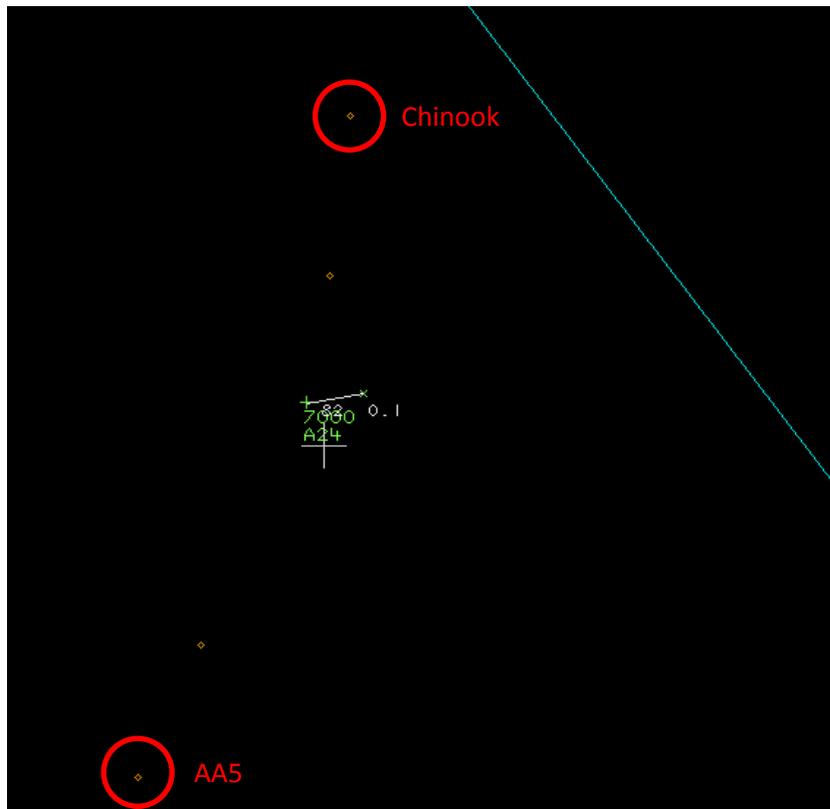
The Chinook and AA5 pilots shared an equal responsibility for collision avoidance and not to operate in such proximity to other aircraft as to create a collision hazard¹. If the incident geometry is considered as head-on or nearly so then both pilots were required to turn to the right². If the incident geometry is considered as converging then the Chinook pilot was required to give way to the AA5³.
