AIRPROX REPORT No 2015205

Date: 23 Nov 2015 Time: 1414Z Position: 5114N 00135W Location: 7nm NE Boscombe Down

PART A: SUMMARY OF INFORMATION REPORTED TO UKAB

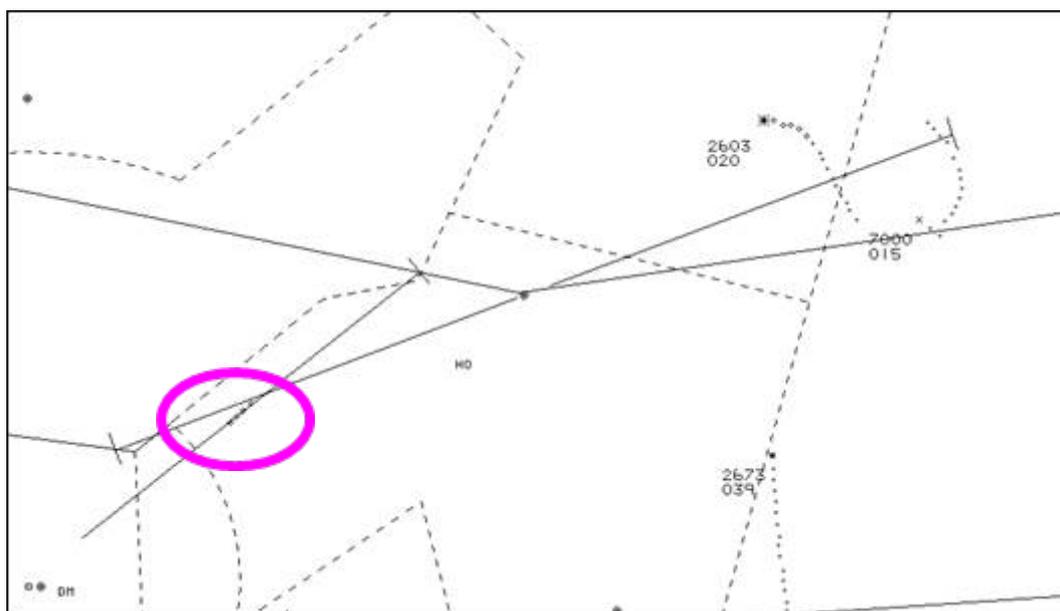
Figure 2: Traffic Information at 1412:53 (B429 2603; Sportcruiser non-squawking-circled).

The Sportcruiser departed Thruxton transponding 7000 and the Boscombe Controller provided Traffic Information to the B429 pilot at 1412:53 (Figure 2), as, "*pop up traffic southwest, 3 miles manoeuvring, indicating 1300 feet below, and climbing. Appears to be outbound from Thruxton.*" The pilot responded with "*looking*".

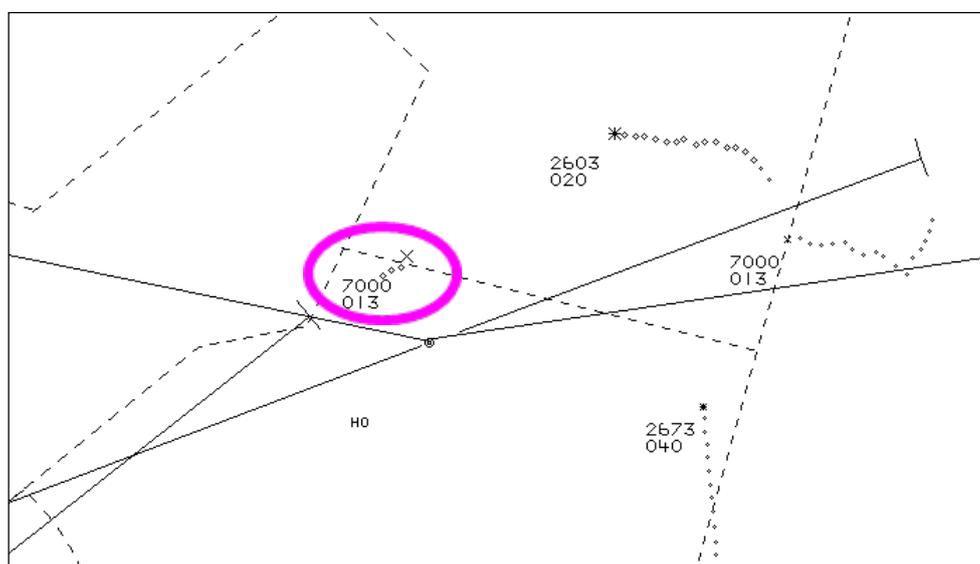
Figure 3: Traffic update at 1413:28 (Sportcruiser 7000).

The Sportcruiser pilot continued to climb and fly up the Boscombe approach lane. At 1413:28 (Figure 3), the Boscombe Director updated traffic with, "*that previously called traffic left 11 o'clock, 2.5 miles, crossing left to right, ahead, indicating 700 feet below climbing, unverified.*"

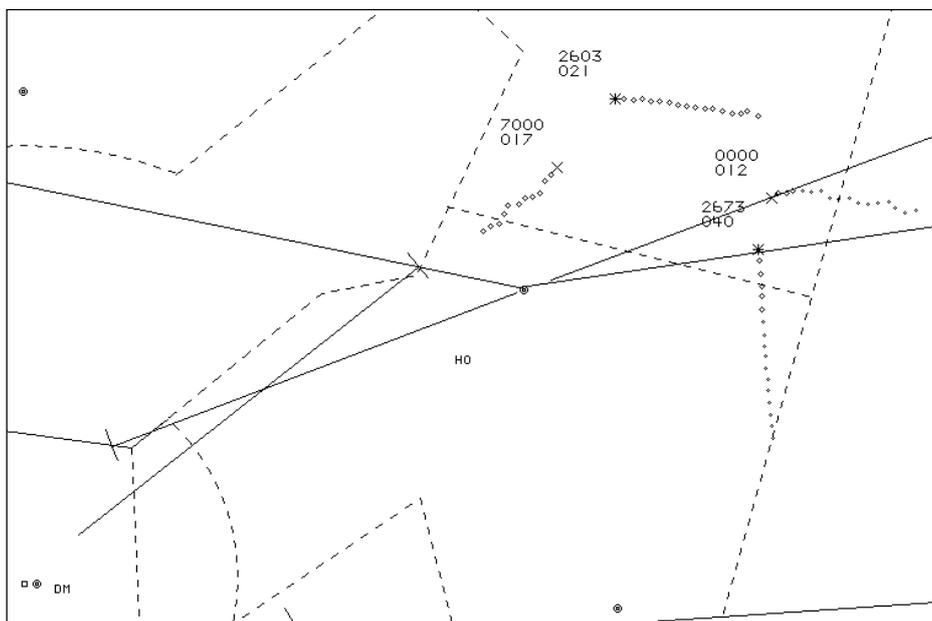
Figure 4: Traffic update at 1413:59.

A further traffic update was provided by the Boscombe Director at 1413:59 (Figure 4), “that previously called traffic is left 10 o’clock 1 mile, crossing left to right behind, indicating 300 feet below climbing, if not sighted continue present heading.”

The ‘if not sighted continue present heading’ instruction at 1413:59 meant that the B429 pilot would be positioned away from the localiser but would also be on a divergent heading from the Sportcruiser. Boscombe had commented that the Sportcruiser pilot had not adopted the normal routing and had flown up the approach lane. The ATC Supervisor contacted the Sportcruiser pilot,

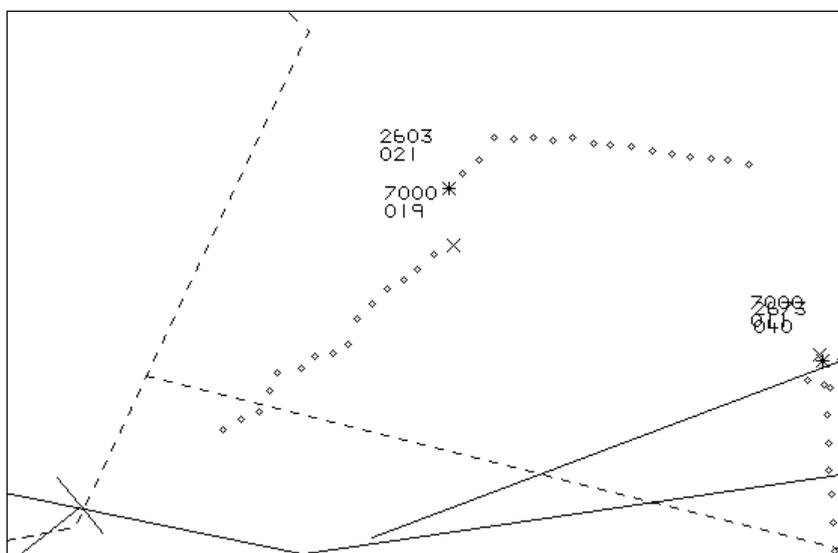
Figure 5: CPA at 1414:15.

The B429 pilot called “visual” at 1414:05 [UKAB note: the B429 pilot then turned inbound on the ILS]. The CPA was estimated at 1414:15 (Figure 5) with 200ft height separation and 0.3nm horizontal separation.
