**AIRPROX REPORT No 2015004**

Date: 22 Jan 2015 Time: 1703Z Position: 5610N 00101W Location: D613C  
(Twilight)

**PART A: SUMMARY OF INFORMATION REPORTED TO UKAB**

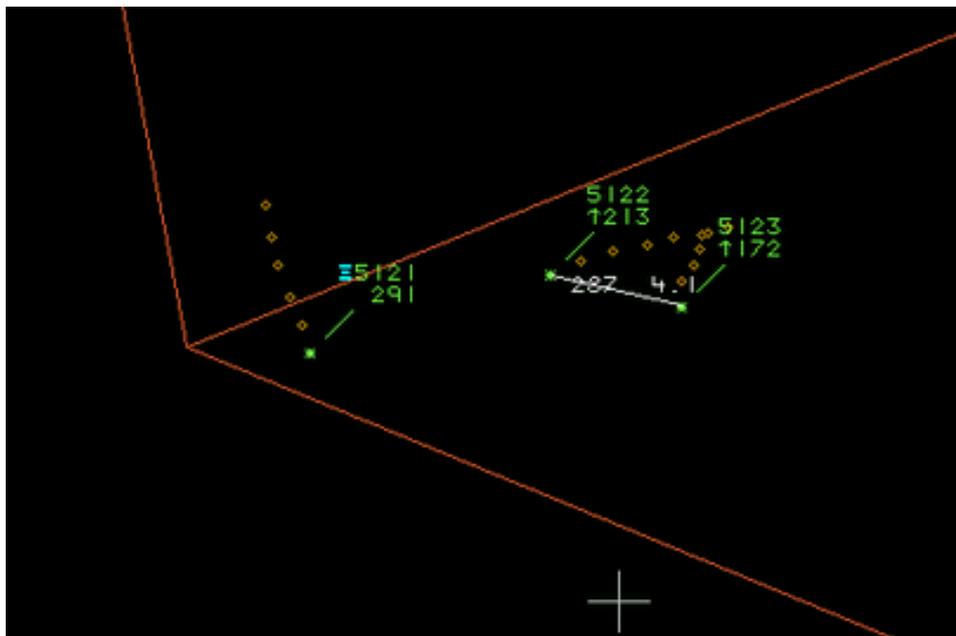
The Hawk pilot requested a climb to FL290 and was provided a climb to FL240 at 1659:44. At 1659:54 (Figure 1) Venom 82 requested left turn own navigation for intercept with Venom 81, which was approved by the WC.

Figure 1: Geometry at 1659:55 (Hawk 5123, Venom 81 5121, Venom 82 5122).

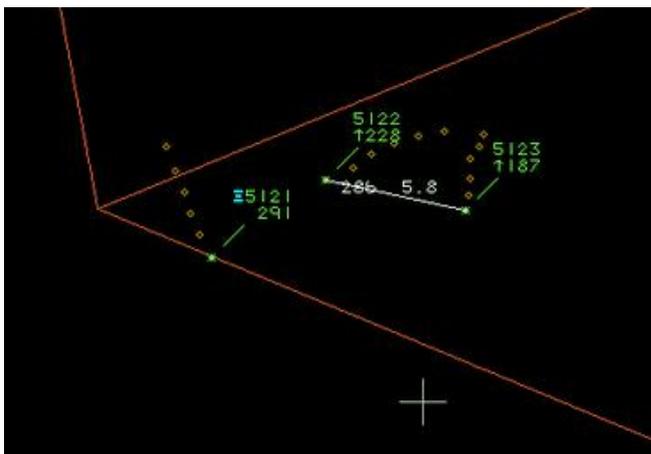
At 1700:06, the WC issued a 'stop climb FL200' to the Hawk pilot because he was planning to descend the Typhoons to meet the tanker. At 1700:11 (Figure 2), the Hawk confirmed the stop climb at FL200.

Figure 2: Hawk stopping climb at FL200 at 1700:11.

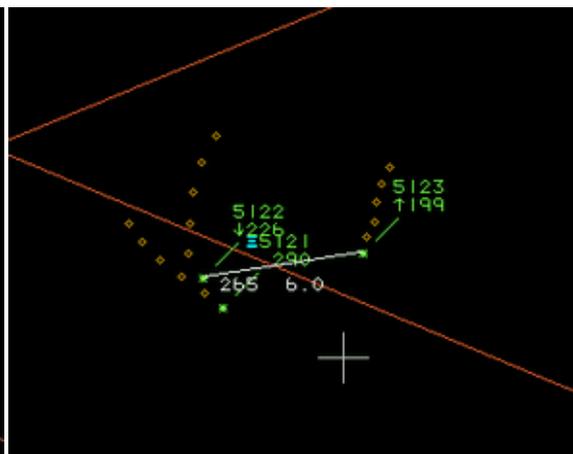
Figure 3: Hawk instructed to descend to FL190 at 1701:01.

At 1701:01 (Figure 3), the Hawk was descended to FL190 with Mode C showing FL199 climbing, and with Venom 82 descending through FL226. At 1701:23 (Figure 4), the WC confirmed that the Typhoons would be descended to FL190 for tanking, once clear of the Hawk.

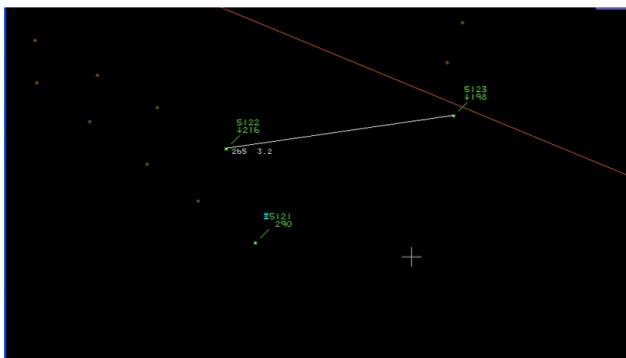
Figure 4: Geometry at 1701:23.

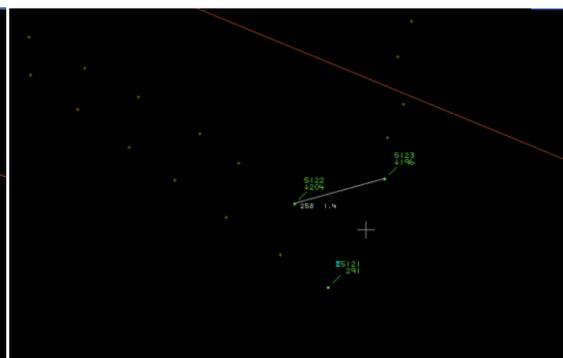
Figure 5: Geometry at 1701:34.

At 1701:34 (Figure 5), Venom 82 was descending through FL204, with the Hawk was in the descent passing FL196. The CPA was estimated at between 1701:42 (Figure 6) and 1701:50 with 0.4 nm and 400 feet separation.

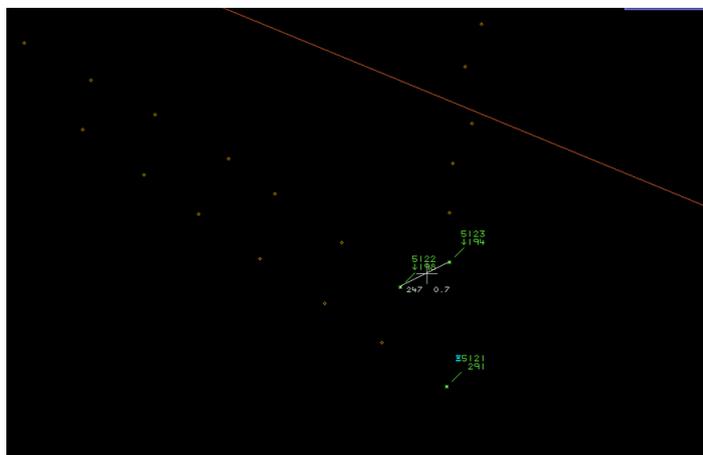
Figure 6: CPA at 1701:42.
