AIRPROX REPORT No 2015009

Date: 4 Feb 2015 Time: 1313Z Position: 5253N 00337W Location: Lake Bala

PART A: SUMMARY OF INFORMATION REPORTED TO UKAB

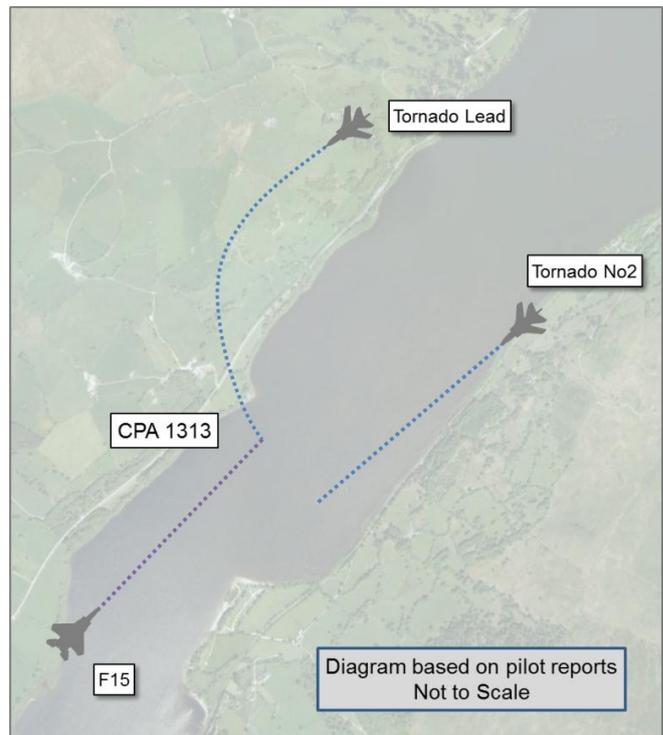
THE TORNADO PILOT reports leading a formation pair, conducting low-level flying in Wales. The formation was approaching Lake Bala from the northeast, on a south-westerly track. The leader identified another aircraft on data-link, about 10nm southwest of his location at low altitude, with a northerly vector. Having called the contact to the No2 pilot on the intra-formation frequency, the leader also made a call on the Low-Level Common frequency, to highlight the formation’s presence, but received no reply. As the leader made a pre-planned left-hand turn over Lake Bala, from heading 230° to 145° and climbing for terrain avoidance, the crew received a ‘Traffic, Traffic’ alert from the TCAS. As they had received the same alert on every previous cross-over turn, they assumed it had again been caused due to the proximity of the No2 and remained ‘heads-out’ to acquire the aircraft previously indicated by data-link as approaching from the south. As they turned, the rear-seat crew member saw an F15 pass directly beneath their aircraft, heading northeast along the lake. The pilot noted that the Airprox occurred approximately 30sec after the initial data-link detection. He also noted that the crew did not recall seeing any conflict on the TCAS screen, nor were they able to correlate the Traffic Alert, with either the No2 Tornado or the approaching F15E; both crew members were concentrating on lookout to try to visually acquire the conflicting traffic. The other aircraft in the formation was not fitted with data-link or TCAS. Its crew relied upon the calls from the formation leader, but did not see the conflicting traffic until after CPA.

THE F15 PILOT reports conducting a planned low-fly in Wales from south to north. The crew had data-link information on the Tornado formation for about two minutes prior to the close-pass but did not notice due to task saturation executing the low-fly. As the pilot turned to proceed north down Lake Bala, there was radar awareness of the Tornado formation at about 7nm that also went unnoticed due to preparation for a simulated attack. The Tornado formation's advisory radio call over the Low-Level Common frequency was slightly broken and not understood. The F15 pilot became visual with a Tornado at a range of about 1.5nm, over Bala Lake, as the Tornado formation was executing a descending turn in the opposite direction. The F15 pilot bunted to descend below the Tornado as it

passed overhead. At this point another Tornado was seen, which passed closely off the right hand side. The pilot noted that CADS was filed but with incorrect timing due to a change in plan and miscommunication with mission planning members.

The Occurrence Investigation identified that: the approaching F15 was masked from the Tornado crews by terrain, hindering radio calls and aircraft systems and visual acquisition; the formation turn necessitated lookout in directions other than that of the approaching F15; and the F15 sortie was not correctly entered on CADS, denying the crews awareness of potential confliction.

Cause: A late sighting by the F15E crew and effectively a non-sighting by the Tornado crews.
