AIRPROX REPORT No 2015056

Date: 1 May 2015 Time: 1506Z Position: 5640N 00503W Location: Glen Coe nr Ben Nevis

PART A: SUMMARY OF INFORMATION REPORTED TO UKAB

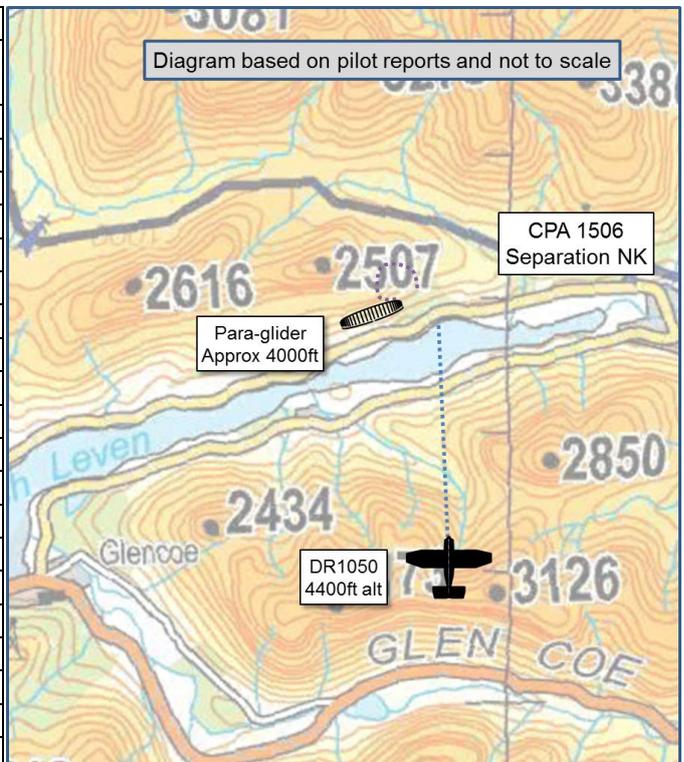
THE DR1050 PILOT reports flying VFR and navigating by local knowledge. It was low-workload and good visibility. He glanced down to check his oil pressure gauge and, when he looked up, he saw a para-glider, who had right of way. He turned to the right, although the turn made very little difference because he was unable to avoid flying close to the para-glider. He had a compact digital camera mounted on the passenger seat and, when he reviewed the footage after landing, he realised that, although it merged with the background, the para-glider was in fact visible much earlier. It was unfortunate timing that he had chosen that moment to check his instruments.

THE SIGMA 9 PILOT reports that he was on a para-glider cross-country flight. He entered the Glencoe valley from the west fairly low, but managed to thermal up the sunny side of the ridge; however, he was working hard to do so. He eventually cleared the ridgeline and heard what he thought was a motor-bike from the road below. When he came back round in the thermal, facing south, he was head-on and “very close” with a white light aircraft. He tightened the turn to dive down, and the other pilot banked aggressively to the right; it was the light aircraft’s right turn that avoided a collision.

An Airprox was reported on 1 May 2015 at 1506 between a DR1050 and a Sigma 9 para-glider at Glen Coe. Both pilots were operating under VFR in VMC and neither were receiving an ATS. Both pilots took avoiding action; the incident did not show on radar and the exact separation is not known; however, video of the incident was helpfully posted by the pilot of the DR1050 on YouTube and can be viewed at: <https://www.youtube.com/watch?v=7h9k2hCSL80>. The paraglider becomes visible at about 2:45 into the video, and CPA occurs about 10 seconds later.
