AIRPROX REPORT No 2015066

Date: 11 May 2015 Time: 0819Z Position: 5202N 00022W Location: Nr Ledbury

PART A: SUMMARY OF INFORMATION REPORTED TO UKAB

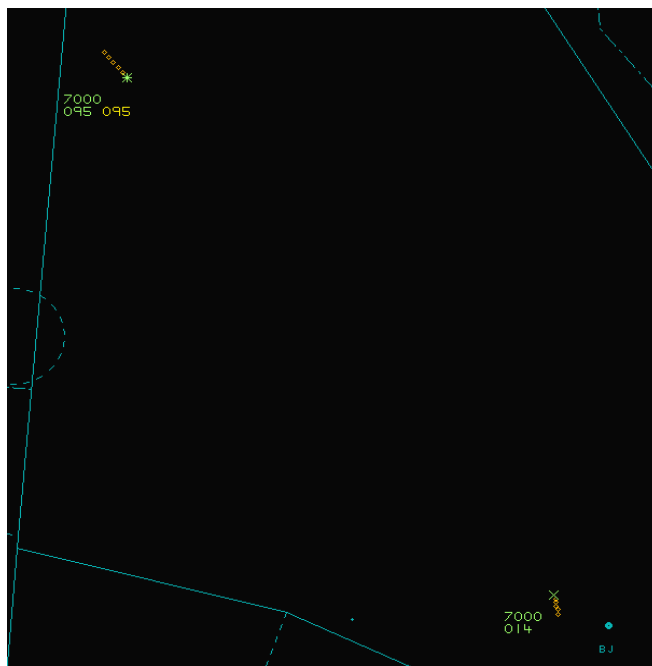
Figure 1 (0815:28)

At 0813:15 (during the telephone call to Western Radar), the L410 was cleared for take-off by the Gloucester controller. At 0814:30, the BE20 reported on the Gloucester Approach frequency at FL95 and a Basic Service was agreed. The Gloucester controller then passed Traffic Information on the departing L410. At 0815:28, the L410 was provided with a Procedural Service. Traffic Information on the BE20 was then passed to the L410 (Figure 1) as the L410 was passing 1400ft.

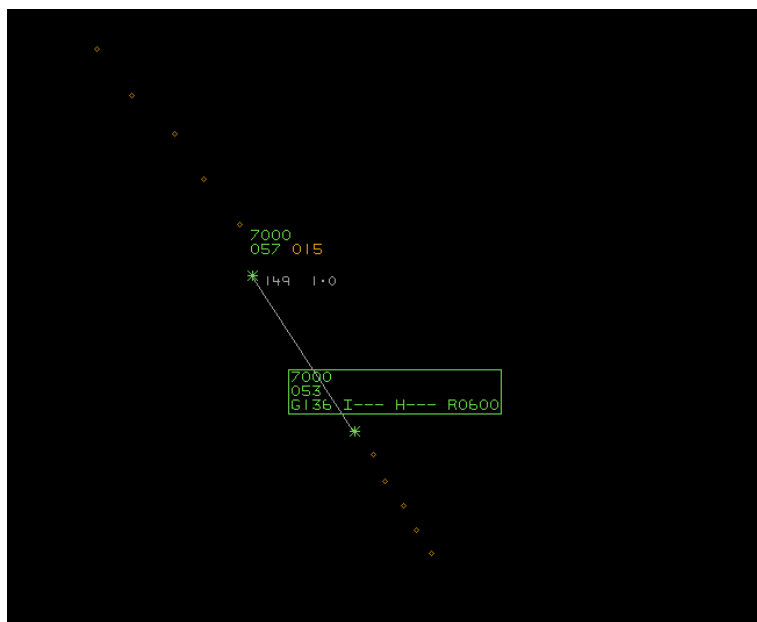
Figure 2 (0819:19)

At 0819:19 Figure 2 shows the aircraft were 1nm apart and opposite direction. The L410, which was the southerly of the 2 contacts, showed a climb rate of 600ft per minute and was at FL53. The BE20 appeared to be commencing a right turn at this point and passing FL57 in the descent.

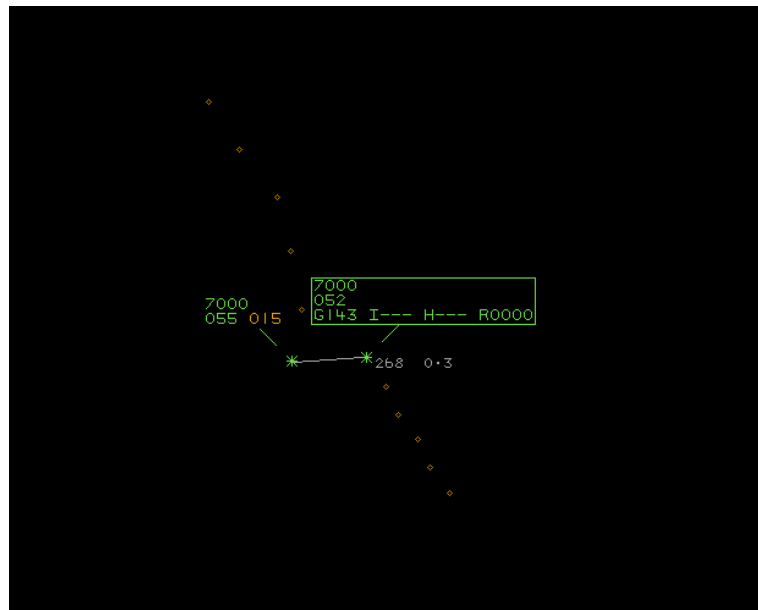
Figure 3 (0819:39)

At 0819:39, CPA occurred (0.3nm and 300ft) as the BE20 had turned to the right (Figure 3). The L410 had stopped the climb and descended to 5200ft – the climb rate indicated the L410 had levelled off.
