AIRPROX REPORT No 2015072

Date: 26 May 2015 Time: 0927Z Position: 5236N 00028E Location: 6nm SW Marham

PART A: SUMMARY OF INFORMATION REPORTED TO UKAB

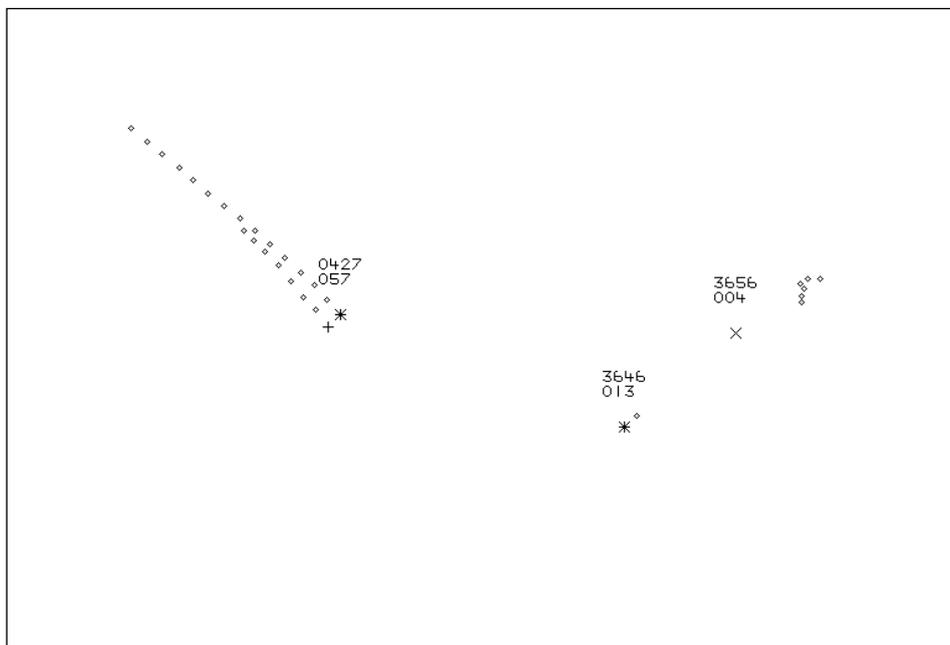
At 0925:41, the Tornado crew called Marham airborne for a Traffic Service. Lakenheath capped the F15 pilot's descent to FL40 at 0925:43. Marham ATC replied to the Tornado crew on the incorrect frequency and the Tornado crew asked for a radio check at 0925:52. The outbound Tornado first appeared on radar at 0925:55 (Figure 1). At 0925:59, Lakenheath requested Traffic Information from Marham and, at 0925:59, Lakenheath called traffic to the F15 pilots as: left 11 o'clock, 5nm, and 1600ft, westbound.

Figure 1: Tornado first appearing on radar replay (Tornado squawk 3646; F15s 0427).

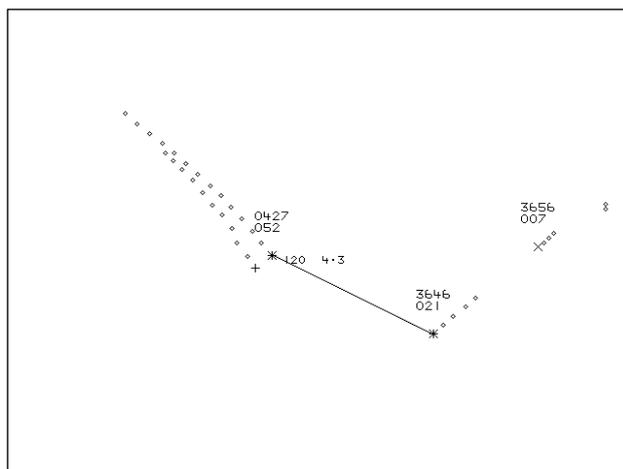
At 0926:07 (Figure 2), Marham transmitted on the correct frequency to provide a Traffic Service, climbing to FL50, with Traffic Information passed as: 1 o'clock, 3nm, crossing right to left, indicating FL45; the controller finished with a stop climb at FL40. At the same time, Lakenheath had offered an agreement of the F15s at FL50 and the Tornado at FL40. [UKAB Note: but this was not finally understood and agreed between the two controllers as formal coordination until 0926:24]

Figure 2: 0926:07: Traffic Information from Marham and height separation requested by Lakenheath.

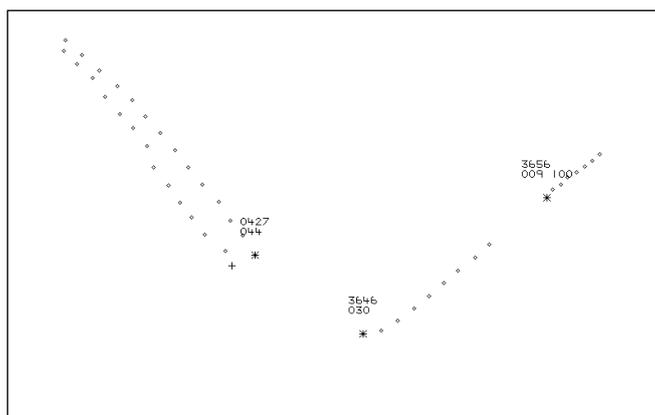
At 0926:19, Lakenheath instructed the F15 pilots to climb and maintain FL50 for traffic 12 o'clock, 2nm, and indicating 3000ft. [UKAB Note: at this point, the F15 rate of descent indicates that they were already at approximately 4700ft and descending at about 2000fpm]. At 0926:24 (Figure 3), Marham had agreed co-ordination with Lakenheath, and the Tornado crew had asked for a repeat of the previous transmission. At 0926:27, Marham re-iterated the instruction for the Tornado crew to stop climb FL40 [UKAB Note: this was not acknowledged by the Tornado crew until 0926:43, which was after CPA]. At 0926:28, the F15 pilots had called visual with the Tornados [UKAB Note: this was 9sec before CPA].

Figure 3: Geometry at 0926:24.

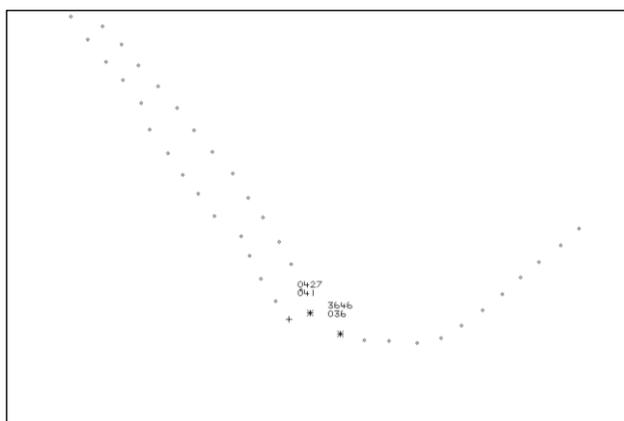
At 0926:31, the Marham Supervisor commented that co-ordination had been at FL50 but the F15s were indicating FL41. At 0926:34 (Figure 4), Lakenheath reiterated the 'climb and maintain FL50' to the F15 pilots.

Figure 4: Geometry at 0926:34

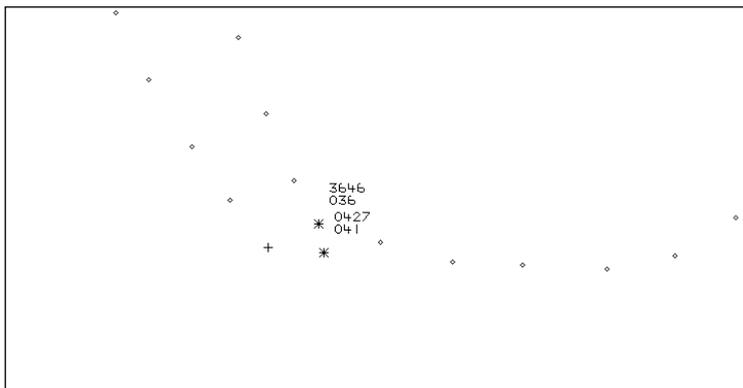
The CPA was estimated at 0926:37 (Figure 5) with 500ft and 0.1nm separation. At 0926:38, the F15 pilots stated that the traffic was not a factor and they requested a descent to 3000ft.

Figure 5: CPA estimated at 0926:37.
