AIRPROX REPORT No 2015085

Date: 18 Jun 2015 Time: 1016Z Position: 5140N 00210W Location: Gloucester Airport (101ft)

PART A: SUMMARY OF INFORMATION REPORTED TO UKAB

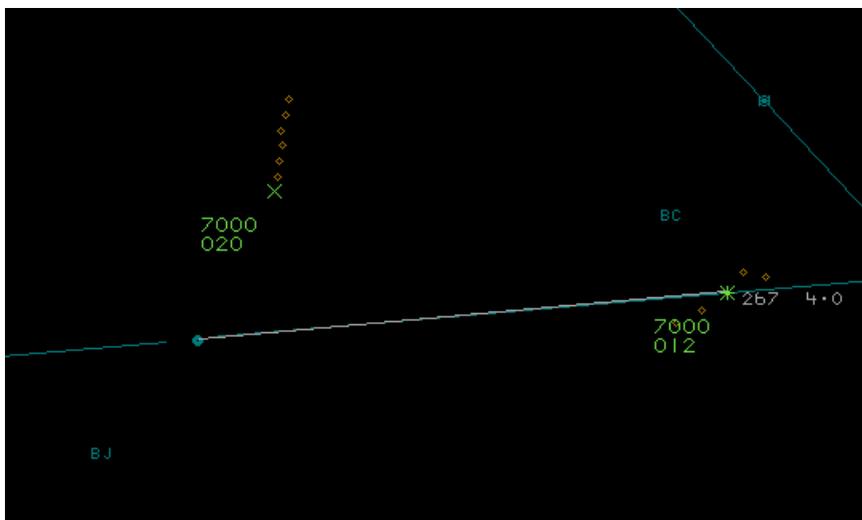
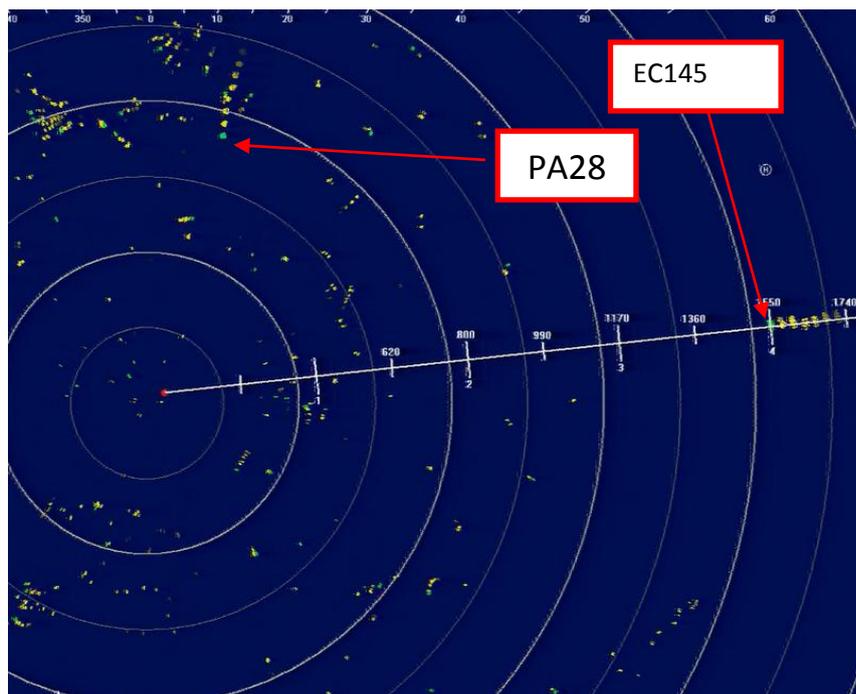
Figure 1 – 1013:50

At 1013:50, the PA28 was approaching the Gloucestershire overhead 1.2nm to the NE at FL020 for an overhead join. The EC145 was established on a 4nm final RW27, still receiving a service from Gloster Approach (Figure 1 & 1.1).

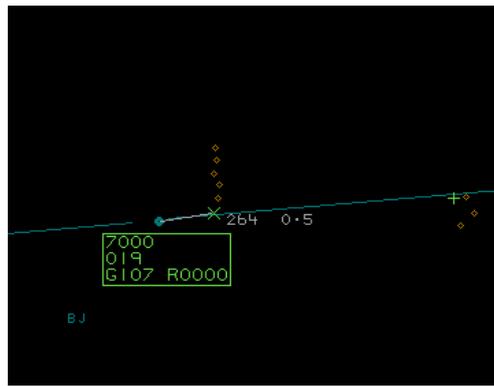
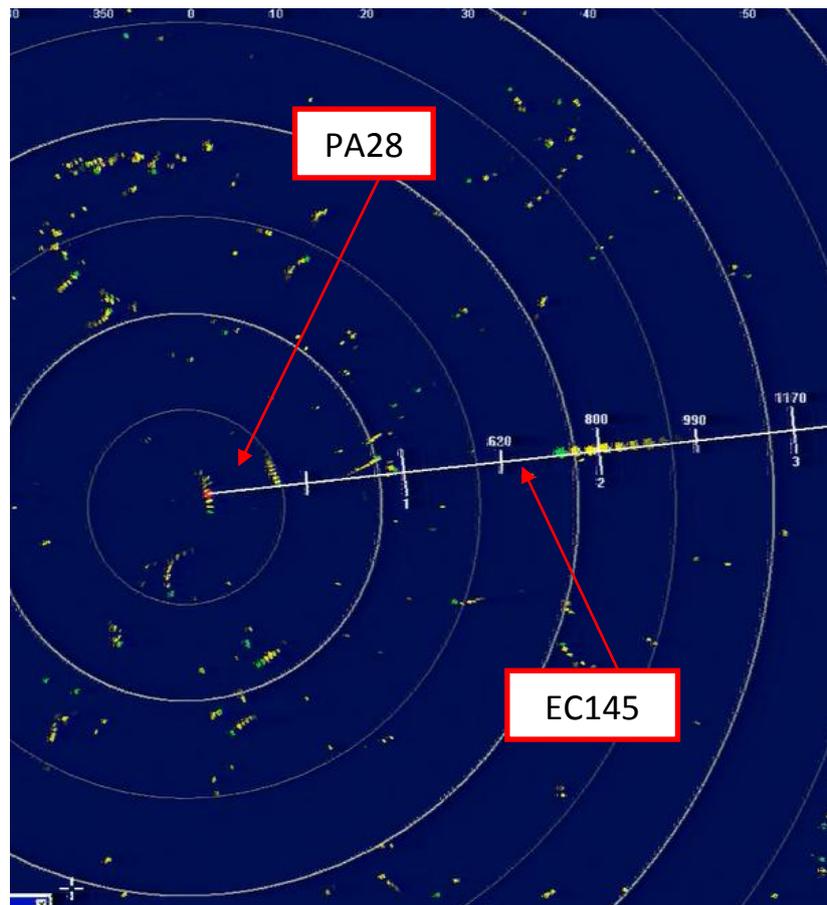
Figure 2 - 1014:30

At 1014:00 the EC145 pilot reported on frequency with Gloster Tower, and reported being at 3DME. The tower controller instructed the EC145 to continue approach which was acknowledged by the pilot. At 1014:06 the PA28 pilot reported in the overhead; however, the tower controller did not reply, shortly afterwards another aircraft called for permission to taxi to which the controller did reply. At 1014:30 the southbound PA28 passed 0.5nm east of the airfield at FL019 (Figure 2 & 2.1)

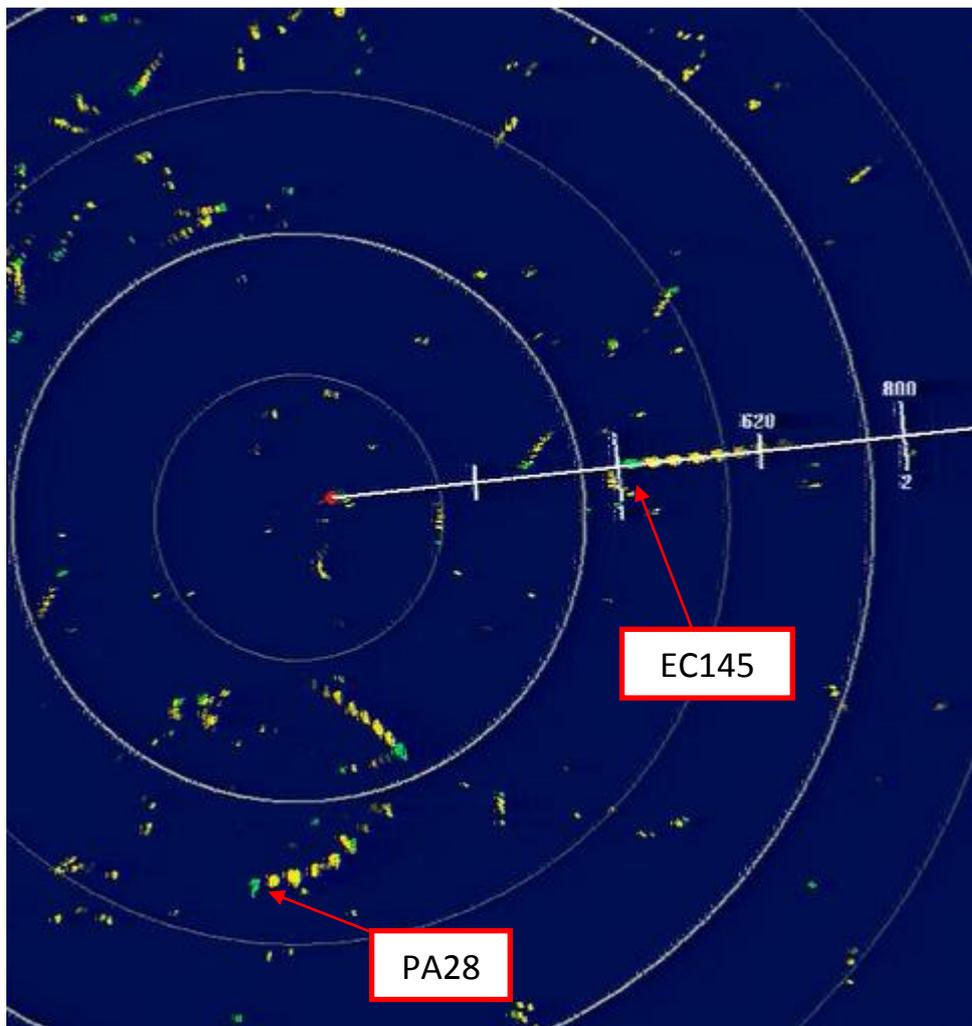
The radar return of the PA28 disappeared on the Swanwick radar recording shortly afterwards. The radar return of the EC145 also continued intermittently for a couple of sweeps before disappearing completely. On the Gloucestershire Airport primary radar recording, the tracks of the PA28 and EC145 continued to be visible. Figure 3 shows the relative positions of both aircraft when the EC145 was 1nm final.

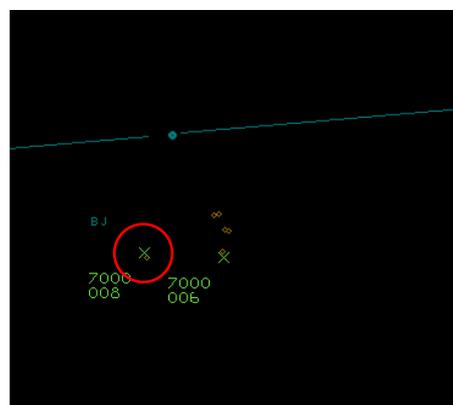
Figure 4 – 1015:43

At 1015:25 the EC145 was cleared for a low approach. Immediately afterwards, the PA28 pilot reported descending on the dead-side, and was instructed to report downwind right-hand for RW27 by the tower controller. The Gloucestershire Airport ATC unit investigation stated that when the PA28 pilot reported descending dead-side, the unit radar recording showed the aircraft to be just upwind of the (RW09) threshold, about to turn crosswind. At 1015:43, the radar return of the PA28 re-appeared on the Swanwick radar recording, indicating FL008 (ringed in red) (Figure 4).

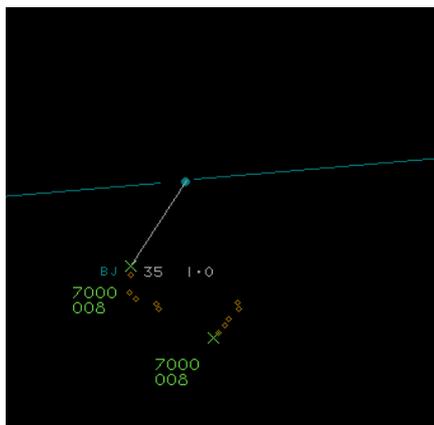
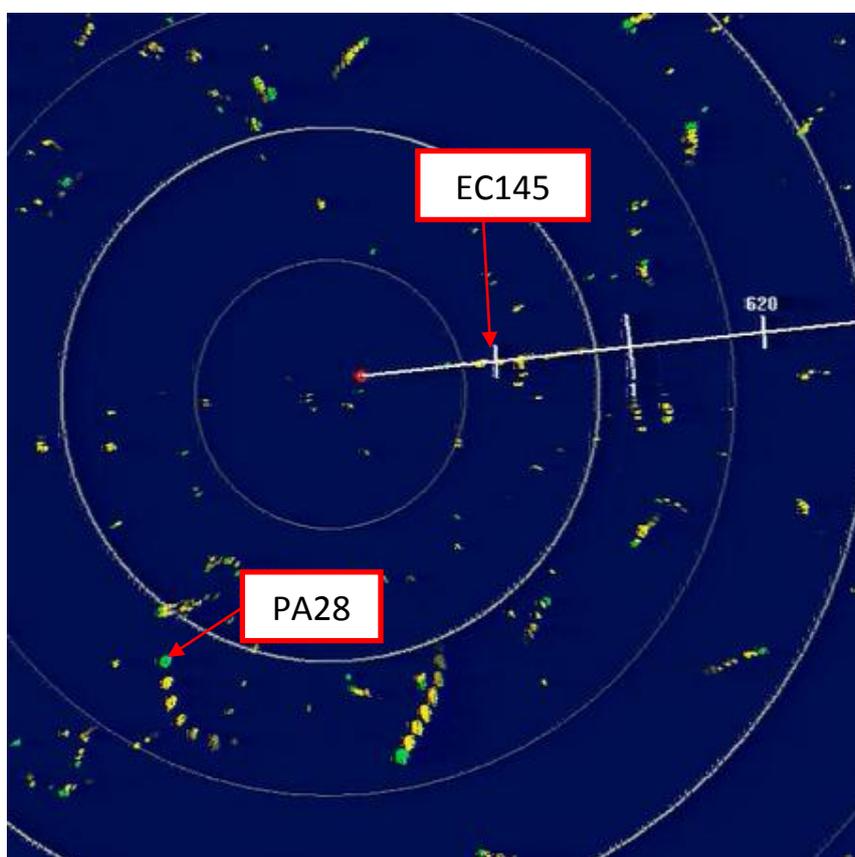
Figure 5 - 1015:58

At 1015:58 the EC145 reported going around, which was acknowledged by the tower controller who then instructed the EC145 to contact Gloster Approach. The PA28 was at this time 1nm SW of the airfield at FL008 tracking north (Figure 5 & 5.1).

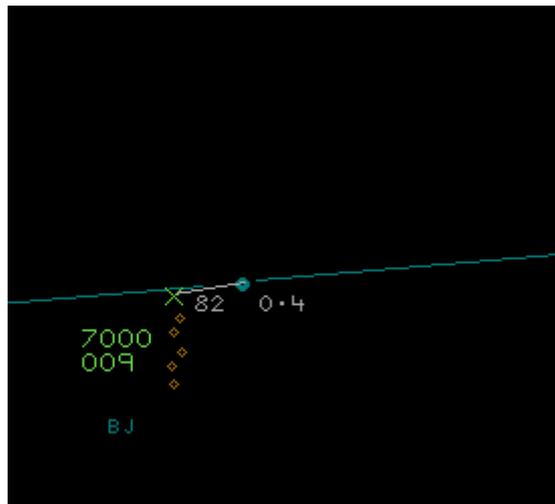
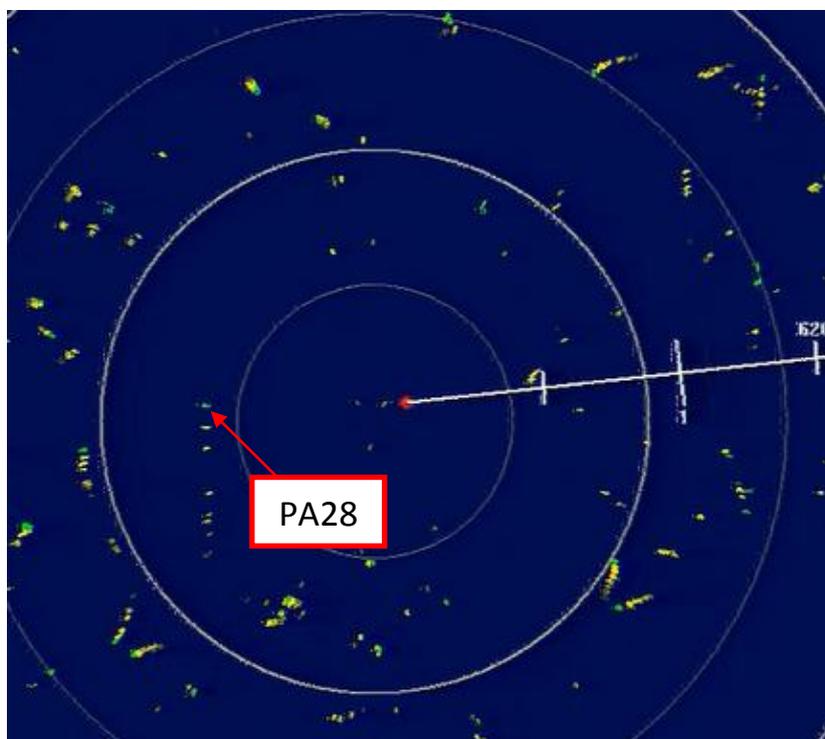
Figure 6 - 1016:40

The EC145 pilot reported on frequency with Gloster Approach at 1016:10 and was instructed to make a right turn onto heading 350°. At 1016:40, the tower controller started to ask the PA28 pilot for a position report, but corrected this to advise the pilot that they were now visual with him. By this time, the PA28 was passing through the RW27 climb-out, less than 0.5nm to the west, maintaining FL009. There was no radar return for the EC145 on either radar recordings (Figures 6 & 6.1)

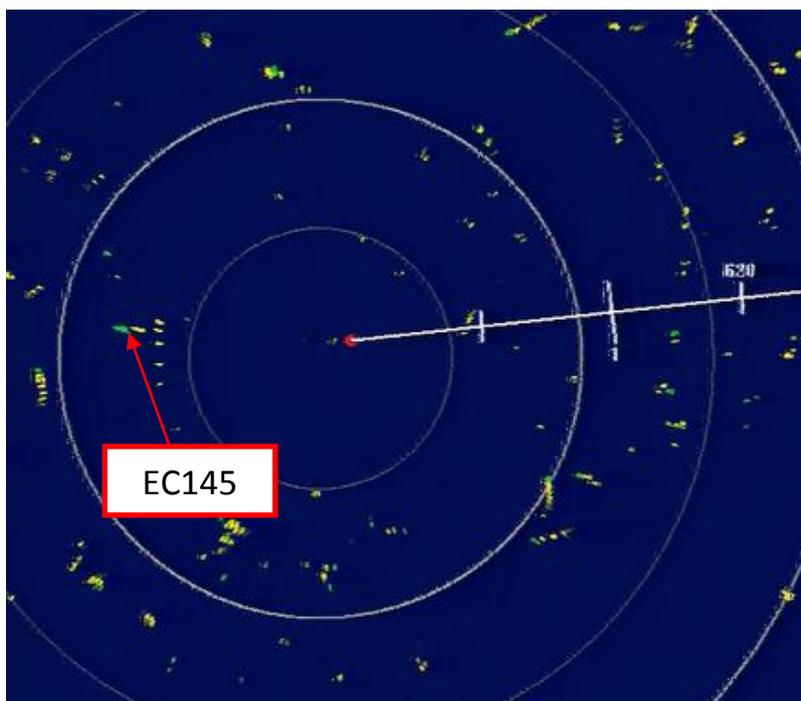
Figure 7

The Swanwick radar recording did not show both contacts at CPA, but the Gloucestershire Airport primary radar recording showed, in the next sweep after Figure 6.1, the reappearance of the EC145 having crossed the northbound track of the PA28 (Figure 7). Analysis of the radar recordings with an assessment of relative track and speed of both aircraft, placed them into a likely conflict at the time the PA28 crossed the RW27 climbout (1016:40 - 300ft vertically, 300m horizontally).

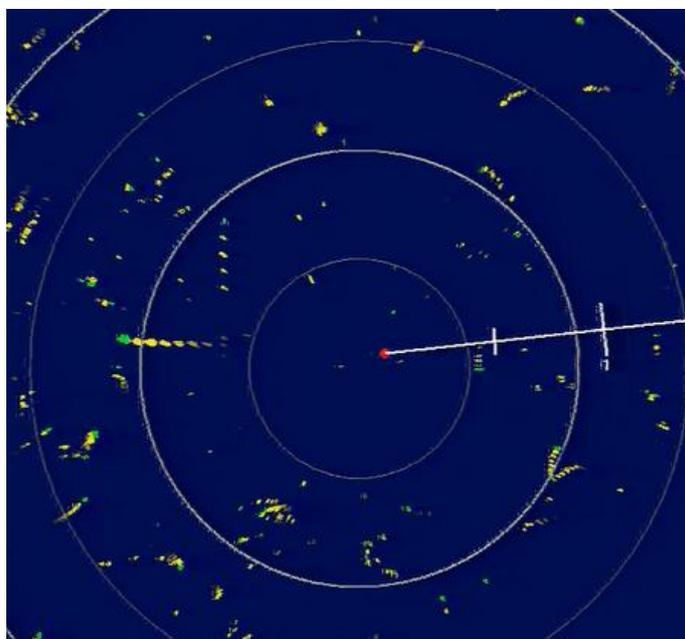
Figure 7.1

The pilot of the EC145, who was training a student in simulated IMC, reported having to take control of the aircraft to perform an avoiding action turn to miss the PA28, which they stated was crossing the runway centreline close to the RW09 threshold at approximately 800-1000ft. The EC145 pilot reported their altitude at the time as 600ft and that they made a descent to 500ft with a slight left turn to avoid, before handing control back to the student. The EC145 continued to track west (Figure 7.1).

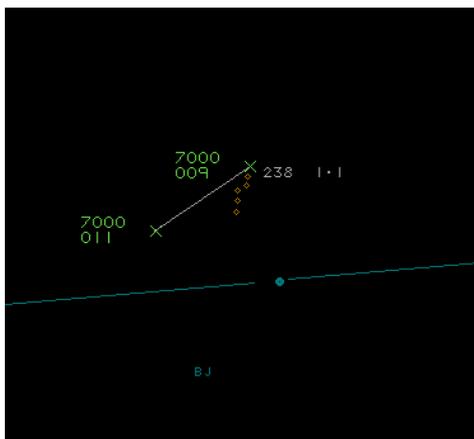
Figure 8 - 1017:15

At 1017:15 the radar return for the EC145 reappeared on the Swanwick radar, now tracking north, 1.1nm SW of the PA28, indicating FL011. The PA28 continued to maintain FL009, and shortly afterwards made a right turn for the downwind leg (Figure 8).

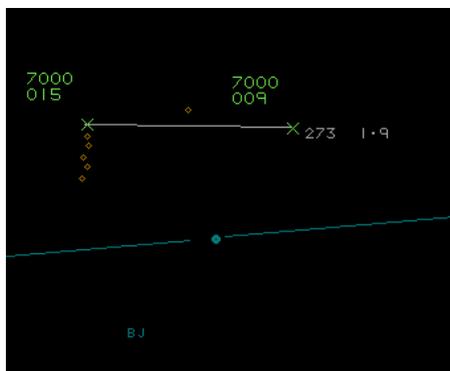
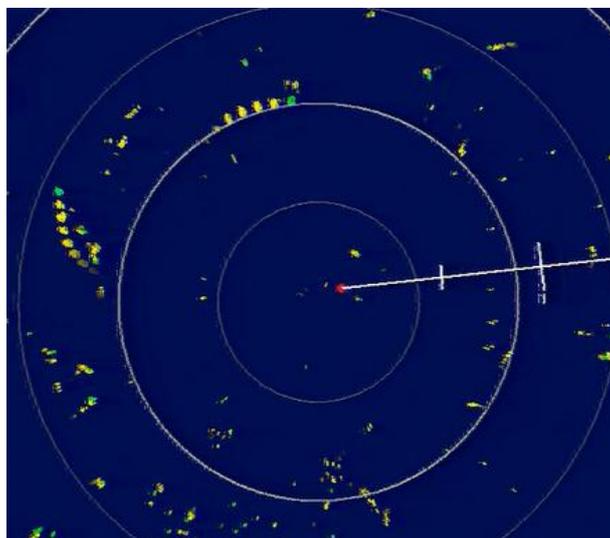
Figure 9

The PA28 continued downwind right-hand, and the EC145 continued in a climb to the north (Figures 9 & 9.1).
