AIRPROX REPORT No 2015087

Date: 26 Apr 2015 Time: 1038Z Position: 5250N 00246W Location: Sleaf Airfield

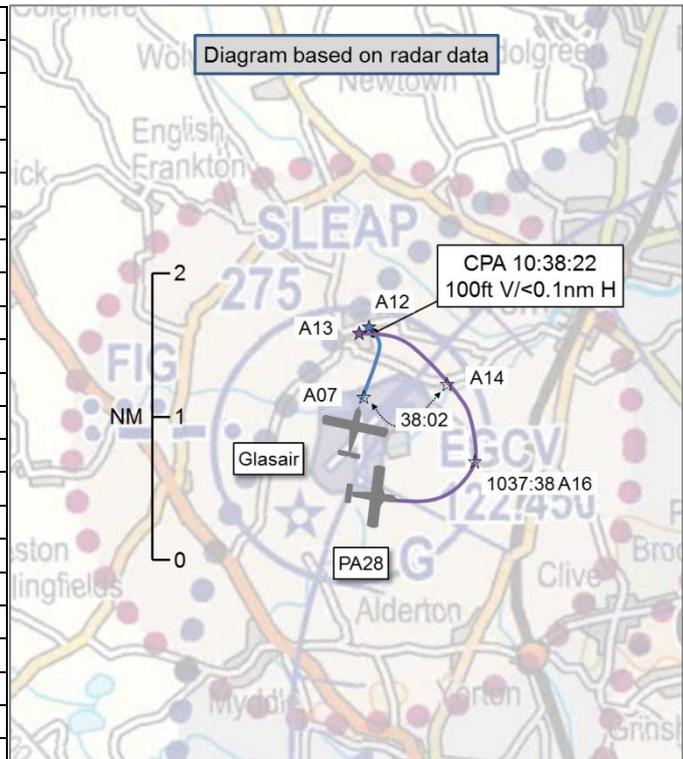
THE GLASAIR PILOT reports departing from Sleaf aerodrome on RW36. As he rolled, he heard another pilot call ‘descending deadside’. He did not see the other aircraft and assumed it would pass behind him, over the upwind threshold of the runway. He continued his take-off and, passing 1400ft at a point about ½-1nm beyond the upwind threshold, a blue, low-wing, ‘T tail’, single-engine Piper aircraft passed directly over him, perpendicular to his flight path and about 50-100ft above. Neither the Glasair pilot, sitting in the left seat, nor the pilot qualified passenger sitting in the right seat, saw the other aircraft before CPA and there was therefore no time to take avoiding action.

An Airprox was reported when a Glasair and a PA28 flew into proximity at 1038 on Sunday 26th April 2015. Both pilots were operating under VFR in VMC, in receipt of an A/G Service from Sleaf. The Glasair pilot had just taken-off and was departing upwind when he saw the PA28 pass directly above, on a perpendicular track, at a vertical separation estimated to be 50-100ft; the PA28 pilot had just arrived at the airfield and was on the crosswind leg of his overhead join. He did not see the Glasair.

Cause: The PA28 pilot flew into conflict with the Glasair.

Contributory Factor: The PA28 pilot did not conform to the 'Standard Overhead Join' procedure.

Degree of Risk: A.

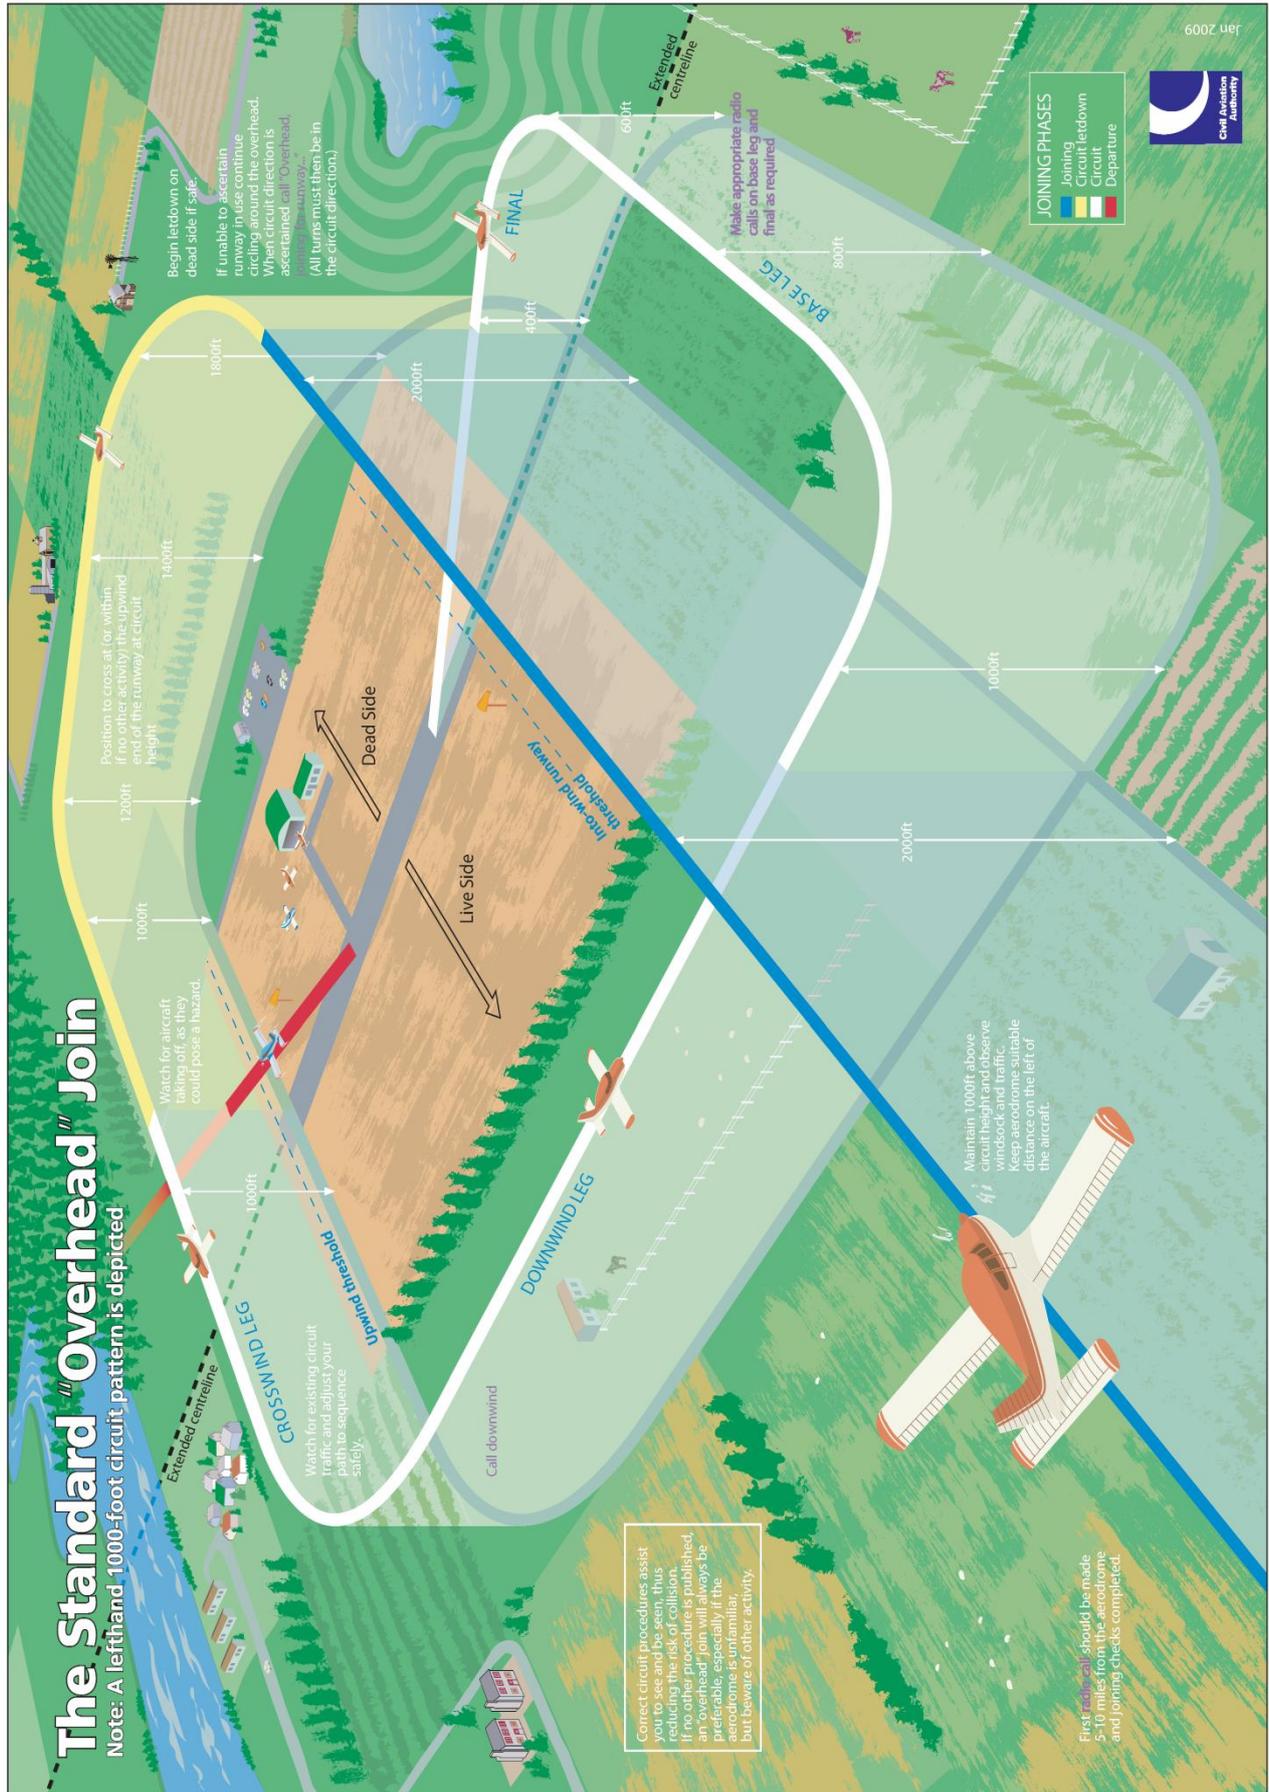
The Glasair and PA28 pilots shared an equal responsibility for collision avoidance and not to operate in such proximity to other aircraft as to create a collision hazard¹. An aircraft operated on or in the vicinity of an aerodrome shall conform with or avoid the pattern of traffic formed by other aircraft in operation². The 'standard overhead join' is not defined in statute but is regarded as 'normal aviation practice'. The CAA GA Safety Poster 'The Standard "Overhead" Join'³ states that pilots should 'Position to cross at (or within if no other activity) the upwind end of the runway at circuit height'. The poster also states, 'Watch for aircraft taking off, as they could pose a hazard'.
