**AIRPROX REPORT No 2015092**

Date: 23 Jun 2015 Time: 1729Z Position: 5311N 0238W Location: Oulton Park

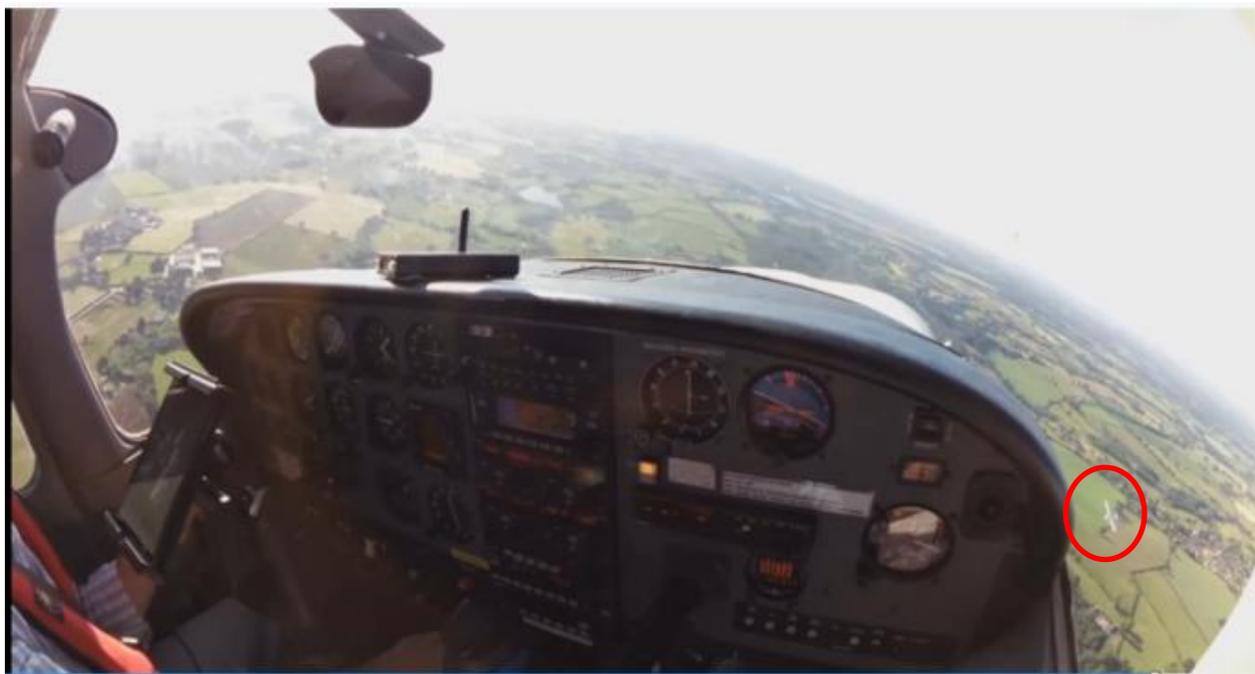
The C182 pilot provided a screen grab of his cockpit video, showing the other aircraft at bottom right, apparently in a left turn:

In considering the cause of the Airprox, the Board noted that neither pilot had seen each other and that this was the reason they had come into proximity. The Board were fortunate that the C182 pilot had provided video of the encounter and, in examining this video; members agreed that safety margins had been much reduced below the norm.

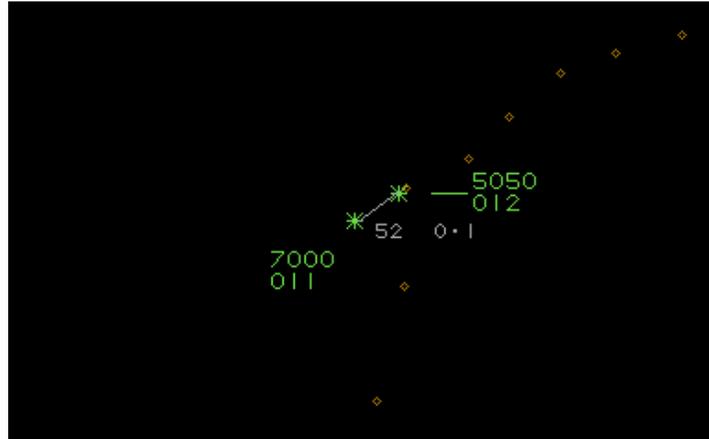
Figure 1 – CPA – Swanwick MRT at 1729:27

ATSI had access to one pilot report, the Swanwick Radar recording and recordings of the relevant radio frequencies. The pilot of the C182 reports listening in to the Liverpool frequency for 5 minutes prior to establishing contact. At 1724:50 a clearance to join controlled airspace via Oulton Park was issued by Liverpool. A Basic Service was agreed outside Controlled Airspace and the C182 was given a SSR code of 5050. The issuance of such a code does not constitute the provision of a surveillance related service<sup>1</sup>. The C182 reported at Oulton Park at 1728:48 but it was approximately 20 seconds before this was acknowledged by the controller. When the call was acknowledged generic traffic information was passed to advise the C182 of traffic in the vicinity that was not working Liverpool. CPA occurred at 1729:27, vertical 100ft and approximately 0.1NM horizontally (Figure 1). Oulton Park VRP is approximately 1 NM southeast of the Liverpool CTR (Figure 2). The unknown aircraft had been routing eastbound until approximately 2 minutes prior to the reported Airprox, when it had turned left onto a westerly track. Under a Basic Service a controller is not required to monitor a flight. Whether traffic information has been provided or not, the pilot remains responsible for collision avoidance without assistance from the controller.<sup>2</sup>
