AIRPROX REPORT No 2015101

Date: 2 Jul 2015 Time: 1407Z Position: 5300N 00037W Location: 5nm SW Cranwell

PART A: SUMMARY OF INFORMATION REPORTED TO UKAB

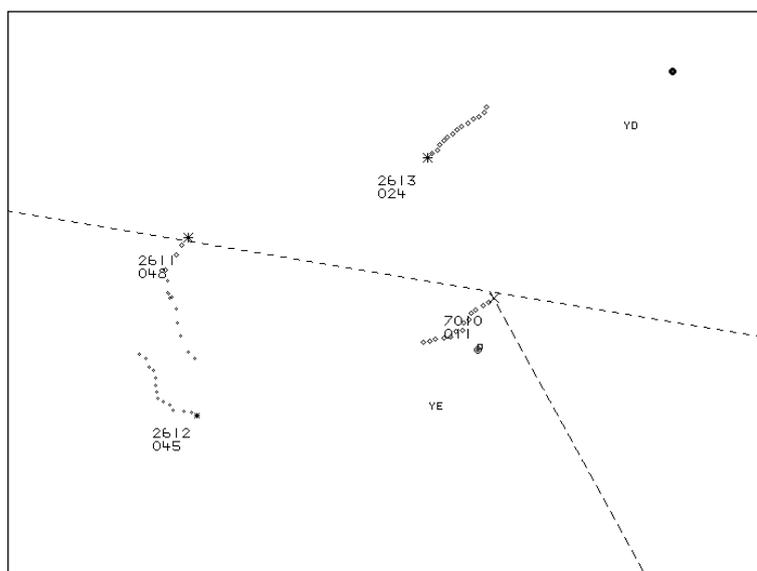
At 1405:40 (Figure 1), the controller transmitted, "{Tutor B}, *further traffic just departed Cranwell similar type, east 2 miles south west bound, 2000 ft below climbing.*"

Figure 1: Traffic Information at 1405:40 (Tutor A squawk 2613; Tutor B squawk 2611)

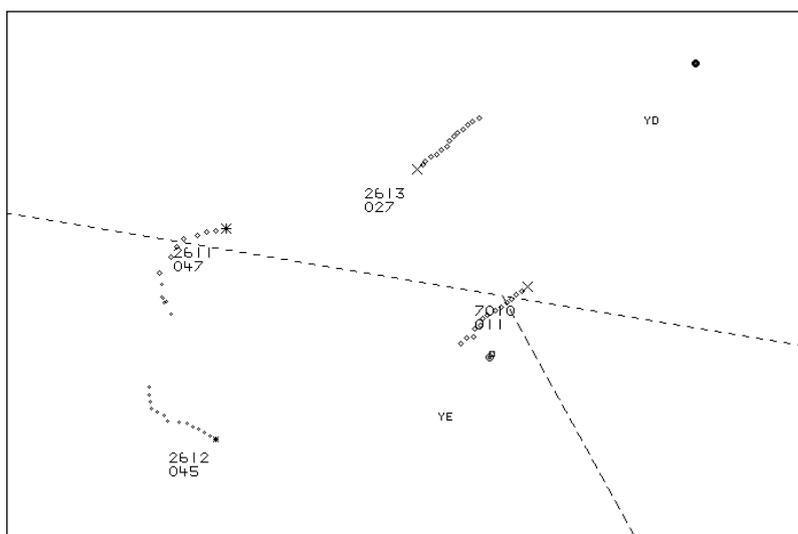
At 1405:57 (Figure 2), the controller transmitted, "{Tutor A} *traffic west 2 miles manoeuvring east bound similar type 2000 ft above.*"

Figure 2: Traffic Information at 1405:57

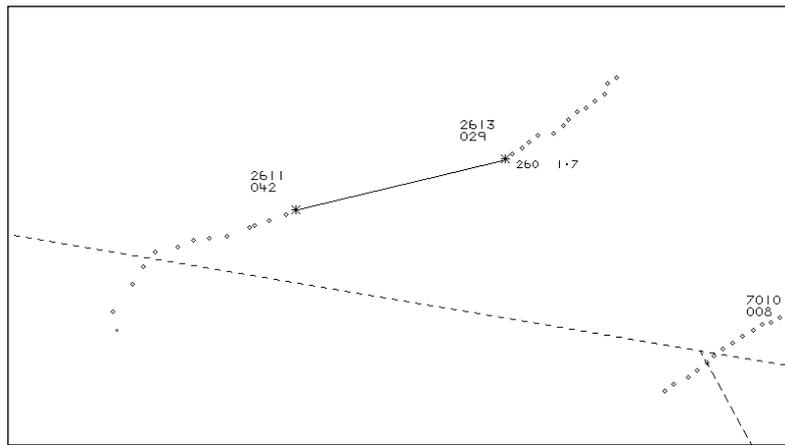
At 1406:17 (Figure 3), an update was provided, "{Tutor B}, *traffic east 1 mile south west bound, tutor 1000 ft below climbing out.*"

Figure 3: Traffic update at 1406:17

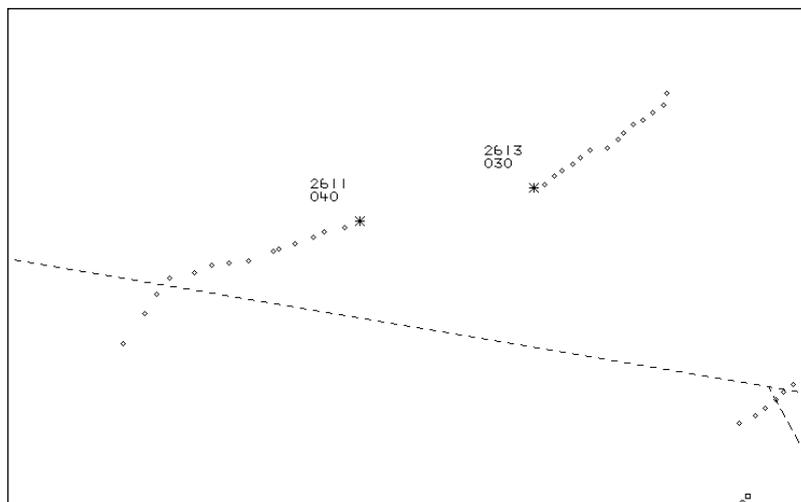
At 1406:22 (Figure 4), Tutor(B) transmitted, “{Tutor B}, is looking and uh, sortie complete requesting a mast (?) join for downwind, visual with that aircraft.”

Figure 4: Tutor B confirming visual at 1406:22

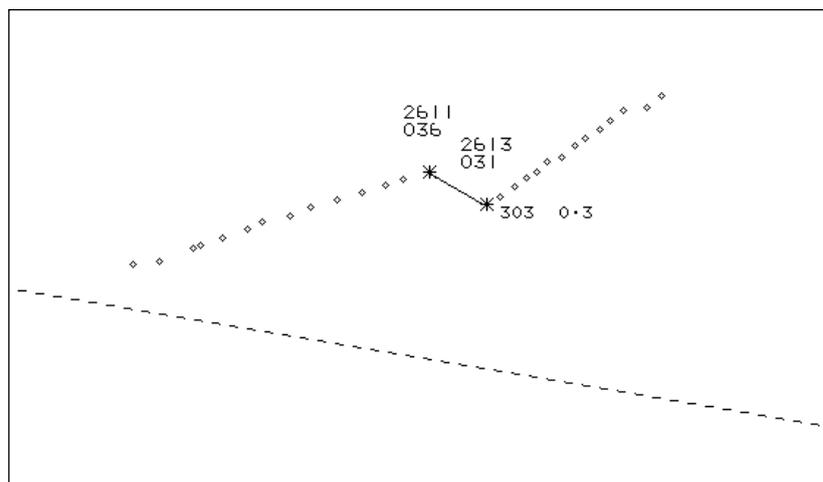
The CPA was estimated at 1406:45 (Figure 5) with 0.3nm and 500ft

Figure 5: Geometry at 1406:45
