AIRPROX REPORT No 2015103

Date: 3 Jul 2015 Time: 1355Z Position: 5154N 00210W Location: Gloucester Aerodrome

PART A: SUMMARY OF INFORMATION REPORTED TO UKAB

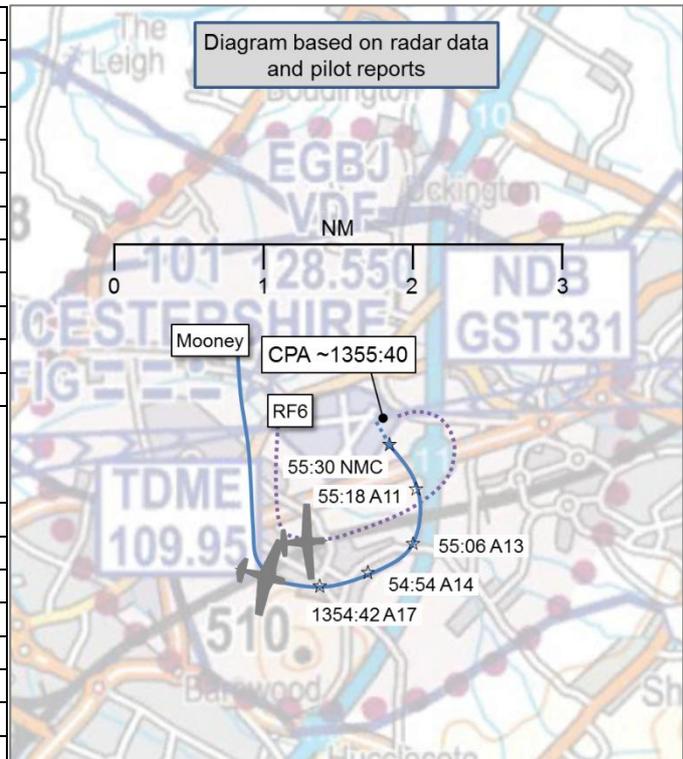
Recorded	Aircraft 1	Aircraft 2
Aircraft	Mooney M20	Fournier RF6
Operator	Civ Pte	Civ Trg
Airspace	Gloster ATZ	Gloster ATZ
Class	G	G
Rules	VFR	VFR
Service	Aerodrome	Aerodrome
Provider	Gloster TWR	Gloster TWR
Altitude/FL		
Transponder	A, C, S	Not fitted
Reported		
Colours	White/red	Yellow
Lighting	Red beacon, wing and tail strobes	NK
Conditions	VMC	VMC
Visibility	>10km	>10km
Altitude/FL	1000ft	1500ft
Altimeter	QFE (1021hPa)	QNH (1022hPa)
Heading	355°	180°
Speed	100kt	75kt
ACAS/TAS	Not fitted	Not fitted
Separation		
Reported	20ft V/<50m H	0ft V/100m H
Recorded	NK

By monitoring the progress of the Mooney and correlating this with the RT recording, it was possible to establish that the Airprox occurred just as the Mooney pilot approached overhead the threshold of RW27, heading north for crosswind RW09 left-hand. The controller would not have been able to see the RF6 turn overhead (as this is not possible from the VCR due to the ceiling), so was reliant on timely and accurate position reports by pilots in order to discharge their responsibility for providing Traffic Information, in accordance with providing an Aerodrome Control Service.
