AIRPROX REPORT No 2015116

Date: 23 Jul 2015 Time: 1100Z Position: 5757N 00113E Location: North Sea

PART A: SUMMARY OF INFORMATION REPORTED TO UKAB

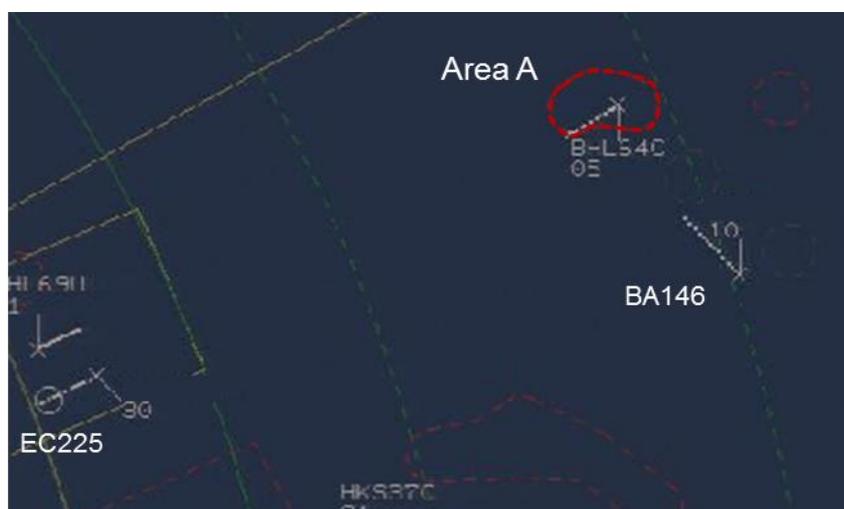
Figure 1 – 1049:45

The EC225 was en-route to the Britannia Platform, in receipt of an Offshore Traffic Service. The BA146 was flying a north-westerly track, at low-level, in receipt of a Basic Service. Prior to the Airprox, the BA146 turned in the vicinity of the Alba and Britannia platforms onto a reciprocal track (Figure 1, Area A). Another helicopter flying inbound to this area approximately 30nm ahead of the EC225 had been passed traffic information on the BA146, as had the BA146 on the helicopter. On initial contact with the Aberdeen controller, the pilot of the EC225 was advised that there was no-known traffic to affect his descent, he was instructed to report passing 1500ft and given a barometric pressure setting.

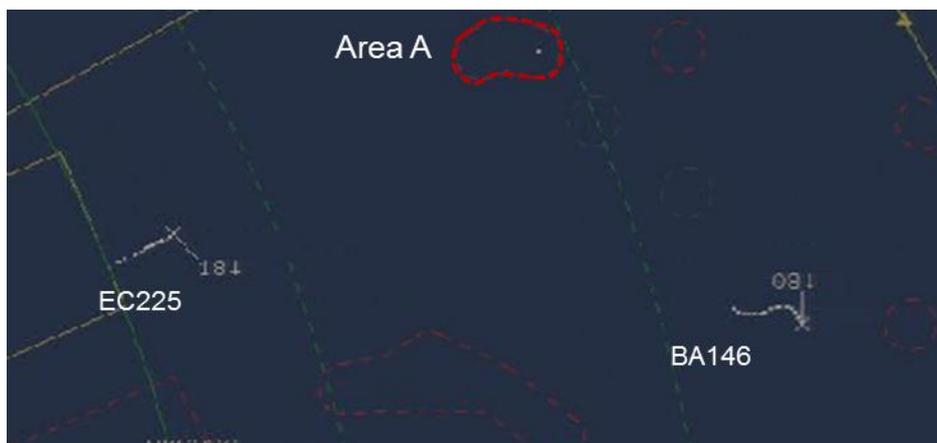
Figure 2 – 1053:30

At 1053:40, the controller terminated the service being given to the EC225 and cleared the pilot to leave the frequency, which the pilot of the EC225 acknowledged. At this time the BA146 was manoeuvring approximately 35nm ESE of the EC225 at an indicated altitude of 800ft, the EC225 was descending, passing an indicated altitude of 1800ft (Figure 2).

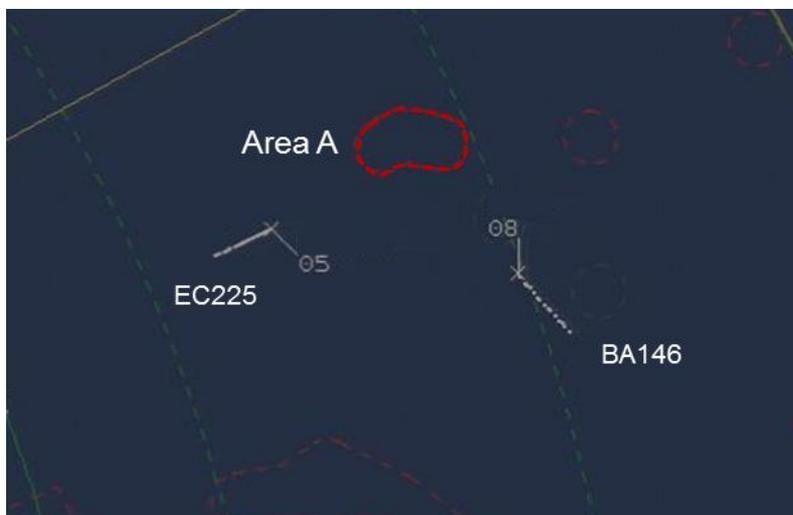
Figure 3 – 1058:09

At 1058:09, the BA146 had re-established on a north-westerly track back towards the area of the platforms flying at an indicated altitude of 800ft. The controller made a call to the EC225, which was now maintaining an indicated altitude of 500ft, but received no response (Figure 3).

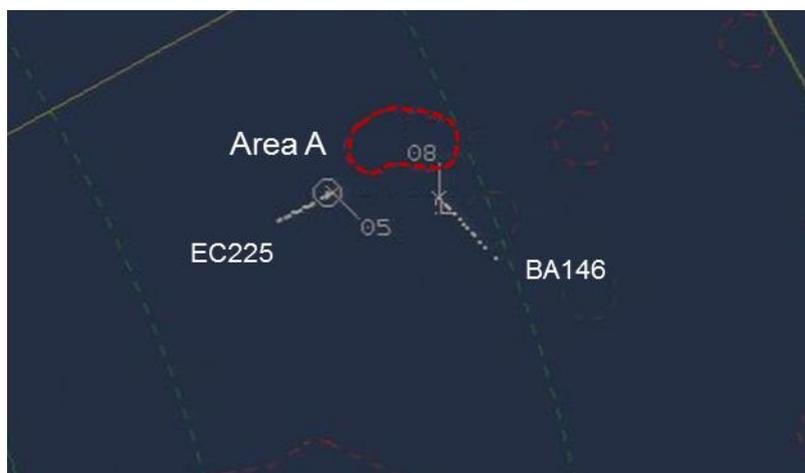
Figure 4 – 1059:50

At 1059:50 a cursor was placed over the EC225 contact on the controller's radar display (Figure 4).

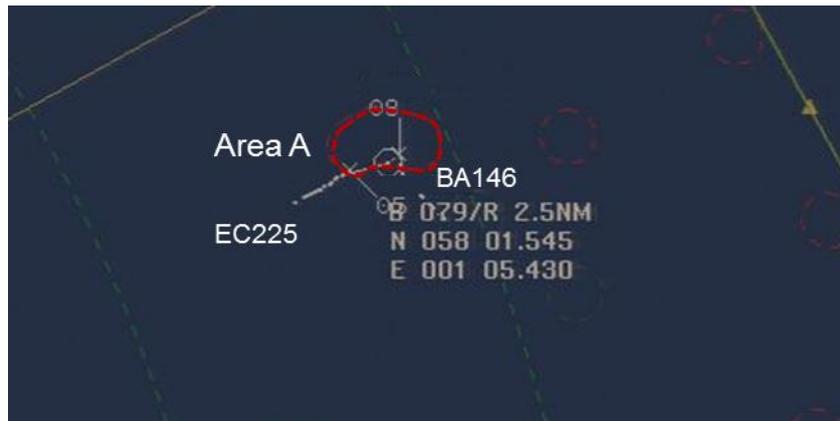
Figure 5 – 1100:36

At 1100:36, the controller measured the distance between the EC225 and BA146 contacts on their radar display. The EC225 was maintaining an indicated altitude of 500ft and the BA146 800ft with an indicated horizontal separation of 2.5nm (Figure 5).

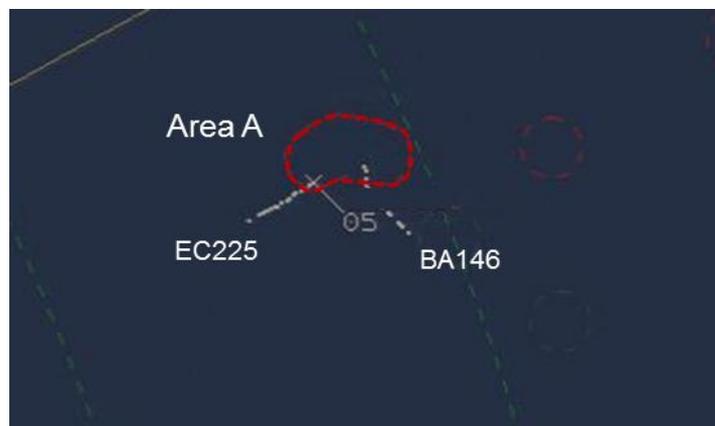
Figure 6 – 1100:44

At 1100:44 the BA146 disappeared from radar, directly ahead of the EC225. The EC225 contact was observed making a right turn, now at an indicated altitude of 400ft (Fig 6).

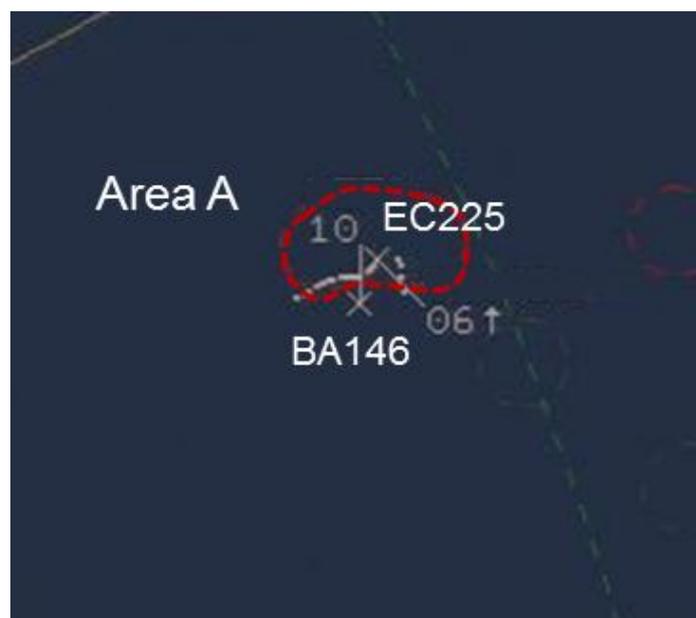
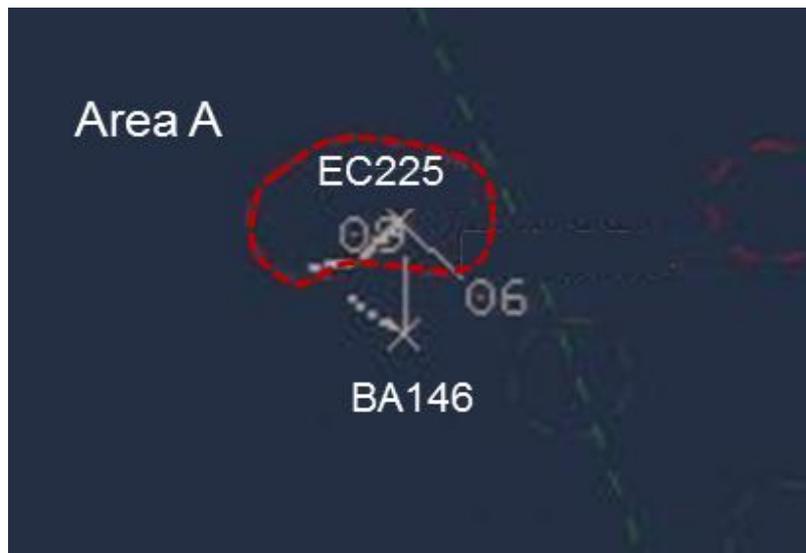
At 1101:37 the BA146 reappeared on radar now on a south-easterly track at an indicated altitude of 1000ft. The EC225 was observed making a turn to the left, with a climb to an indicated altitude of 600ft (Figure 7&8).
